Structural Repair Quality Analysis Report

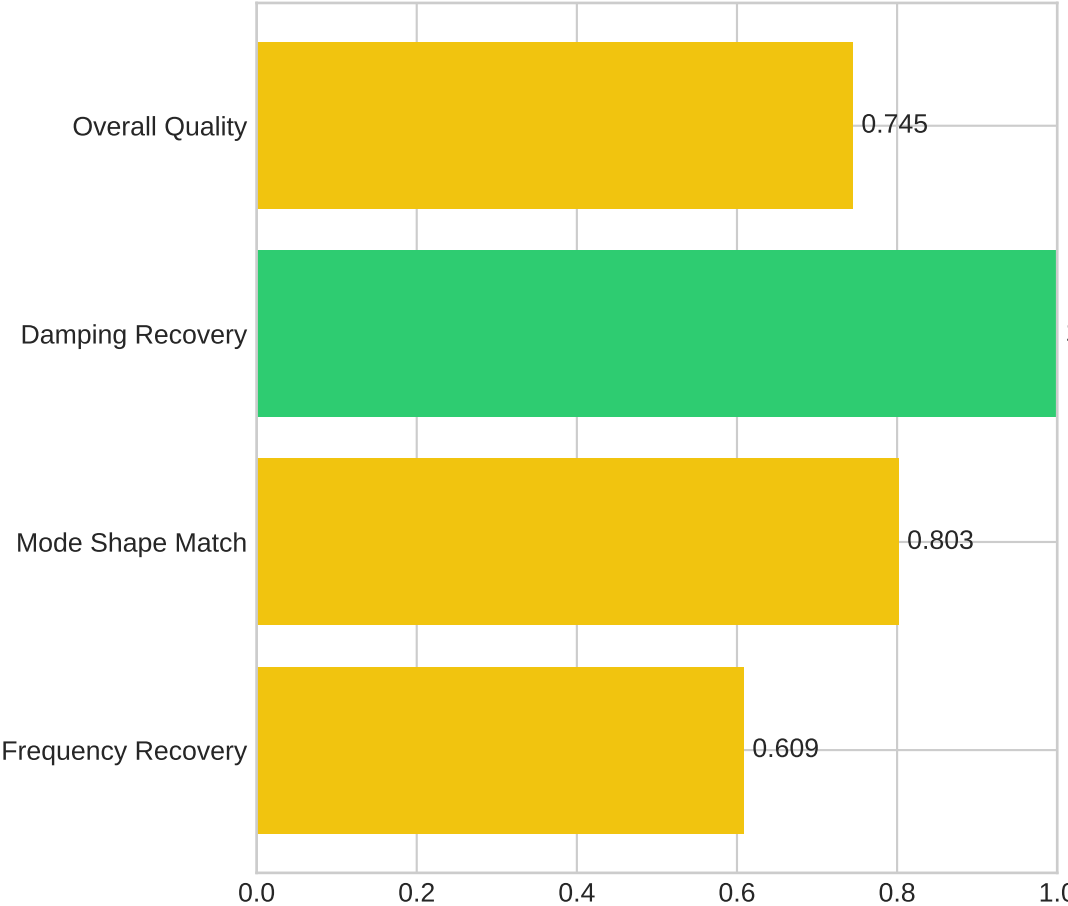
Quality Score Breakdown

0.745

Repair Quality Score

Good - Acceptable Repair
