Structural Repair Quality Analysis Report

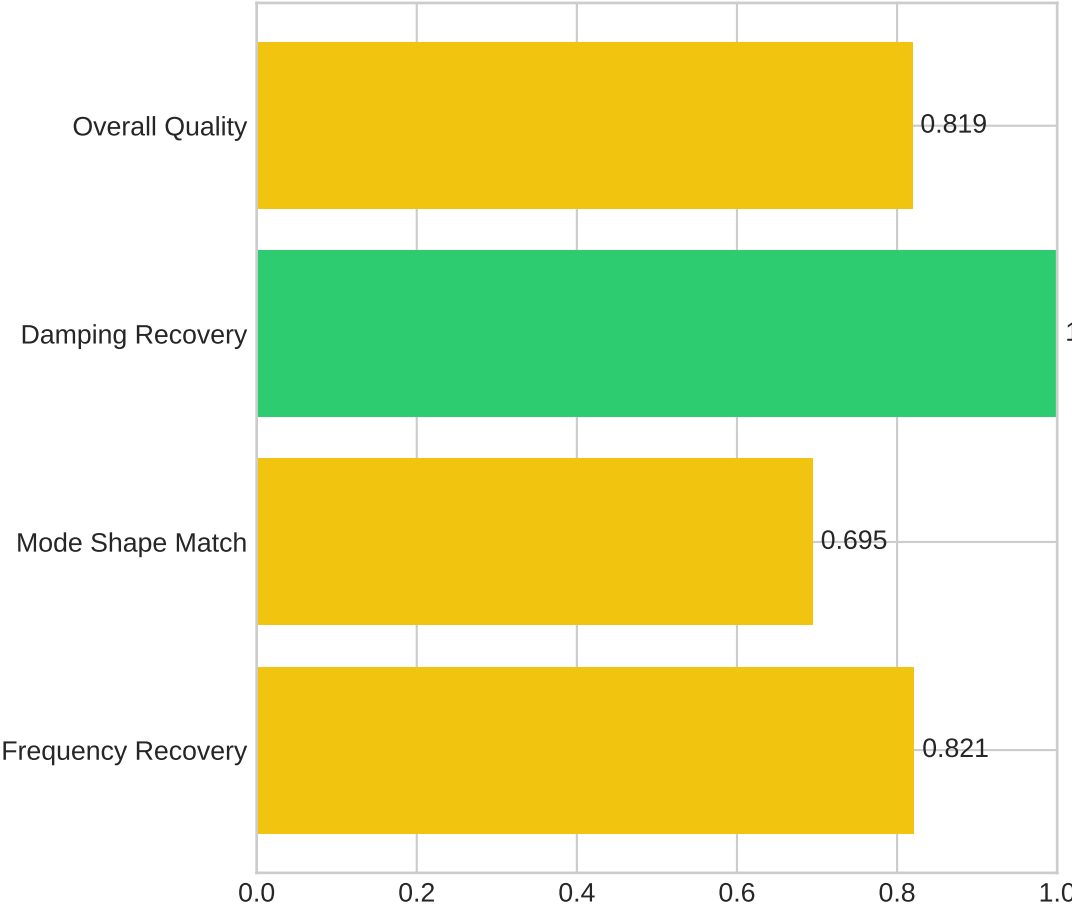
Quality Score Breakdown

0.819

Repair Quality Score

Good - Acceptable Repair
