Structural Repair Quality Analysis Report

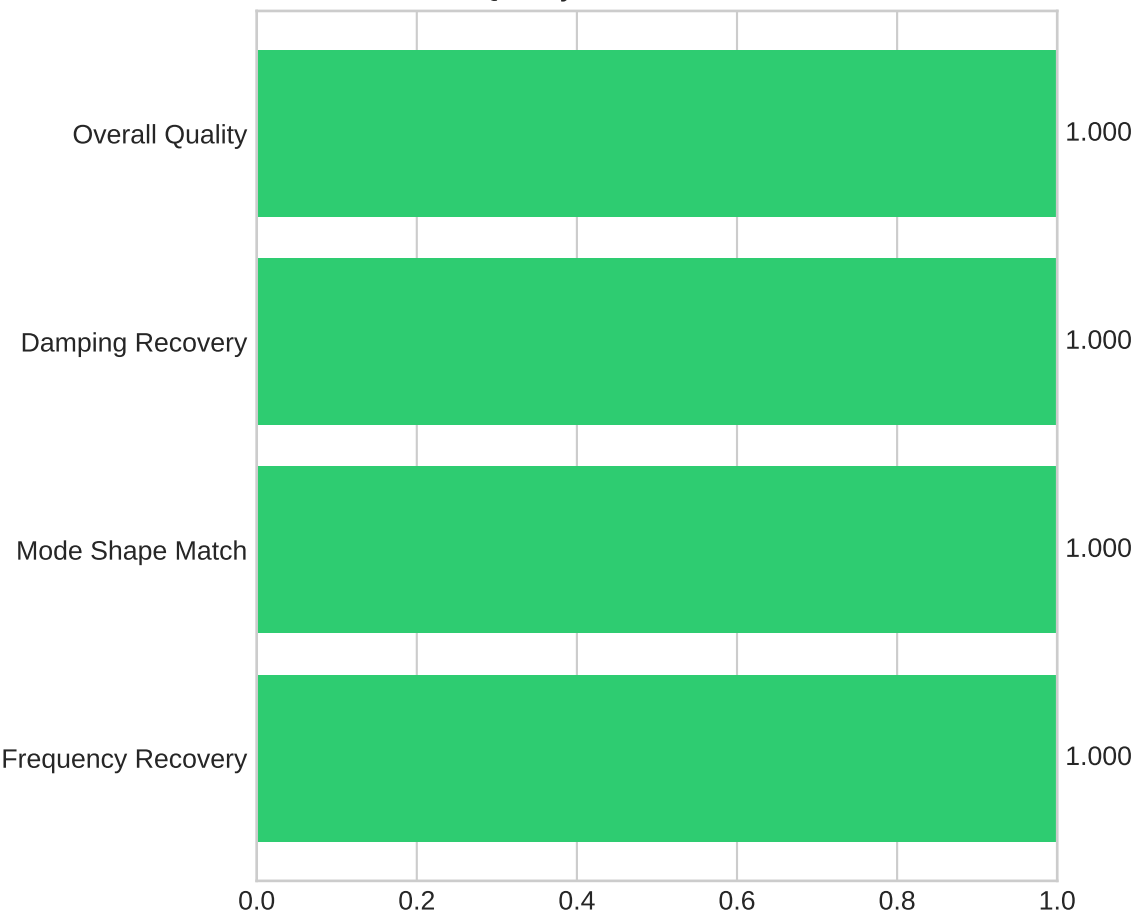
Quality Score Breakdown

1.000

Repair Quality Score

Excellent - Nearly Perfect Repair
