Structural Repair Quality Analysis Report

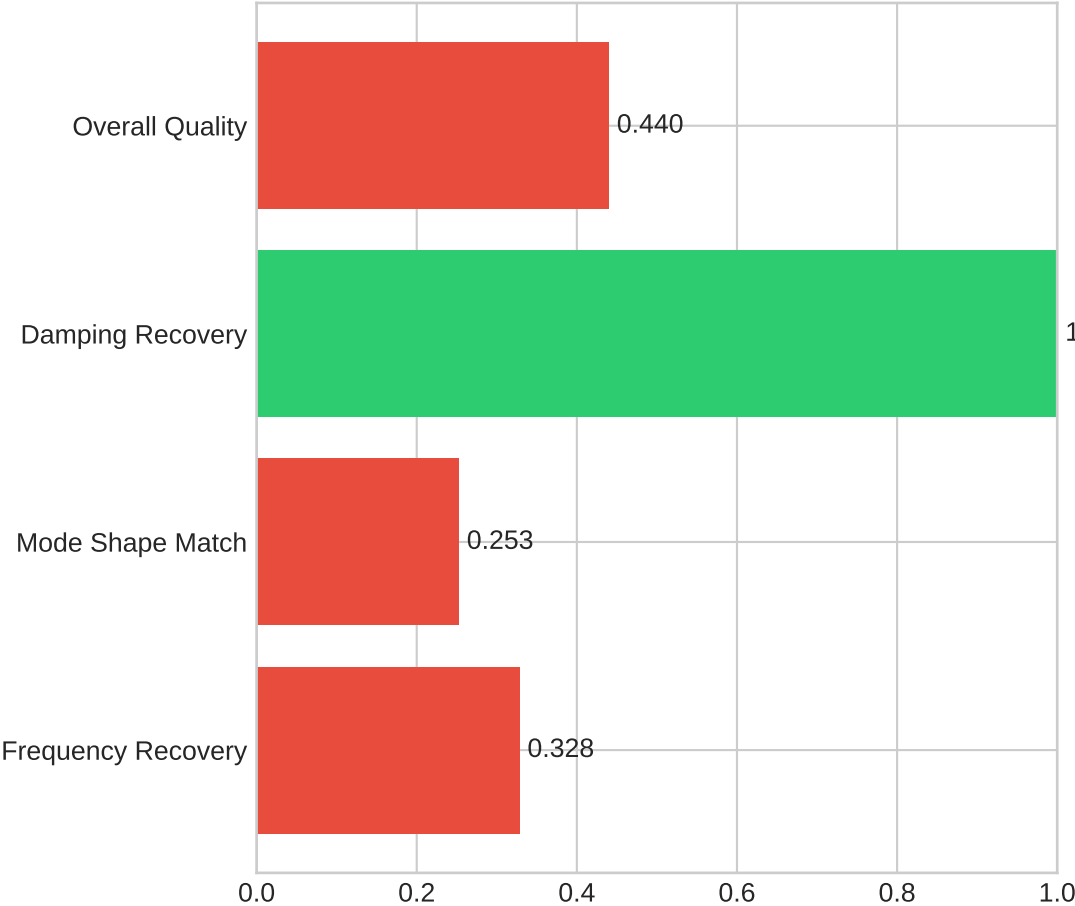
Quality Score Breakdown

0.440

Repair Quality Score

Poor - Minimal Improvement
