Structural Repair Quality Analysis Report

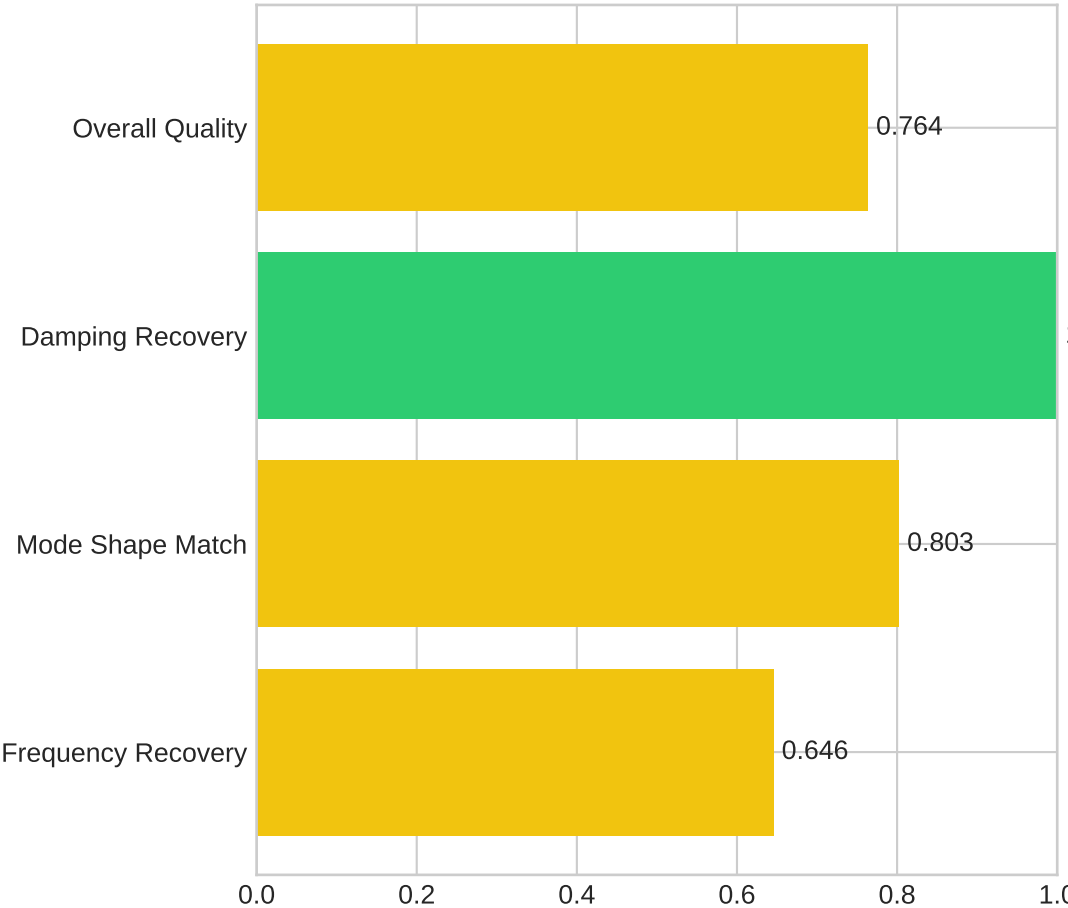
Quality Score Breakdown

0.764

Repair Quality Score

Good - Acceptable Repair
