Structural Repair Quality Analysis Report

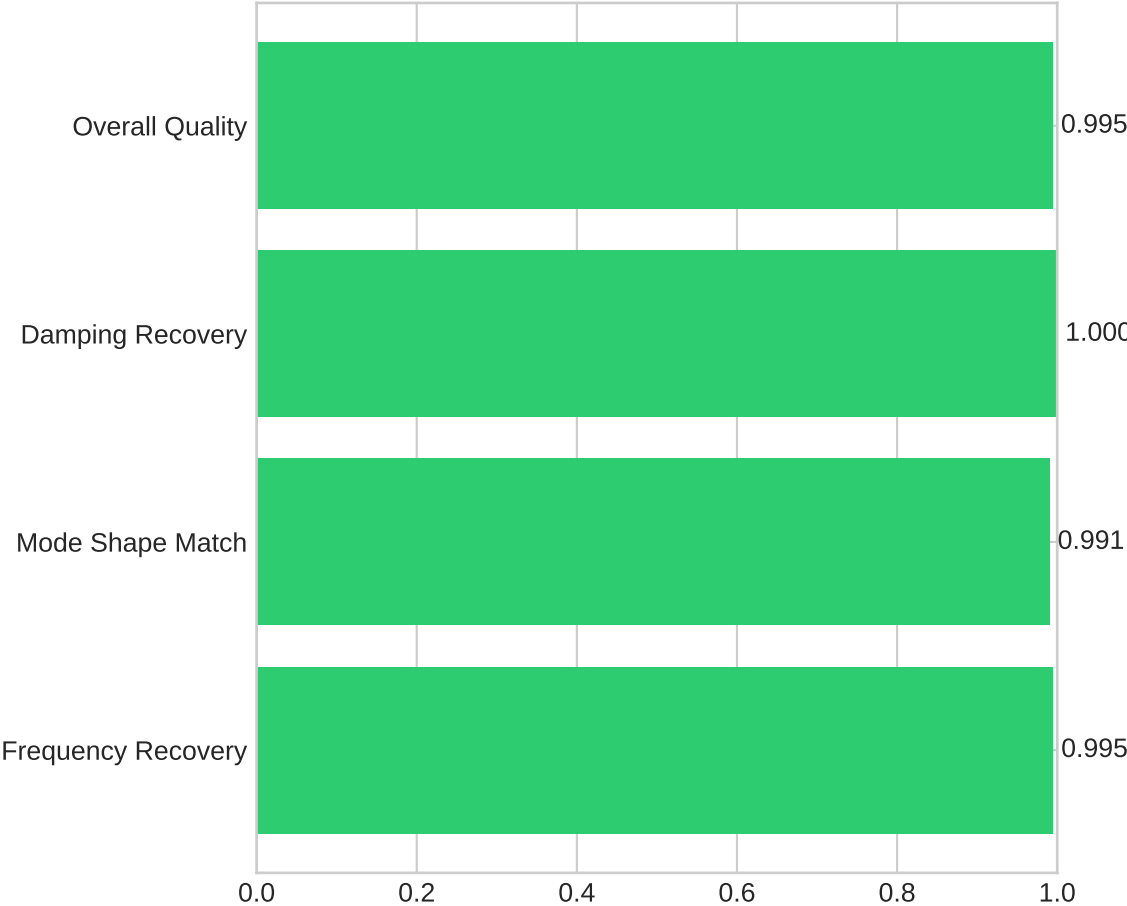
Quality Score Breakdown

0.995
Repair Quality Score
Excellent - Nearly Perfect Repair
2026-01-17 18:58:17
