Structural Repair Quality Analysis Report

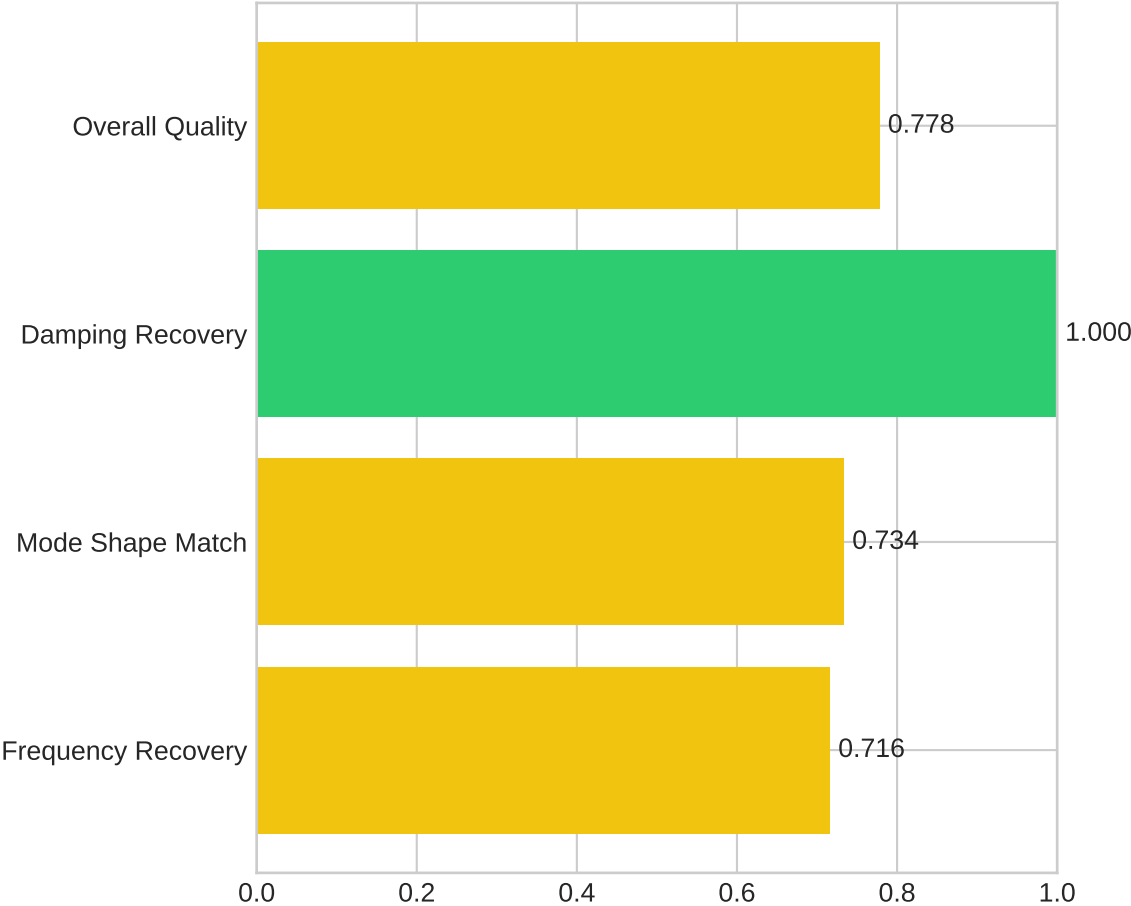
Quality Score Breakdown

0.778
Repair Quality Score
Good - Acceptable Repair
2026-01-15 20:18:25
