# Structural Repair Quality Analysis Report

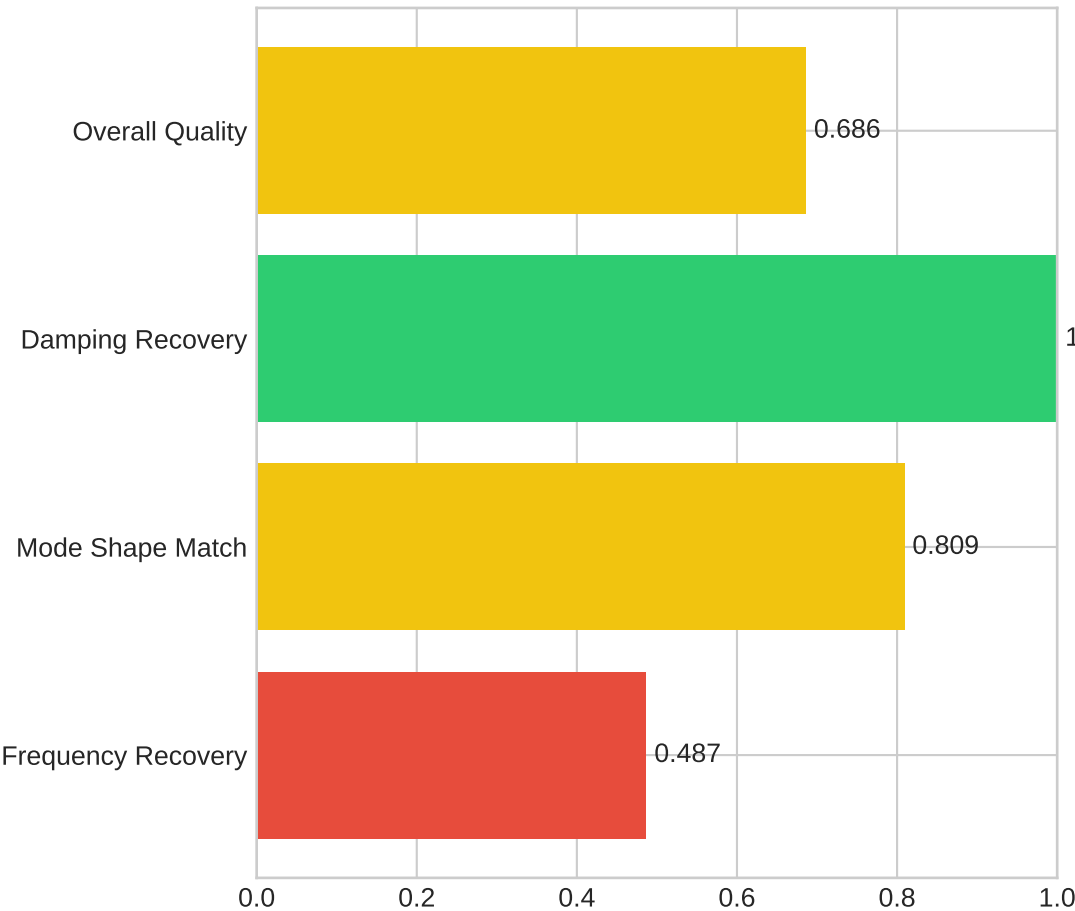
Quality Score Breakdown

0.686

Repair Quality Score

Fair - Partial Improvement
