Structural Repair Quality Analysis Report

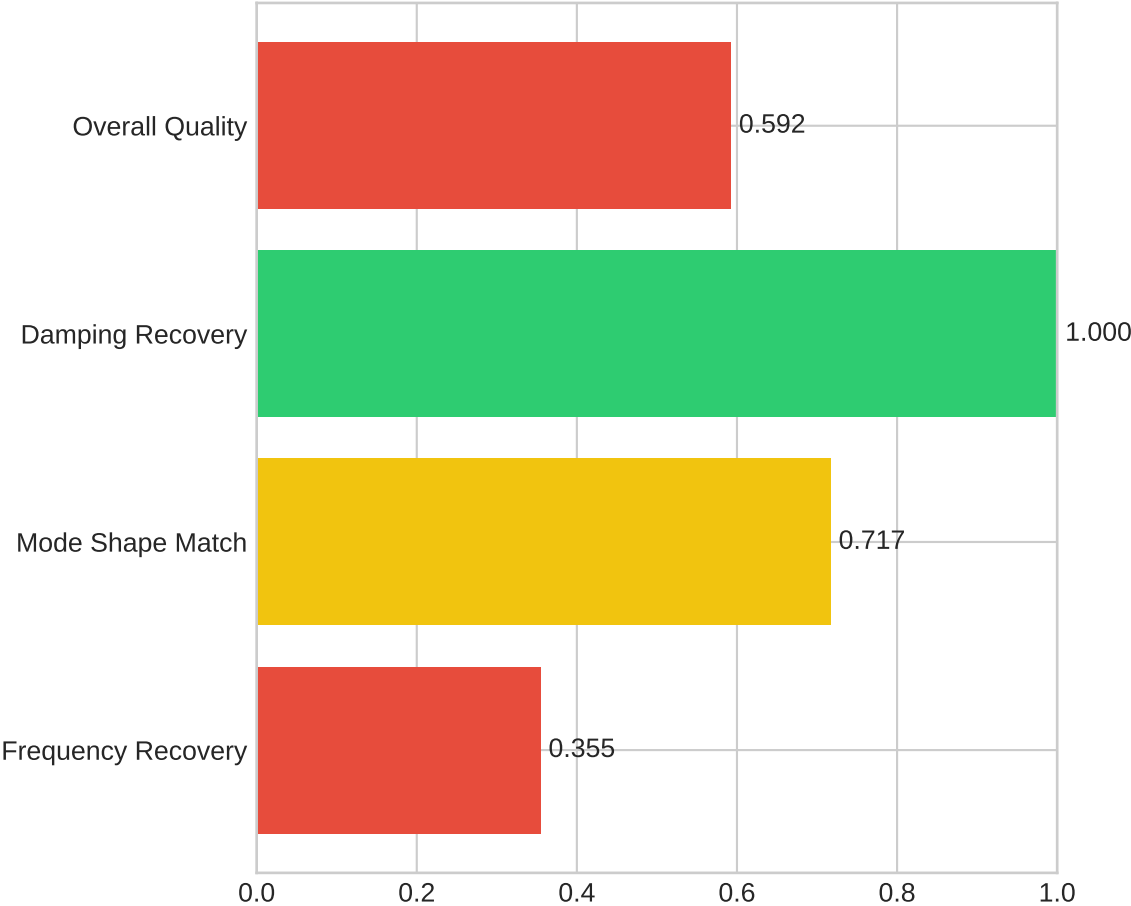
Quality Score Breakdown

0.592

Repair Quality Score

Fair - Partial Improvement
