Structural Repair Quality Analysis Report

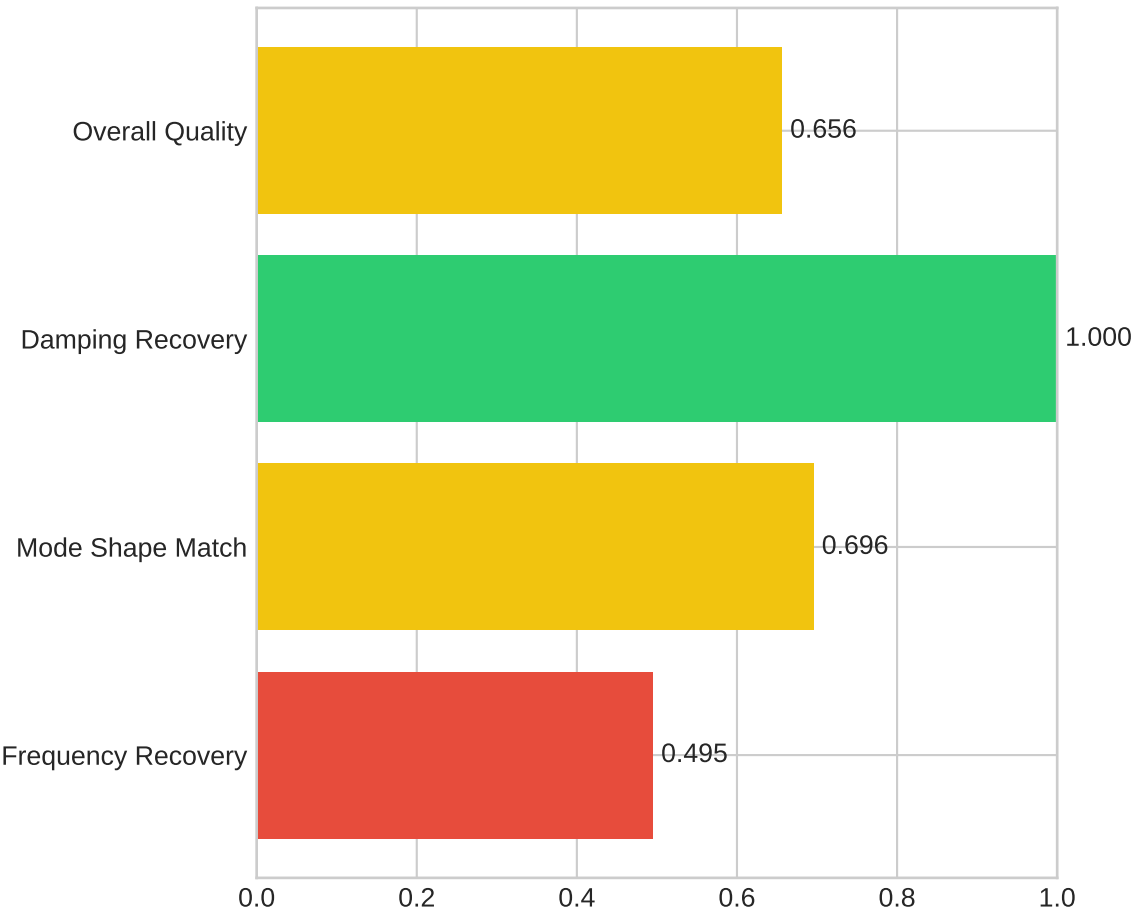
Quality Score Breakdown

0.656

Repair Quality Score

Fair - Partial Improvement
