Structural Repair Quality Analysis Report

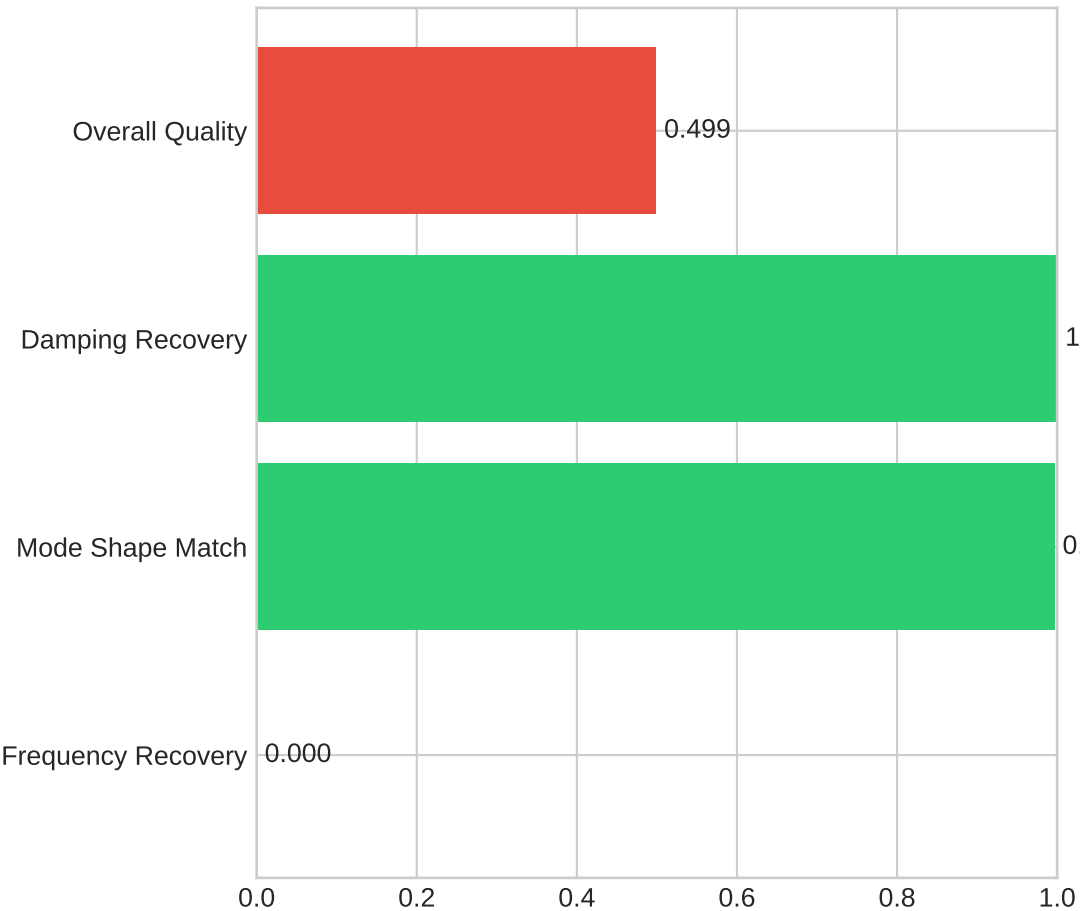
Quality Score Breakdown

0.499

Repair Quality Score

Poor - Minimal Improvement
