Structural Repair Quality Analysis Report

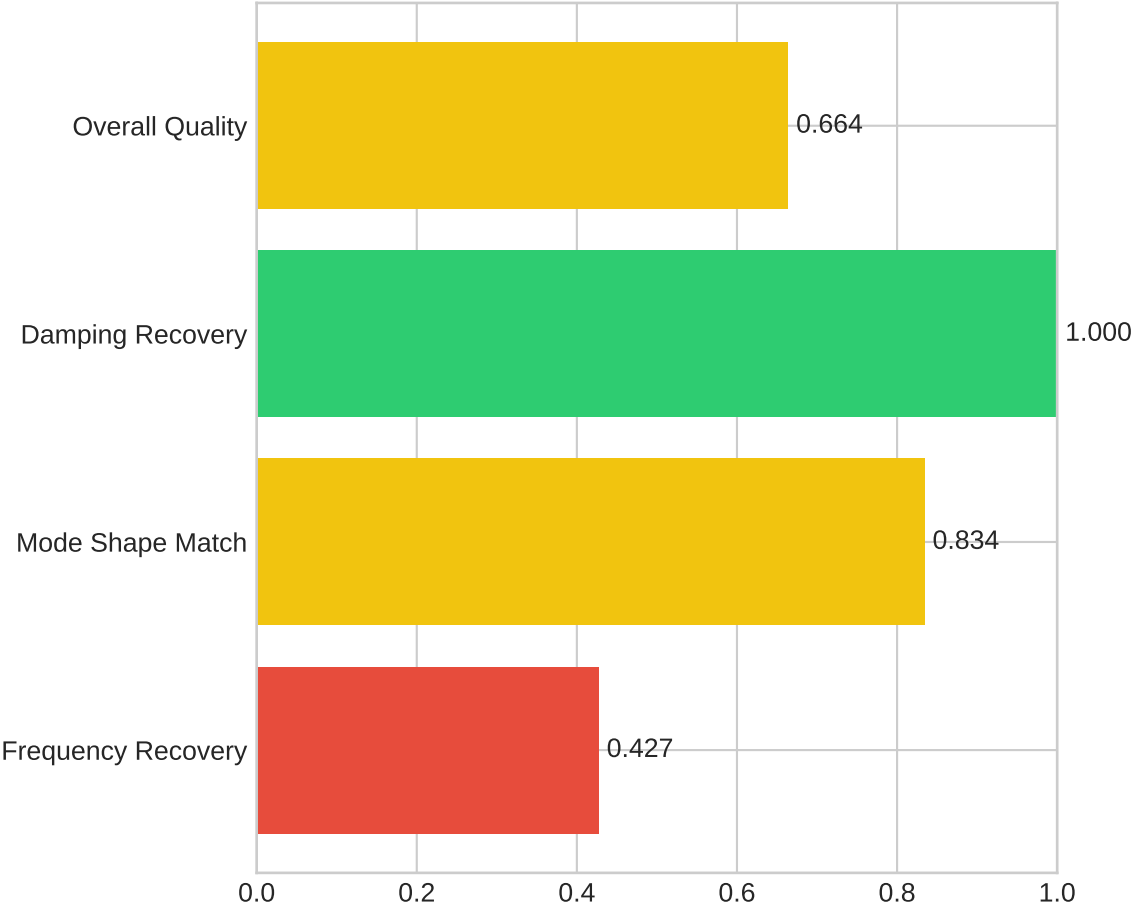
Quality Score Breakdown

0.664

Repair Quality Score

Fair - Partial Improvement
