Structural Repair Quality Analysis Report

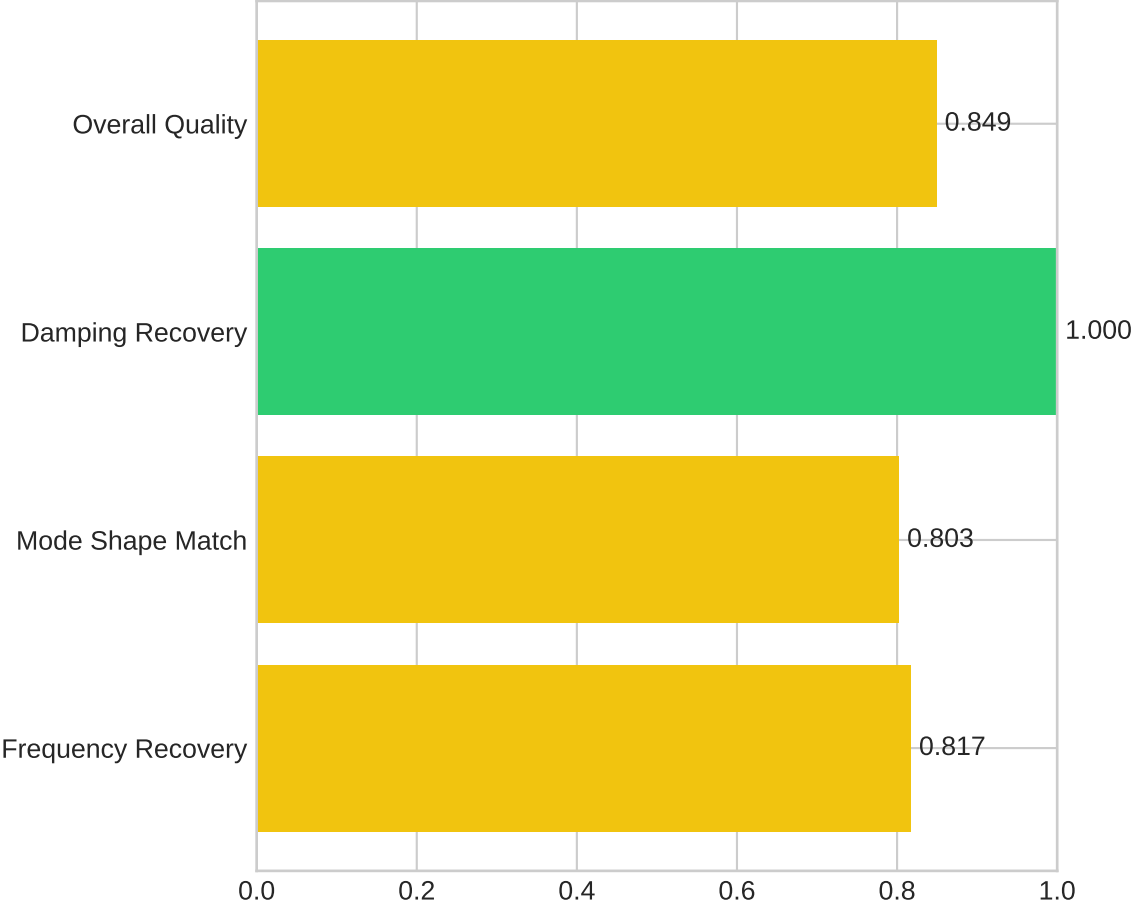
Quality Score Breakdown

0.849

Repair Quality Score

Good - Acceptable Repair
