Structural Repair Quality Analysis Report

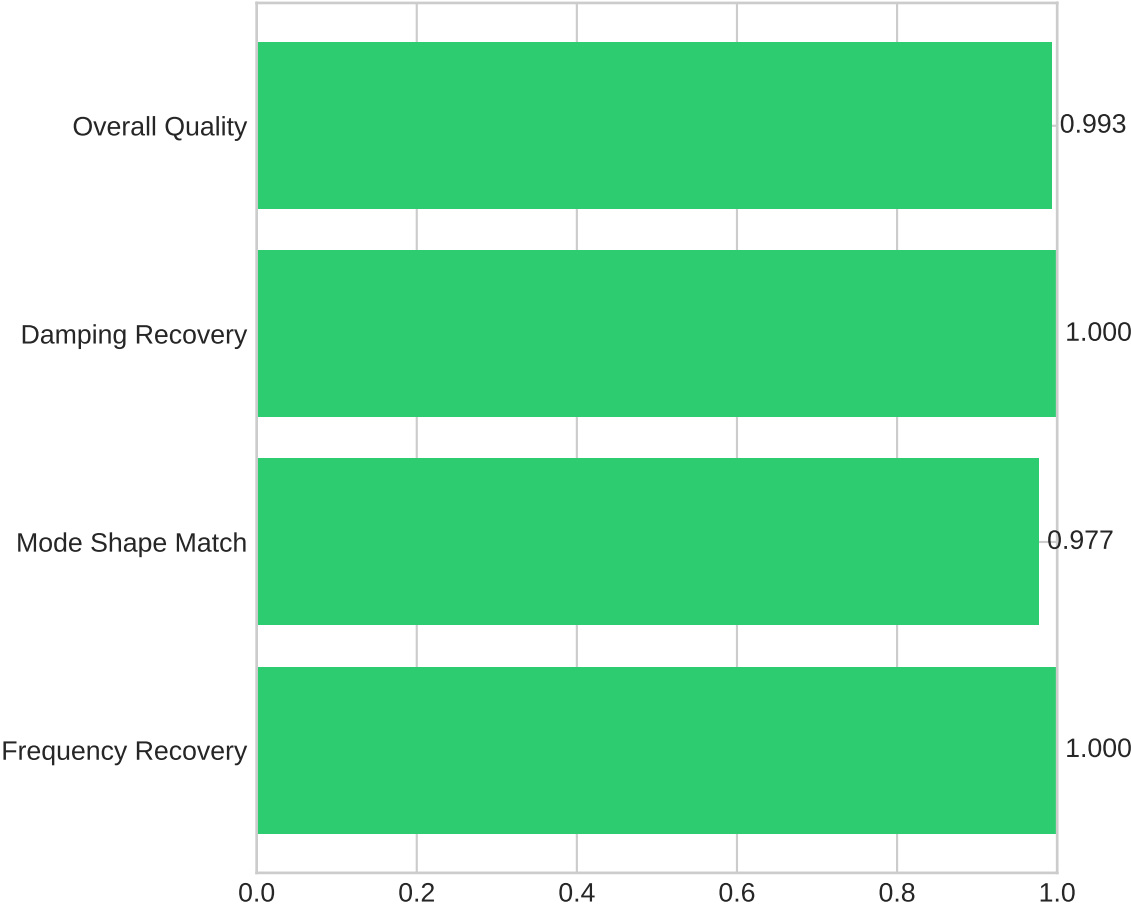
Quality Score Breakdown

0.993
Repair Quality Score
Excellent - Nearly Perfect Repair
2026-01-22 10:01:20
