Structural Repair Quality Analysis Report

Overall Assessment

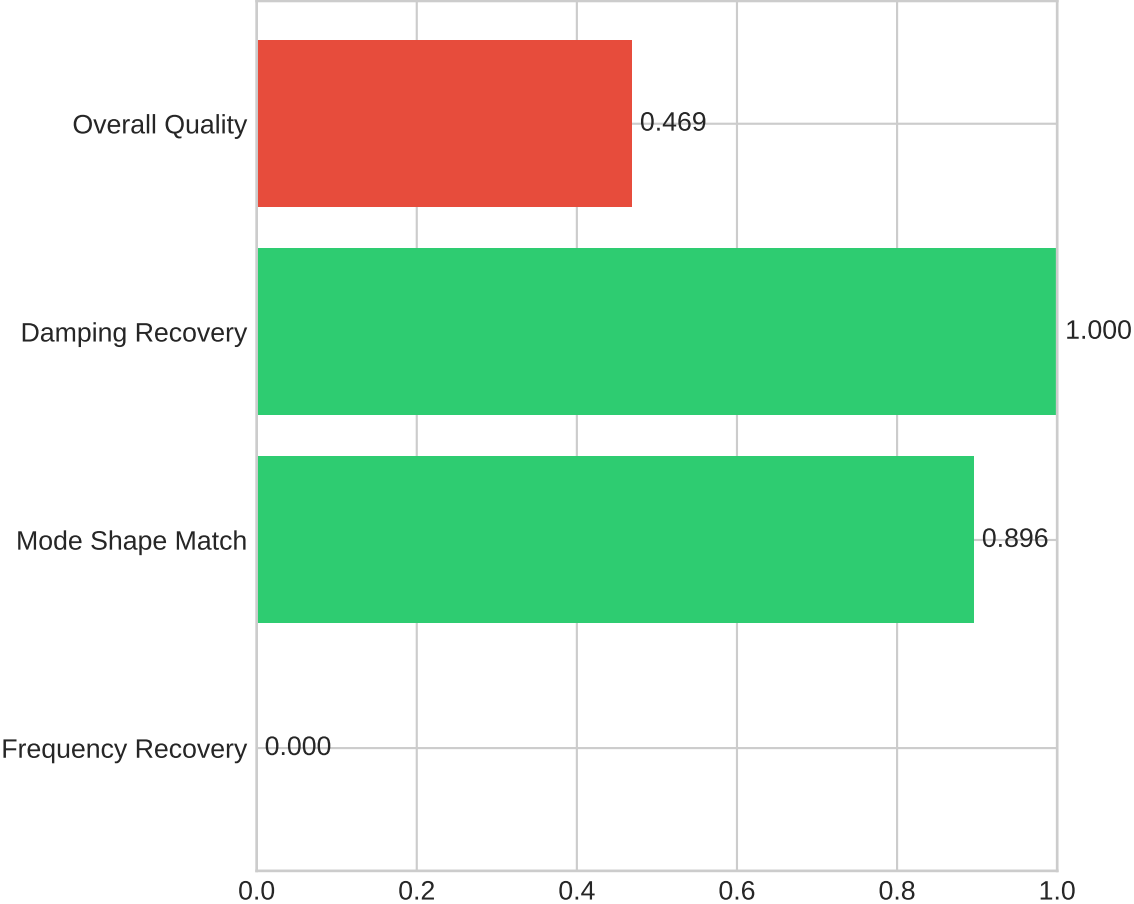
Quality Score Breakdown

0.469

Repair Quality Score

Poor - Minimal Improvement
