# Structural Repair Quality Analysis Report

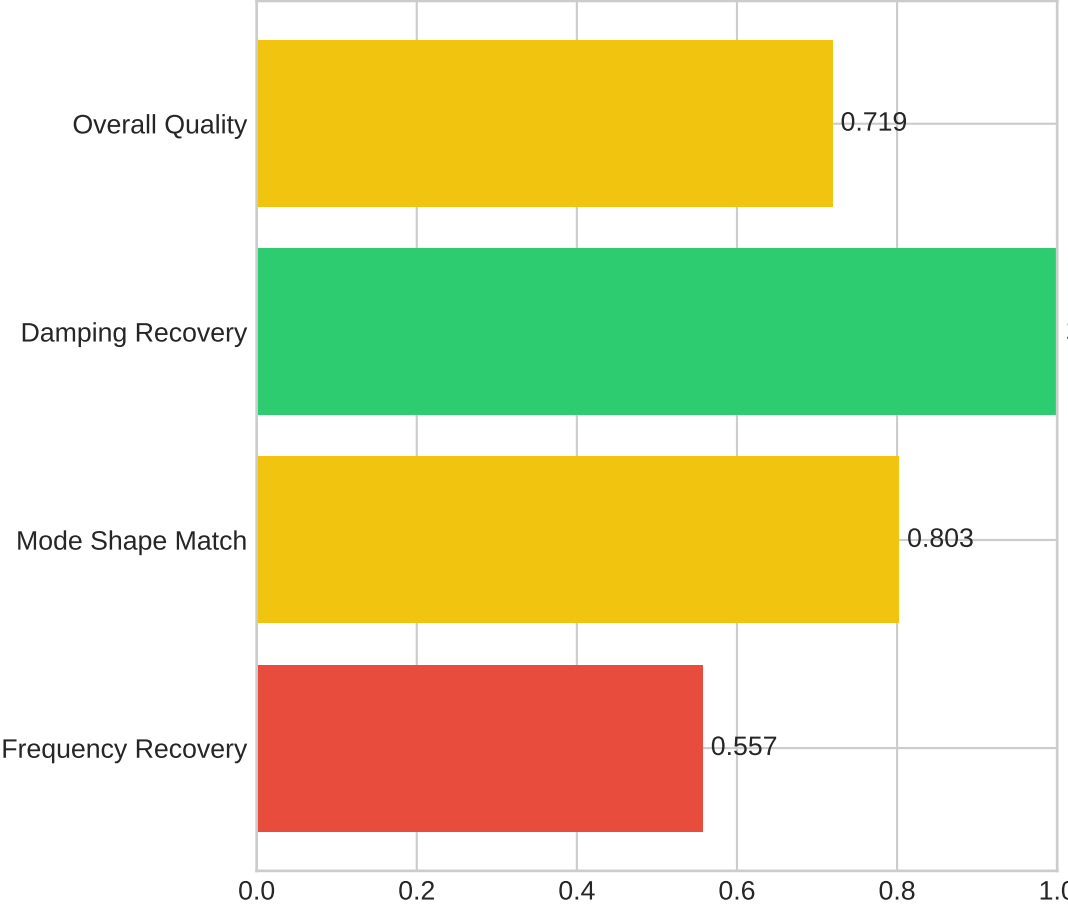
Quality Score Breakdown

0.719

Repair Quality Score

Good - Acceptable Repair
