Structural Repair Quality Analysis Report

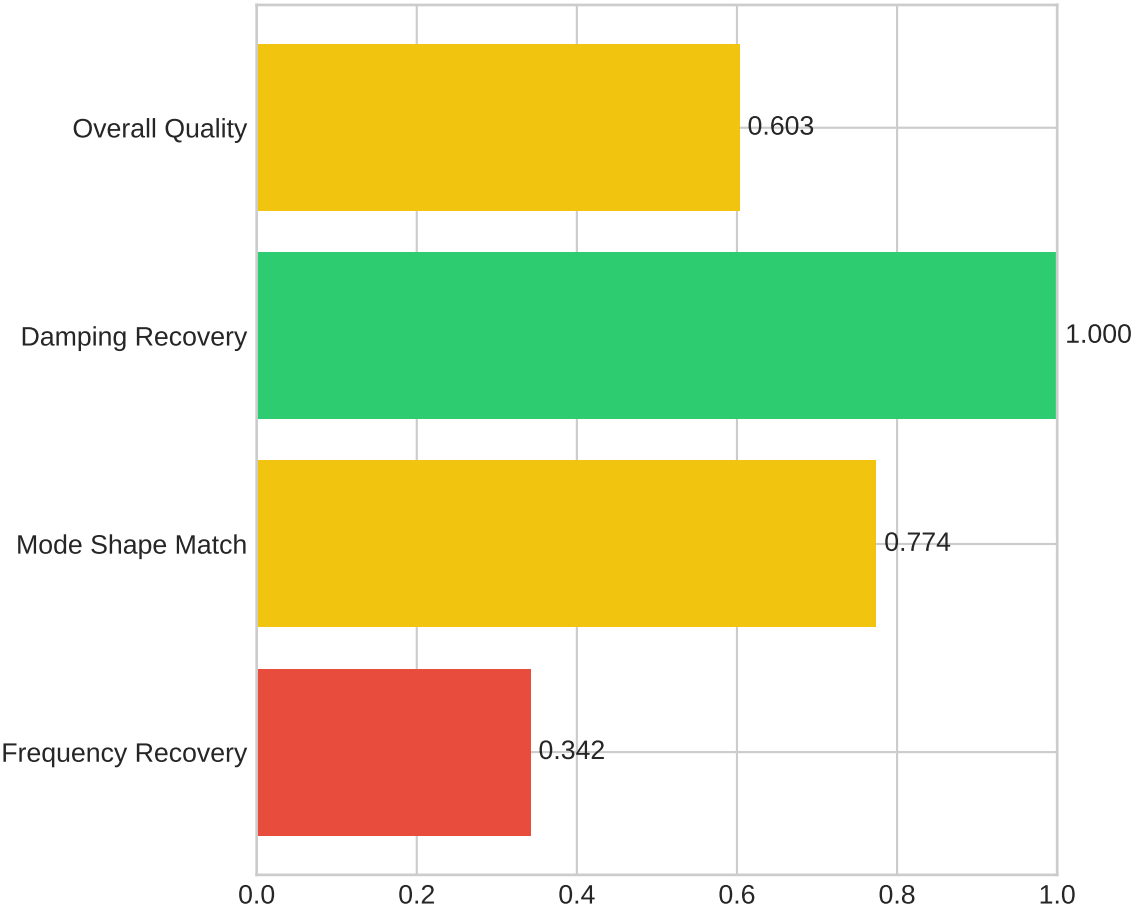
Quality Score Breakdown

0.603

Repair Quality Score

Fair - Partial Improvement
