Structural Repair Quality Analysis Report

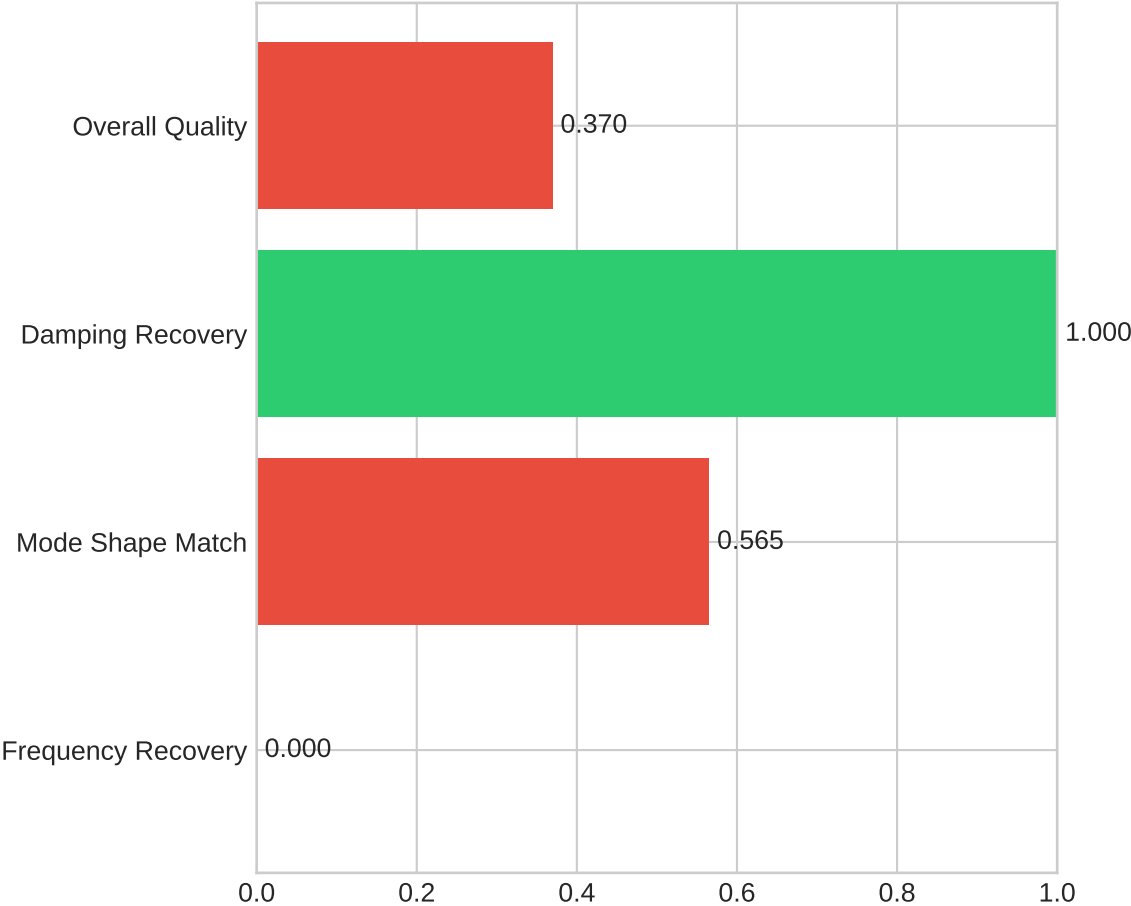
Quality Score Breakdown

**0.370**  
Repair Quality Score  
**Poor - Minimal Improvement**
