Structural Repair Quality Analysis Report

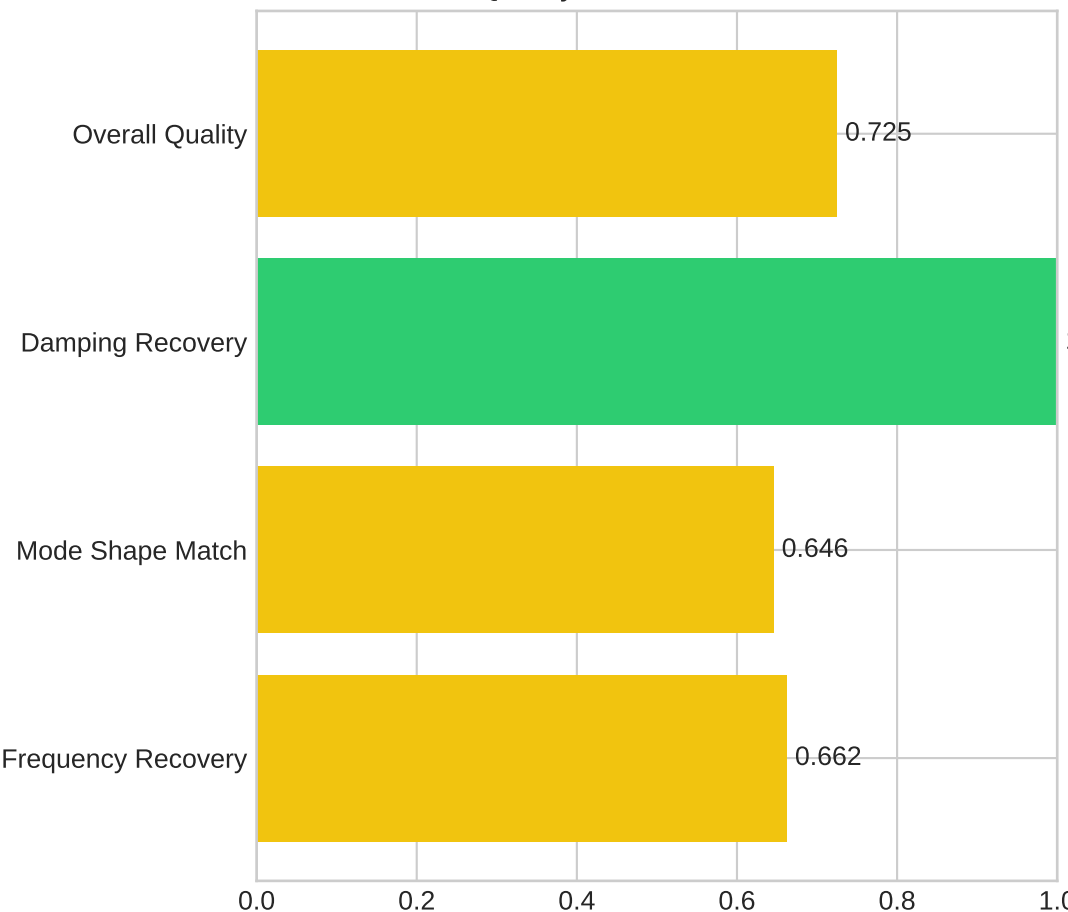
Quality Score Breakdown

0.725
Repair Quality Score
Good - Acceptable Repair
