Structural Repair Quality Analysis Report

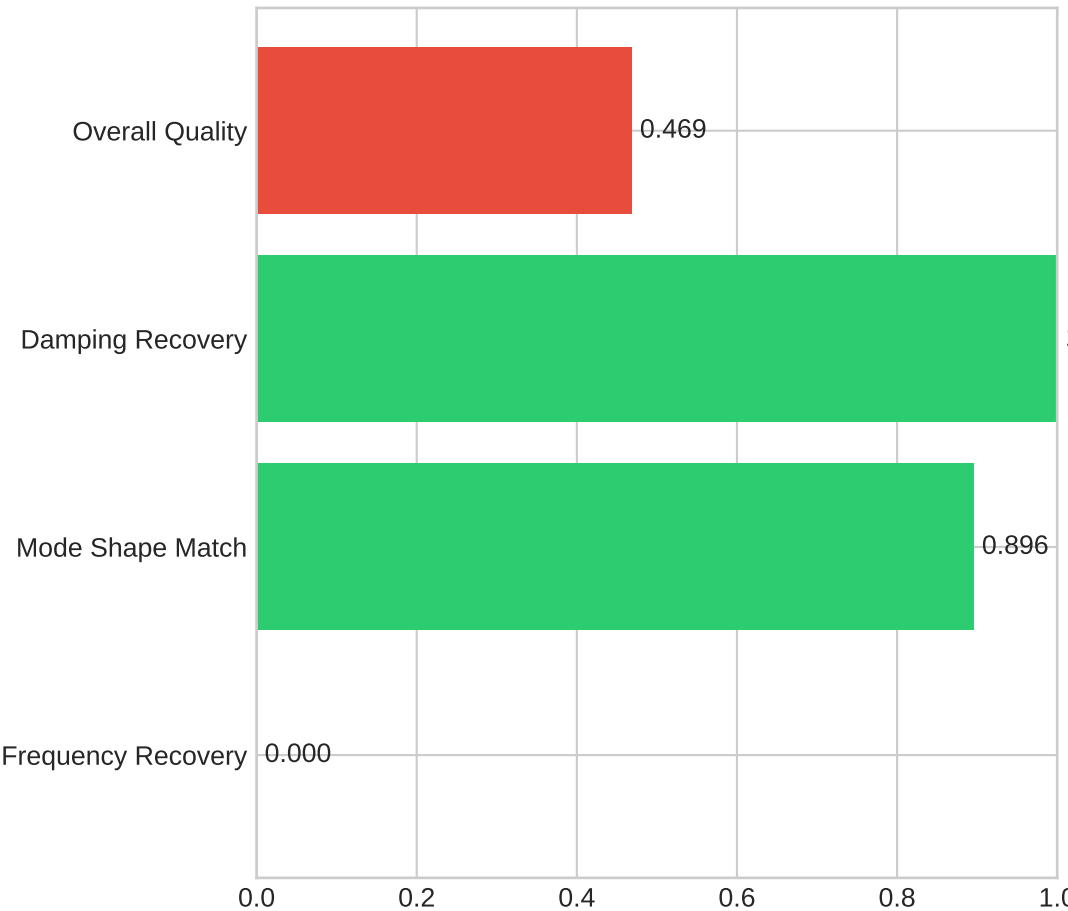
Quality Score Breakdown

0.469

Repair Quality Score

Poor - Minimal Improvement
