Structural Repair Quality Analysis Report

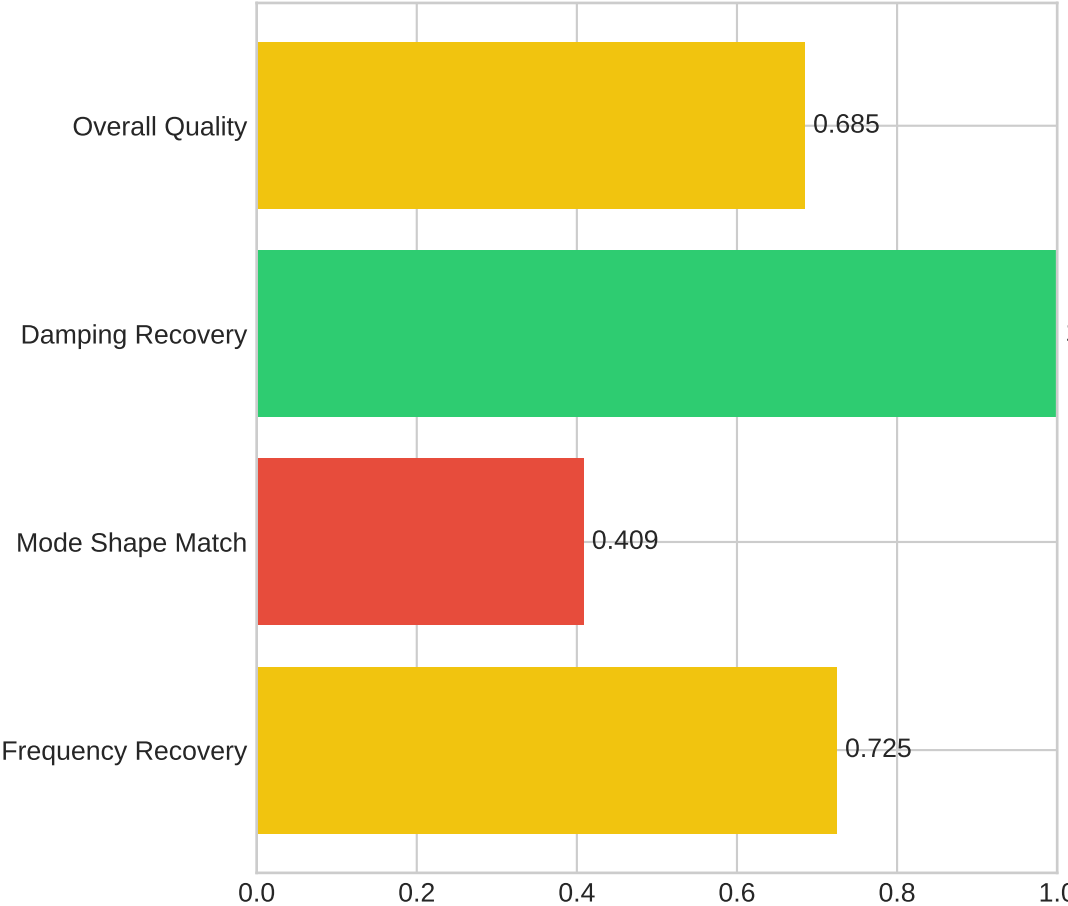
Quality Score Breakdown

0.685

Repair Quality Score

Fair - Partial Improvement
