Structural Repair Quality Analysis Report

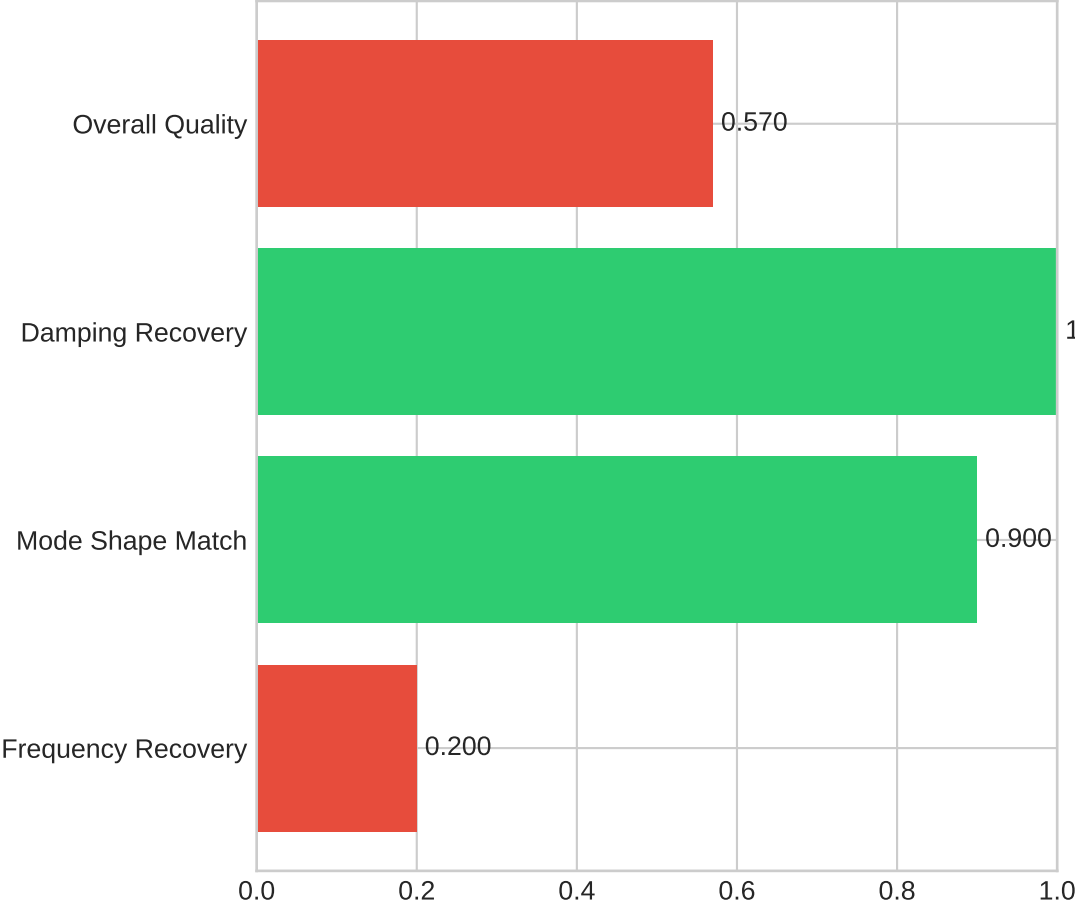
Quality Score Breakdown

0.570

Repair Quality Score

Fair - Partial Improvement
