Structural Repair Quality Analysis Report

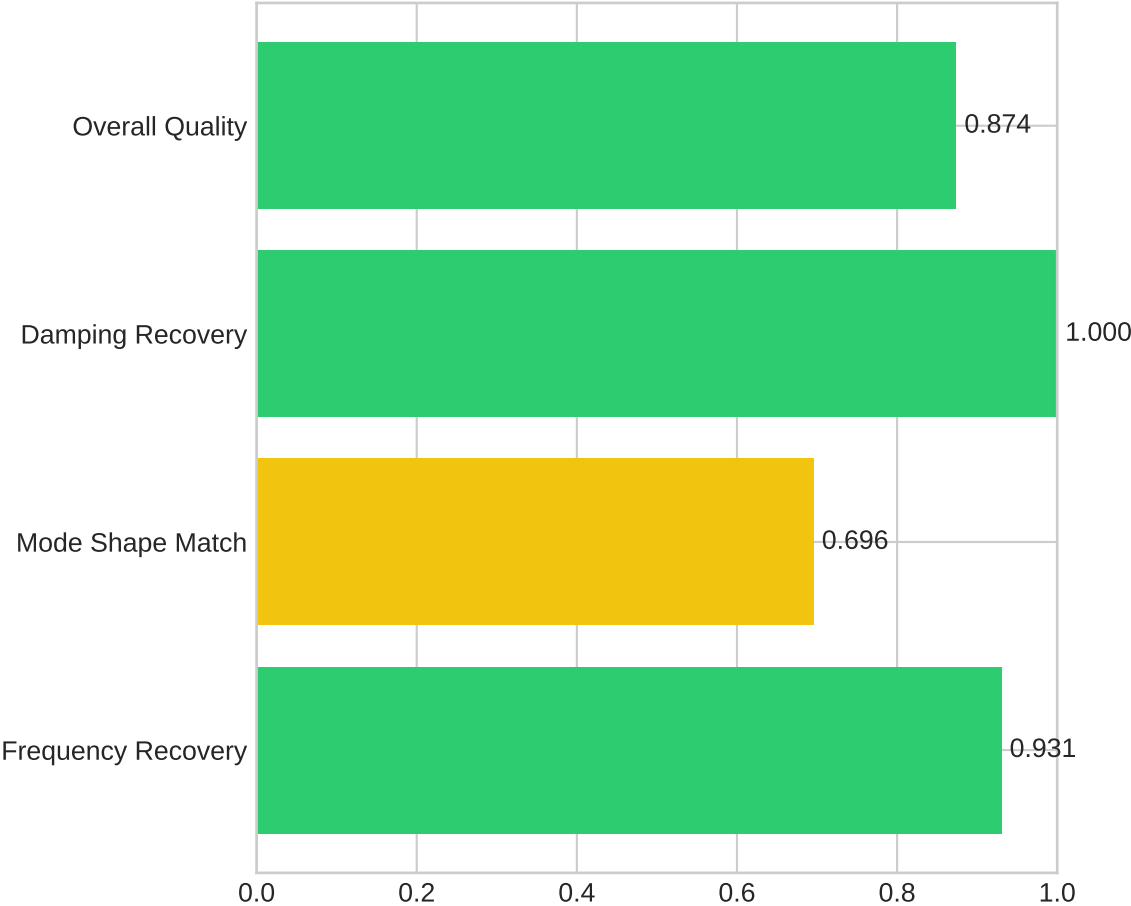
Quality Score Breakdown

0.874
Repair Quality Score
Very Good - Highly Effective Repair
2026-01-17 19:02:41
