Structural Repair Quality Analysis Report

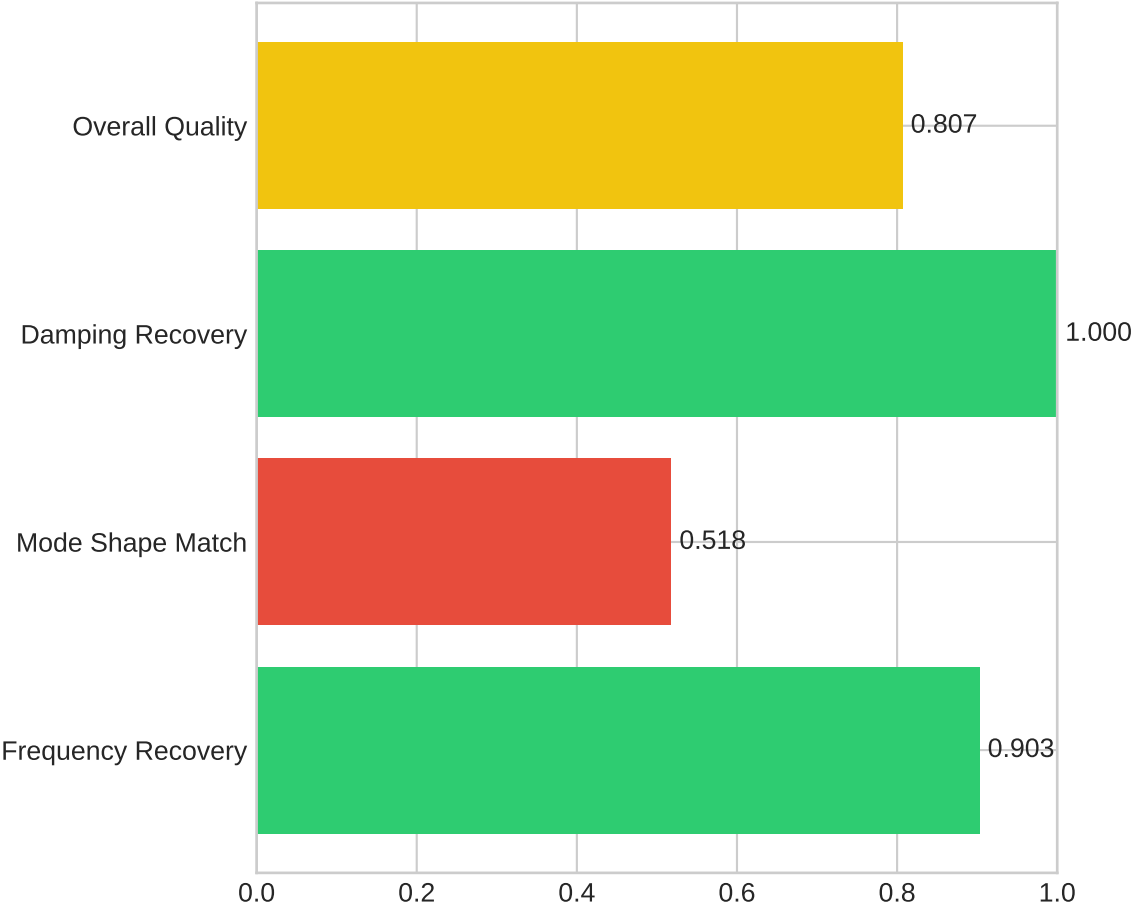
Quality Score Breakdown

0.807
Repair Quality Score
Good - Acceptable Repair
