Structural Repair Quality Analysis Report

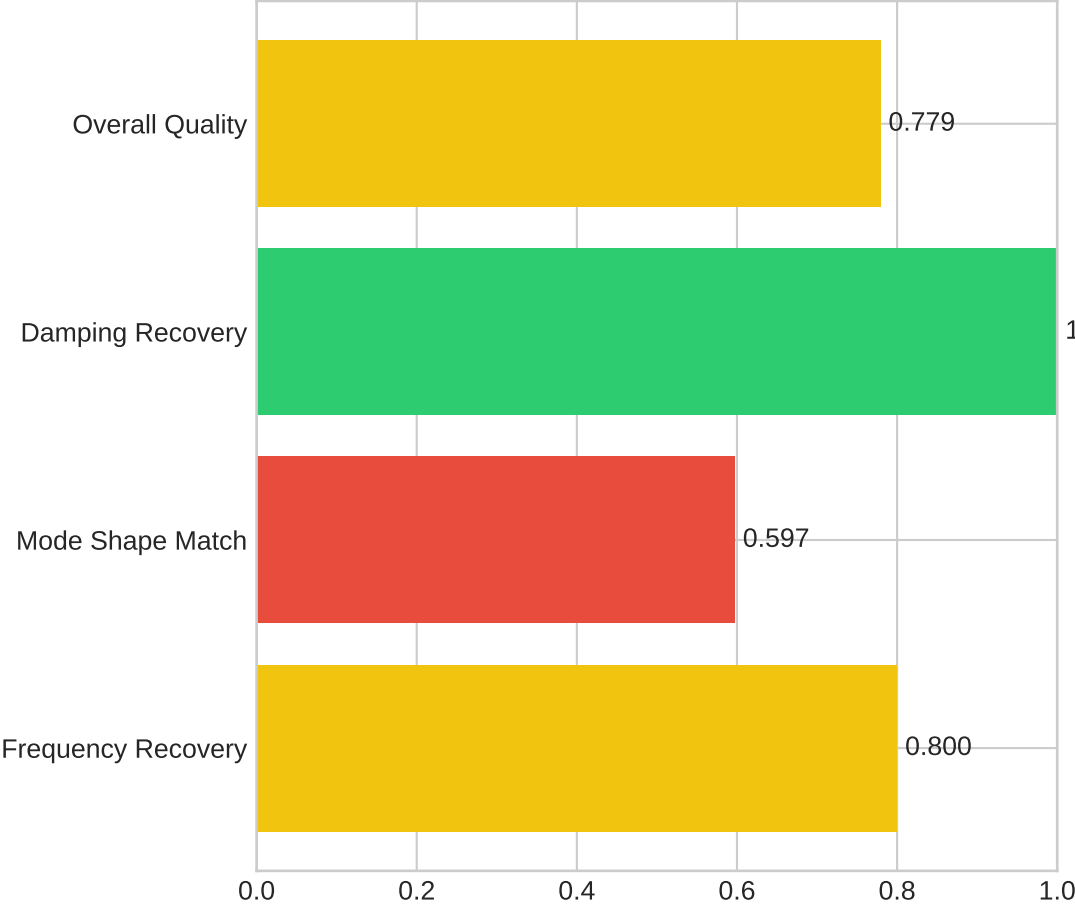
Quality Score Breakdown

0.779
Repair Quality Score
Good - Acceptable Repair
2026-01-17 18:08:12
