Structural Repair Quality Analysis Report

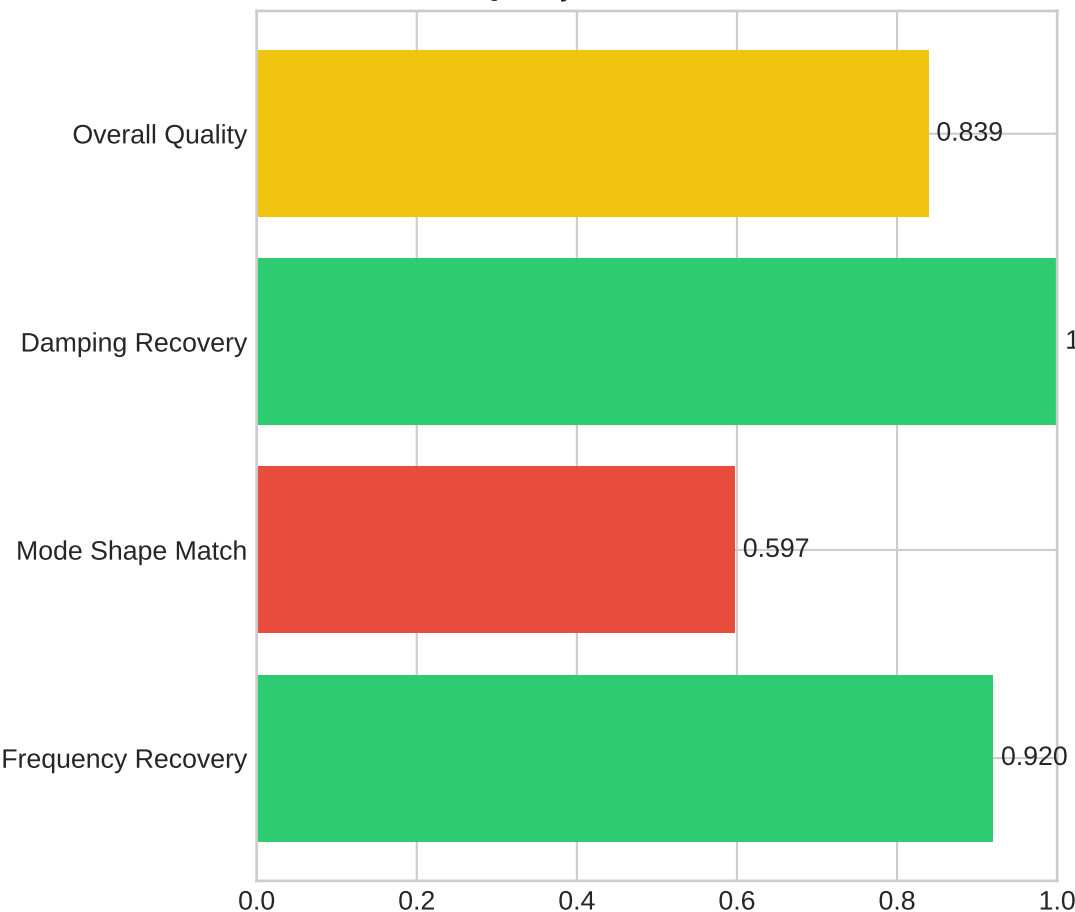
Quality Score Breakdown

0.839
Repair Quality Score
Good - Acceptable Repair
2026-01-17 16:00:26
