Structural Repair Quality Analysis Report

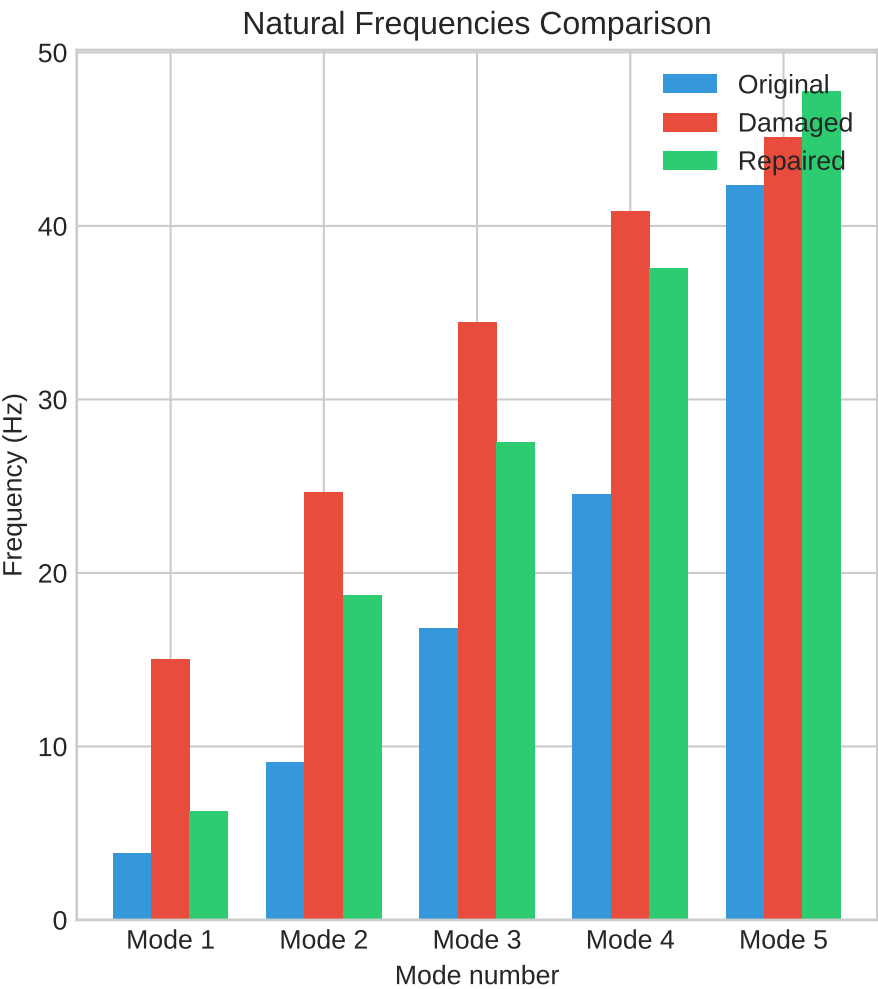
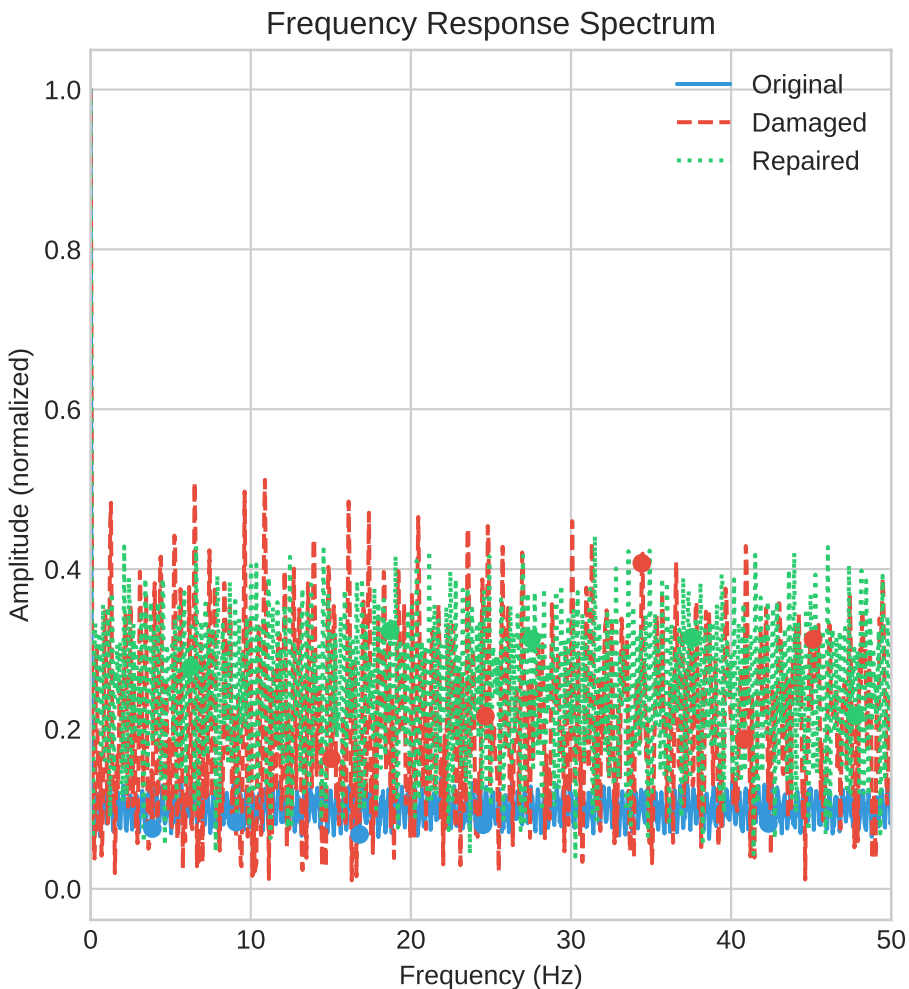
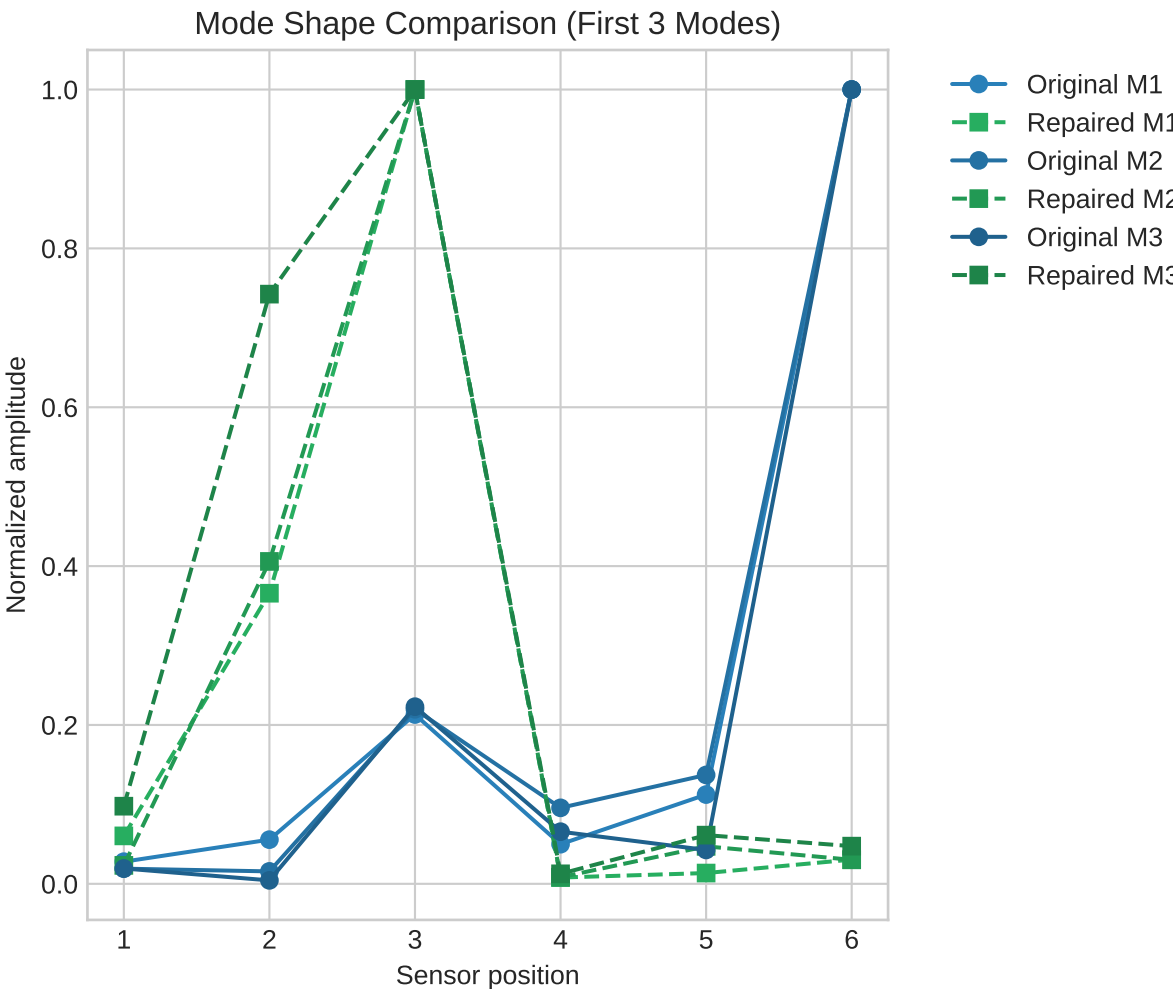
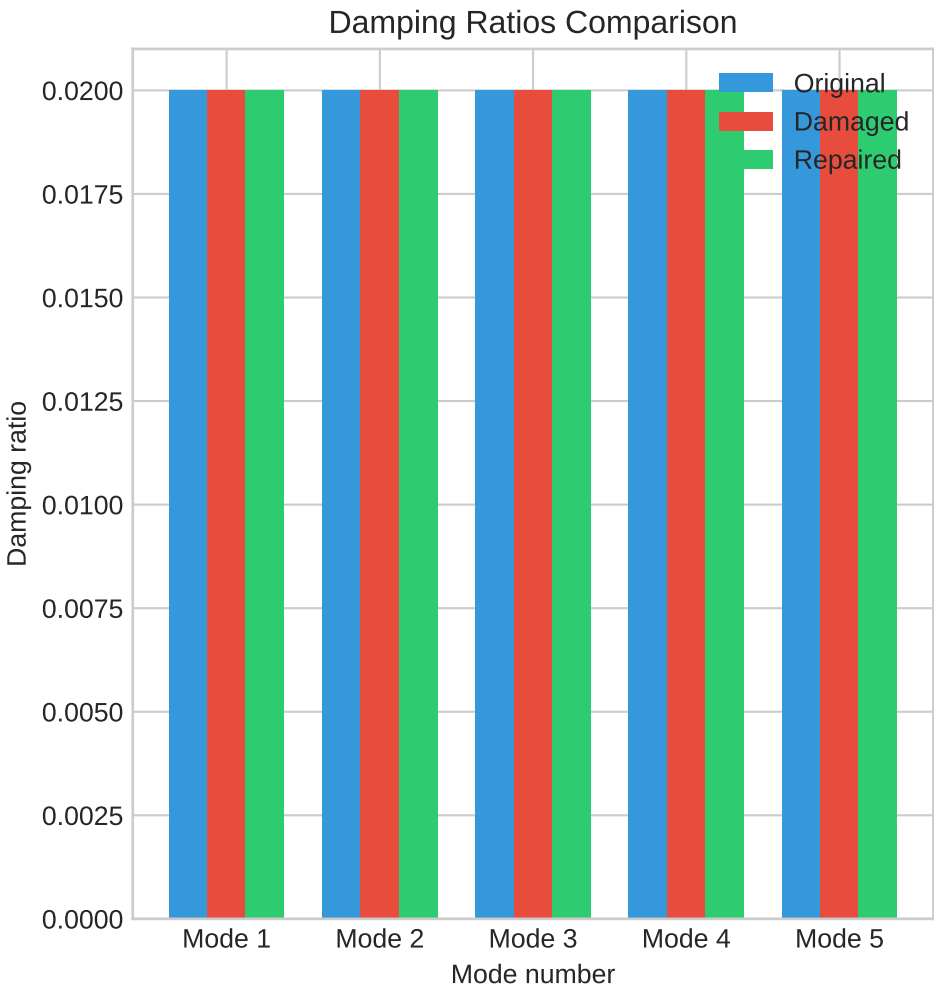
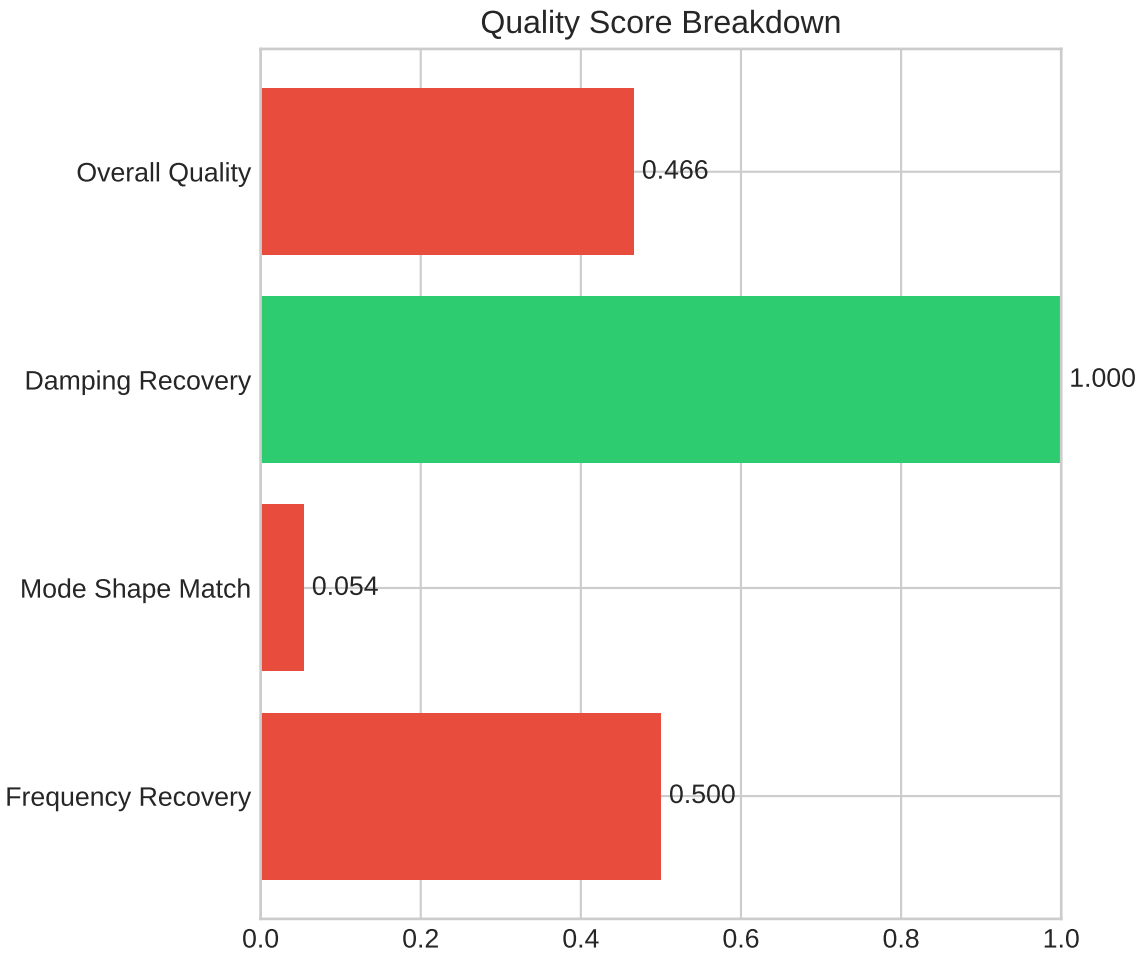
**0.466**

Repair Quality Score

**Poor - Minimal Improvement**
