Structural Repair Quality Analysis Report

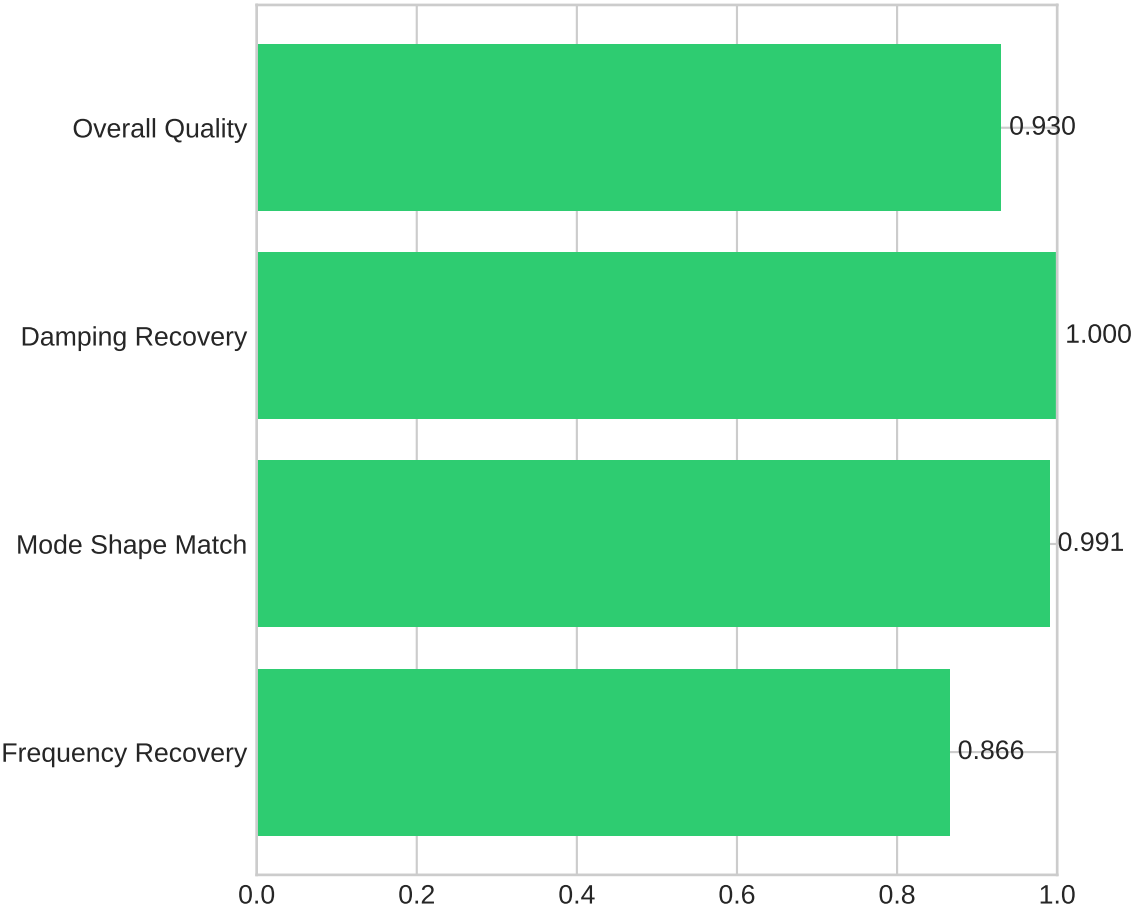
Quality Score Breakdown

0.930
Repair Quality Score
Very Good - Highly Effective Repair
2026-01-22 09:42:30
