Structural Repair Quality Analysis Report

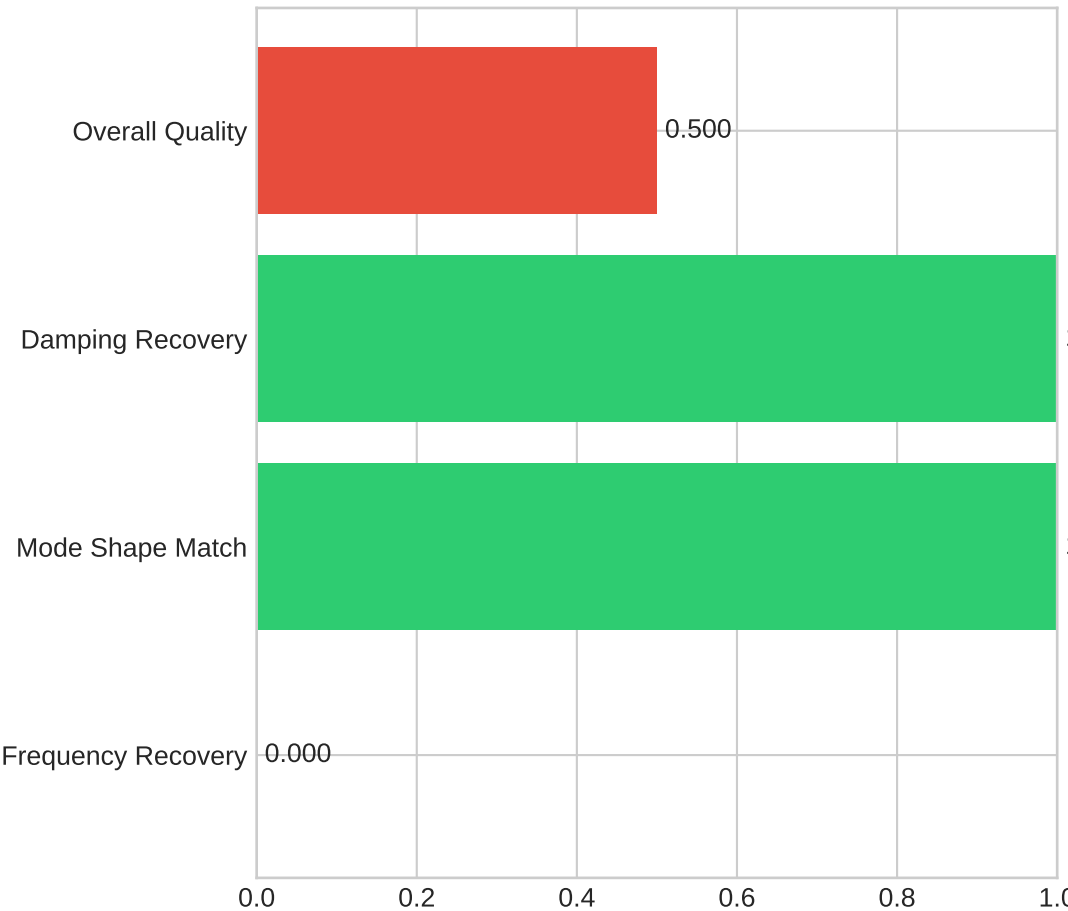
Quality Score Breakdown

0.500
Repair Quality Score
Fair - Partial Improvement
