Structural Repair Quality Analysis Report

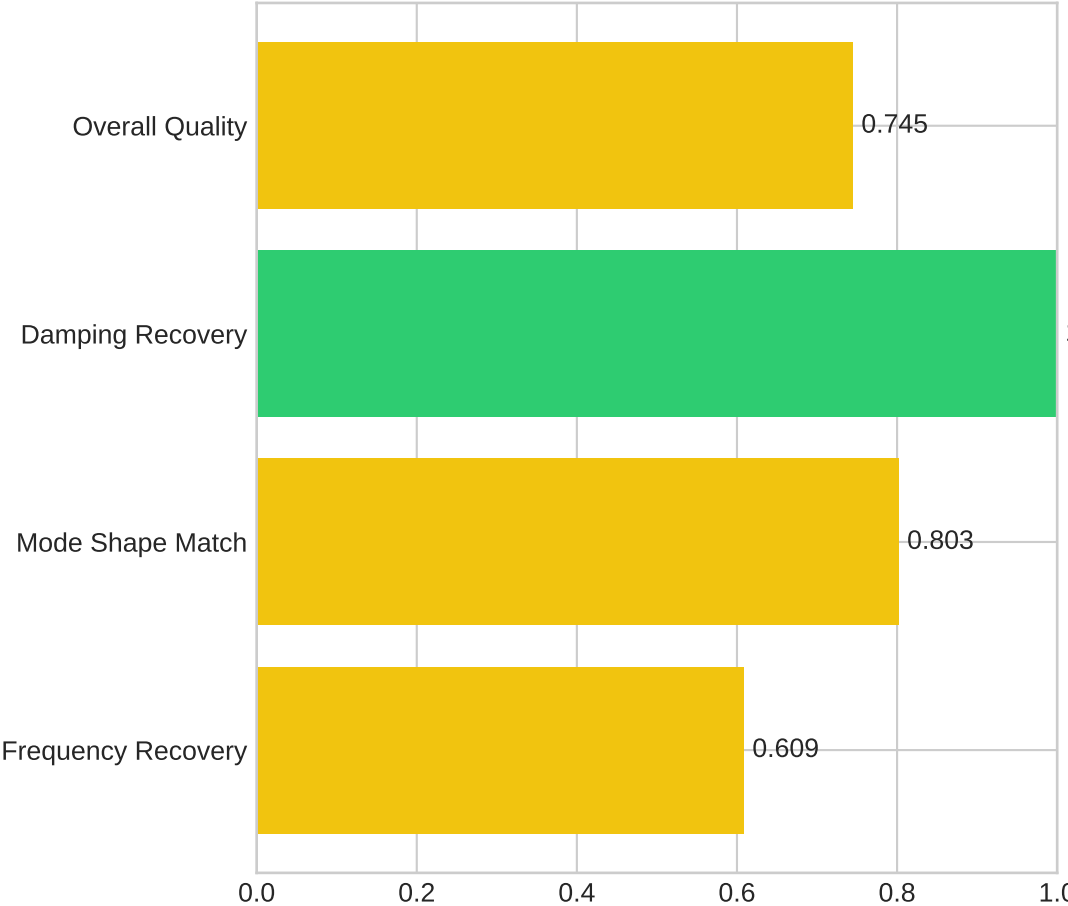
Quality Score Breakdown

0.745
Repair Quality Score
Good - Acceptable Repair
2026-01-26 15:21:04
