Structural Repair Quality Analysis Report

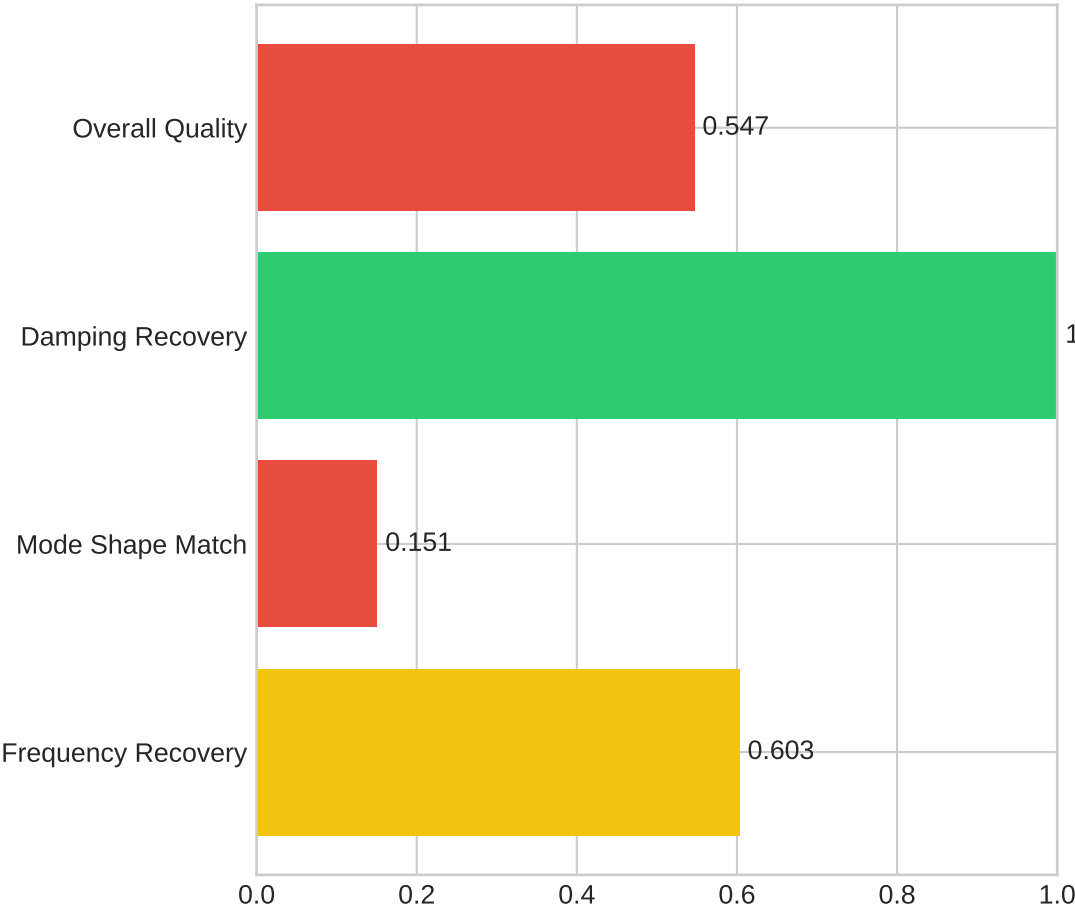
Quality Score Breakdown

0.547

Repair Quality Score

Fair - Partial Improvement
