Structural Repair Quality Analysis Report

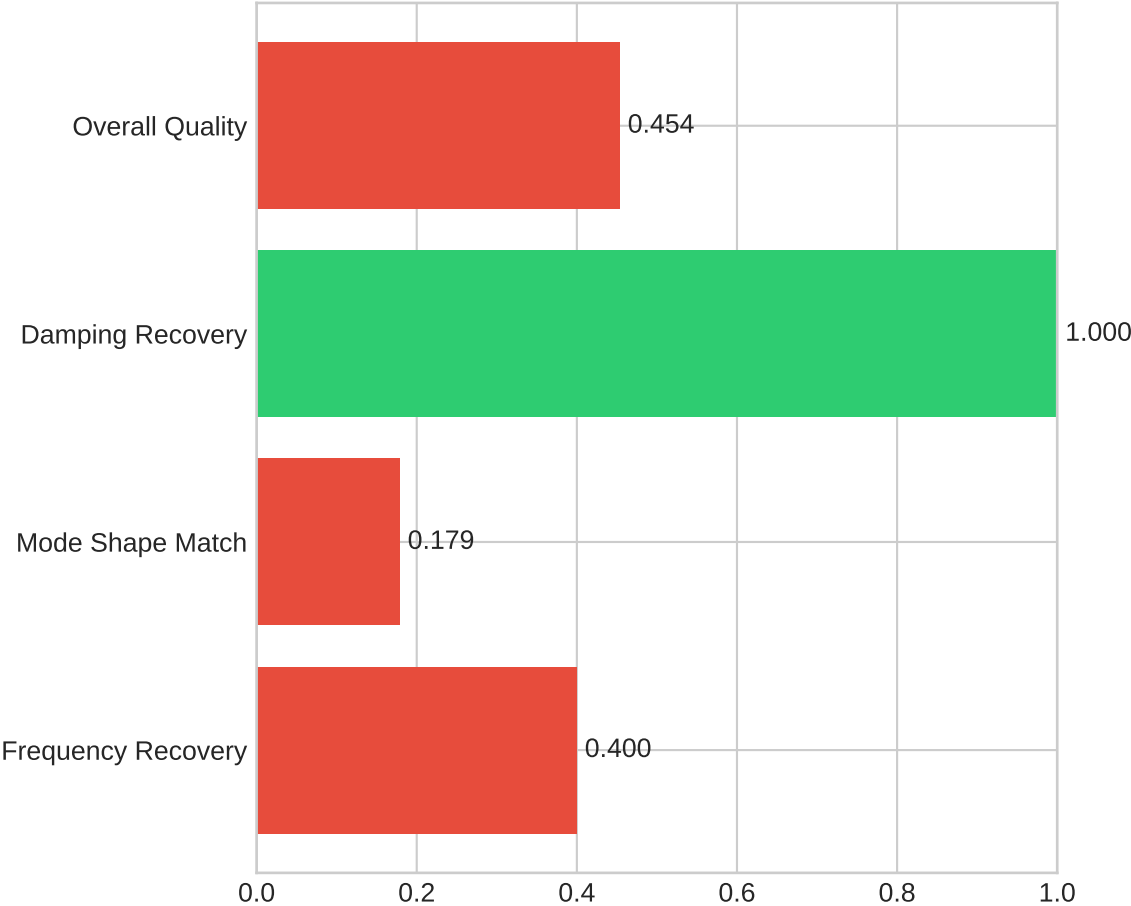
Quality Score Breakdown

0.454

Repair Quality Score

Poor - Minimal Improvement
