Structural Repair Quality Analysis Report

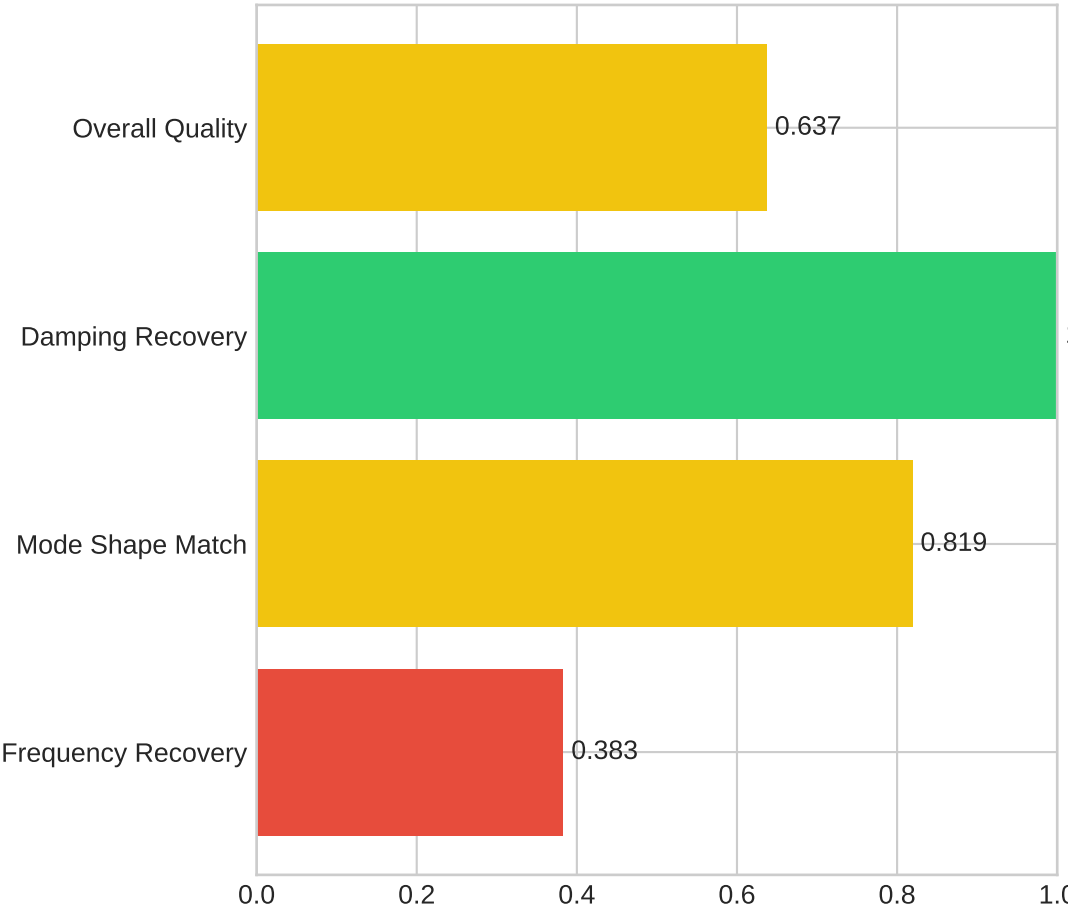
Quality Score Breakdown

0.637

Repair Quality Score

Fair - Partial Improvement
