Structural Repair Quality Analysis Report

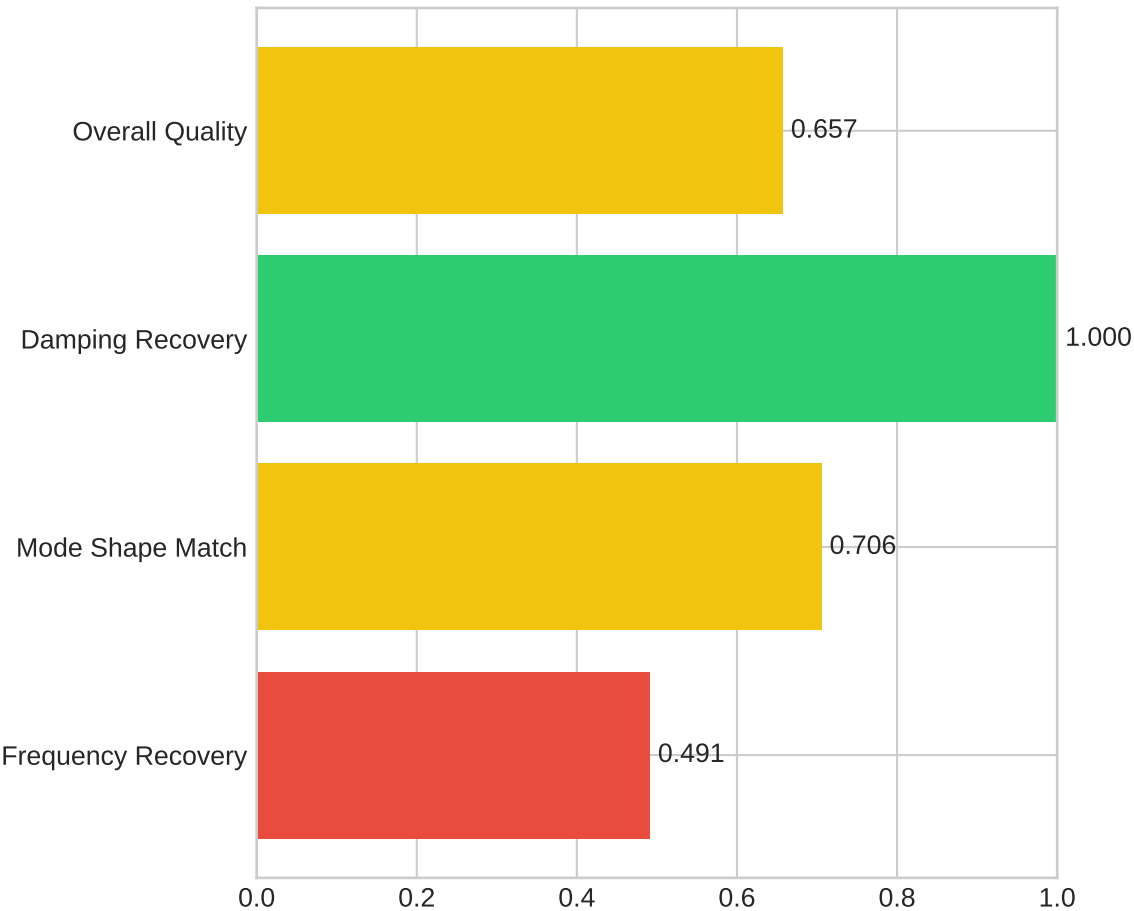
Quality Score Breakdown

0.657

Repair Quality Score

Fair - Partial Improvement
