Structural Repair Quality Analysis Report

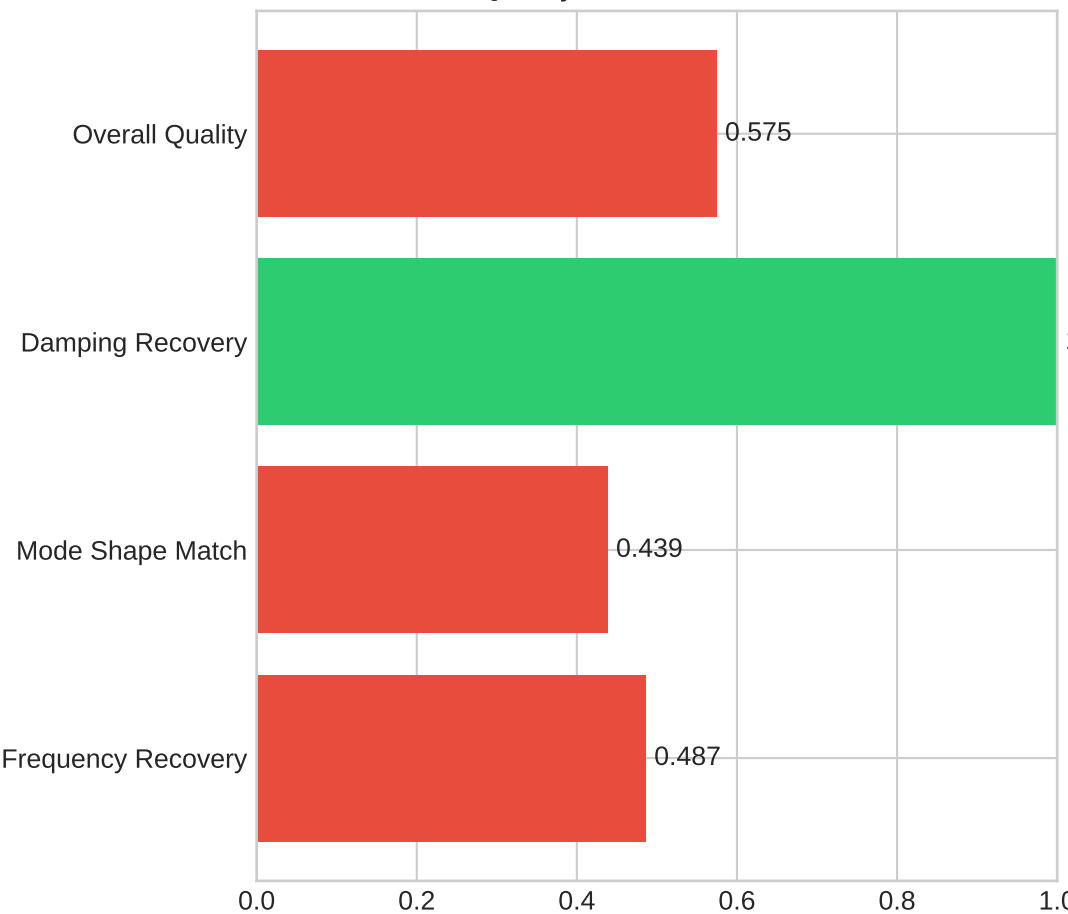
Quality Score Breakdown

0.575

Repair Quality Score

Fair - Partial Improvement
