Montara Blowout

**What went wrong? What are the lessons for
industry and regulators?**

Jane Cutler
Chief Executive Officer
October 2010

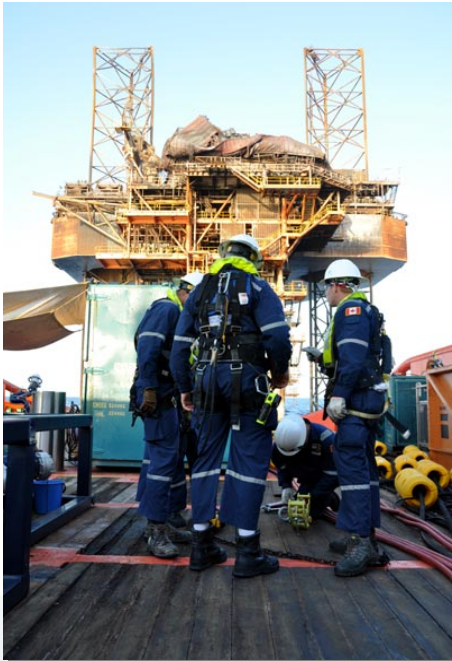
- November 2009:
 - Personnel board West Atlas
 - Personnel board WHP
 - 320 bbl cement pumped via relief well into H1 well
 - Packer set in H1 well, pressure test not completed
 - plugging activities completed
- Sep-Oct 2010:
 - Salvage commenced with Jascon 25

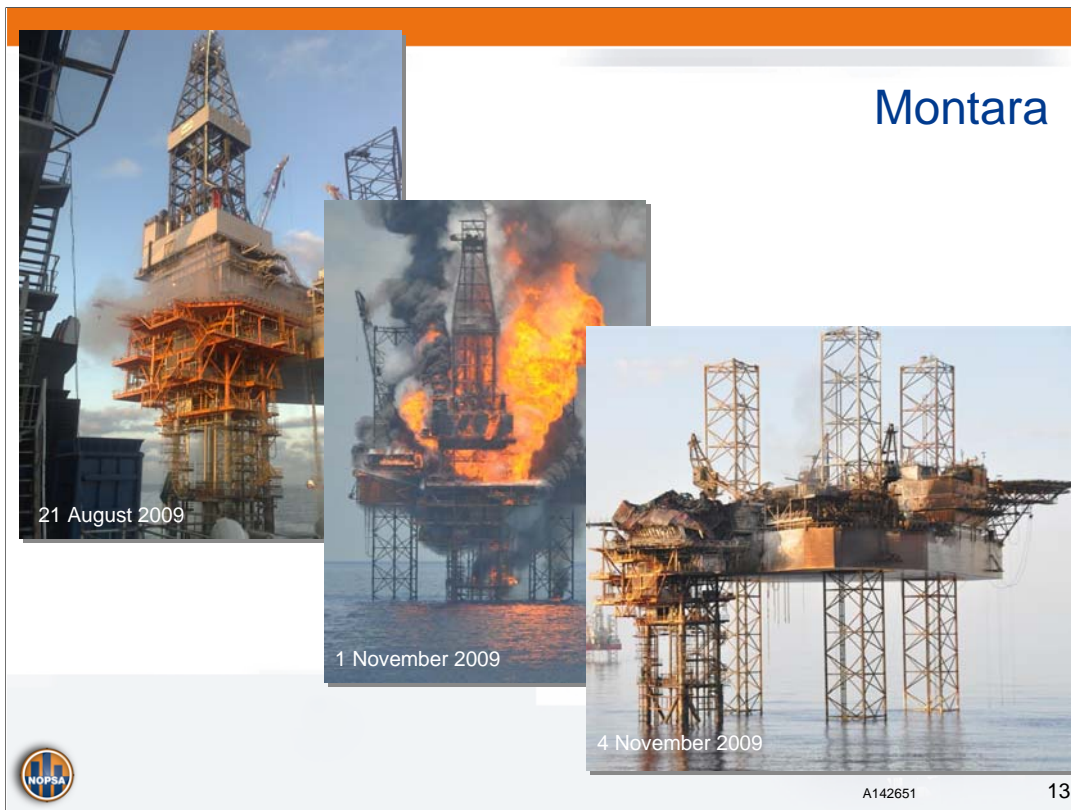
This is an important series of pictures, the one on the left is taken from the Java Constructor which was anchored alongside the Montara WHP when the blowout first occurred. The safety case and the day to day planning of construction and other activities on the Java did not contemplate the vessel being located alongside live hydrocarbon activities. You can see a hardhat in the foreground of that picture and the gas / condensate release from the platform.

We are extremely fortunate that there were not fatalities or serious injuries.

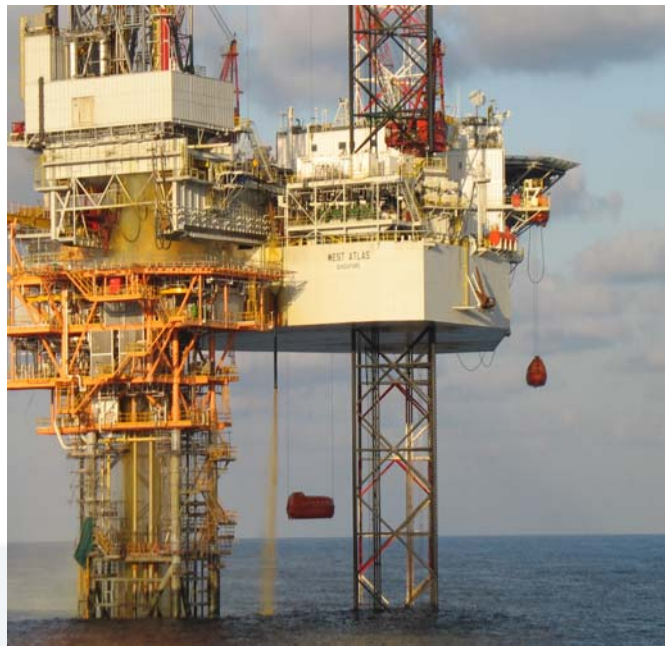
Well Integrity
=
**Pressure
Containment**
=
Barriers

The blowout was the result of systemic failures by the operator to properly manage the integrity of the well as a whole.

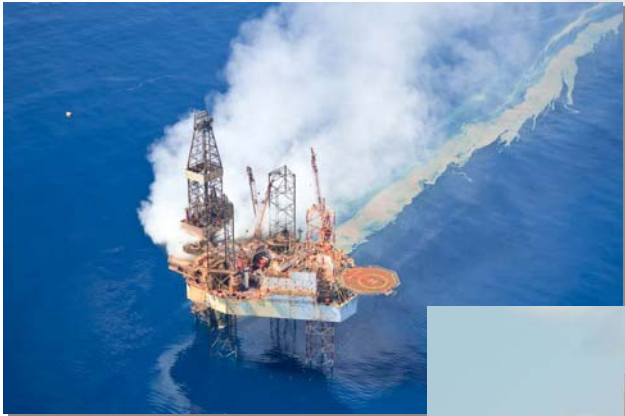
Root Cause:
Systemic failure of management systems, non-compliance with operating procedures

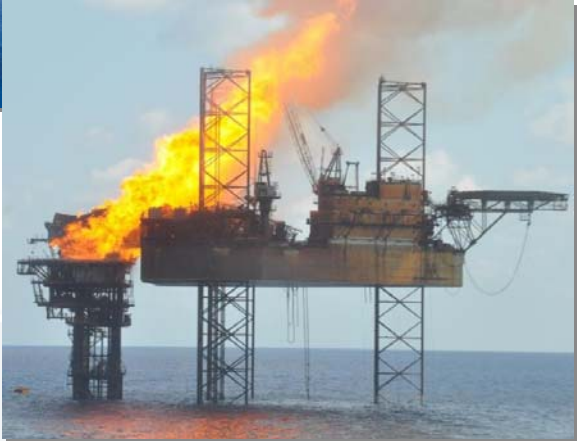
Immediate Cause:
Primary cementing integrity failure

- The immediate cause was a poor cement job and failure of the float valves
- The root cause was a systemic failure of management systems and non-compliance with operating procedures. The standards processes and procedures seem to have been in place but not adhered to for some reason.
