DAS 2016

The influence of high temperature on DV-2 jet engine Ni-based superalloy turbine blade degradation

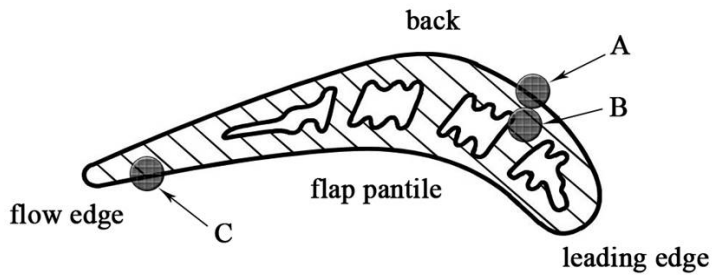
Fig. 4. The cross section of blade and description zones of interests

Area A – the uniformity and homogeneity of alitize layer from 1/4 of blade back.

Area B – morphology and amount of γ' - phase and grain boundary right under alitize layer.

Area C – degradation of alitize layer right before flow edge of blade and needles of Cr rich carbides

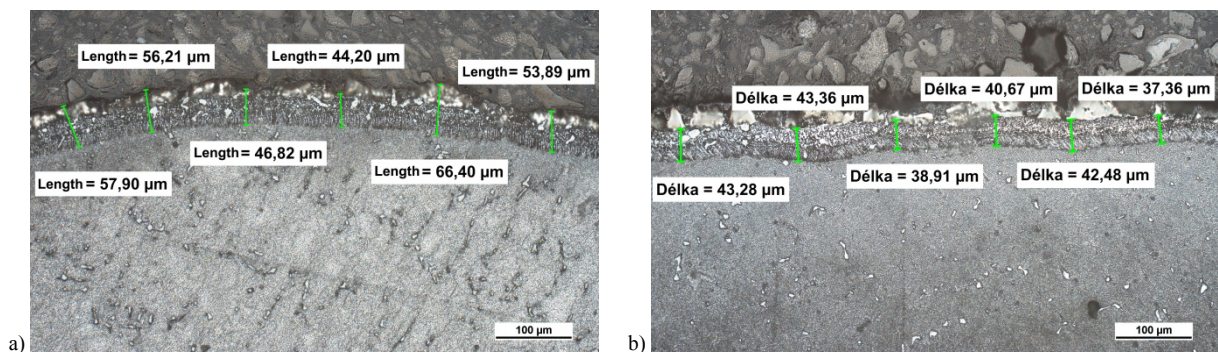
Fig. 5. Al – Si protective layer thickness measurement, non-etched specimen: (a) leading edge with average coating thickness of 50 μm, (b) flow edge with average coating thickness of 45 μm

Al – Si layer thickness h depending from spraying thickness at its application and can be easily determined from dependence $h = 0.7\delta$, where δ is for spraying thickness. Then for starting stage Al – Si layer thickness is around $h = 24.5 \mu\text{m}$ (an optimum spraying thickness for annealing at 950°C is up-to $\delta = 35 \mu\text{m}$). The thickness of Al – Si layer is higher in all observed areas what indicates higher temperature of loading than reported 751°C. Results of analysis are presented on Fig. 5.

- Protective Al – Si layer is significantly degraded all around the surface, its thickness on leading edge is average 50 μm , and on the back is 36 μm and flow edge with average thickness 45 μm , so Al – Si layer is inconvenient. A needle like Cr rich carbides and blocky form of primary Ti rich carbides are forming. In this area is a high expectation of crack initiation at further working cycle of blades.
- Base material, Ni – base superalloy ŽS6K, also shows significant level of degradation, especially on strengthening intermetallic precipitate γ' , which has formed rafts and changes its morphology, from cubic to spheroidal shape. The morphology changing of γ' has influence on creep rupture life of blades due to decreasing of precipitation hardening effect and increasing of γ/γ' mismatch.

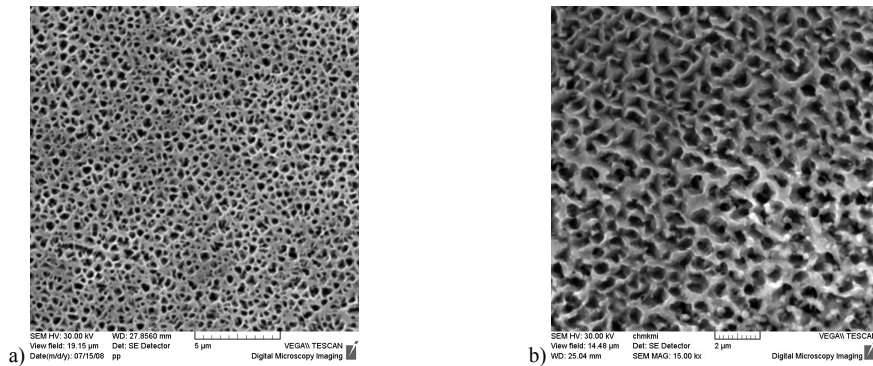
The base material, alloy ŽS6K, shows signs of high temperature degradation at grain boundaries where more secondary M_{23}C_6 carbides formed and lowering creep resistance of base material. The strengthening intermetallic γ' precipitate also degrades by changing its morphology from previous cubic shape like onto coarse spheroidal particles with average size 0.6 μm, Fig. 6.

The changes in shape and size of γ' precipitate cause decreasing creep rupture life of alloy. As a matter of a fact, creep at high temperatures is driven mainly by diffusion mechanism and deformation rate increases with higher amount of dislocations and their easier slip, which have been previously blocked by tide distribution of cubic morphology of γ' precipitates. Coarsening and spheroiding of γ' precipitates leads to creation of wider channels between γ' particles and dislocations can easier move, so deformation of base material can propagate.

Fig. 6. Degradation of γ' precipitate at high temperature (751°C/2s) loading compared to starting stage microstructure:

a) γ' - phase morphology, initial stage, b) after 751°C/2s for 600 hours of loading, etch. Marble, SEM

All reported changes indicate that temperature of overheating was not 751°C/2s. This kind of degradation occurred after longer time exposition at temperatures close to 900°C.
