# US 90 in Beaumont District

- Liberty County, US 90 RM 847
- Project Completed ; 2000
- Thickness ; 10-in
- Base type ; Existing 6" Flexible Base
- Subgrade type ; -
- West (Dayton Direction) ; Gravel
- East (Liberty Direction) ; Limestone(?) or ...
- Survey Date ; 03-15-2012

# Dayton Direction

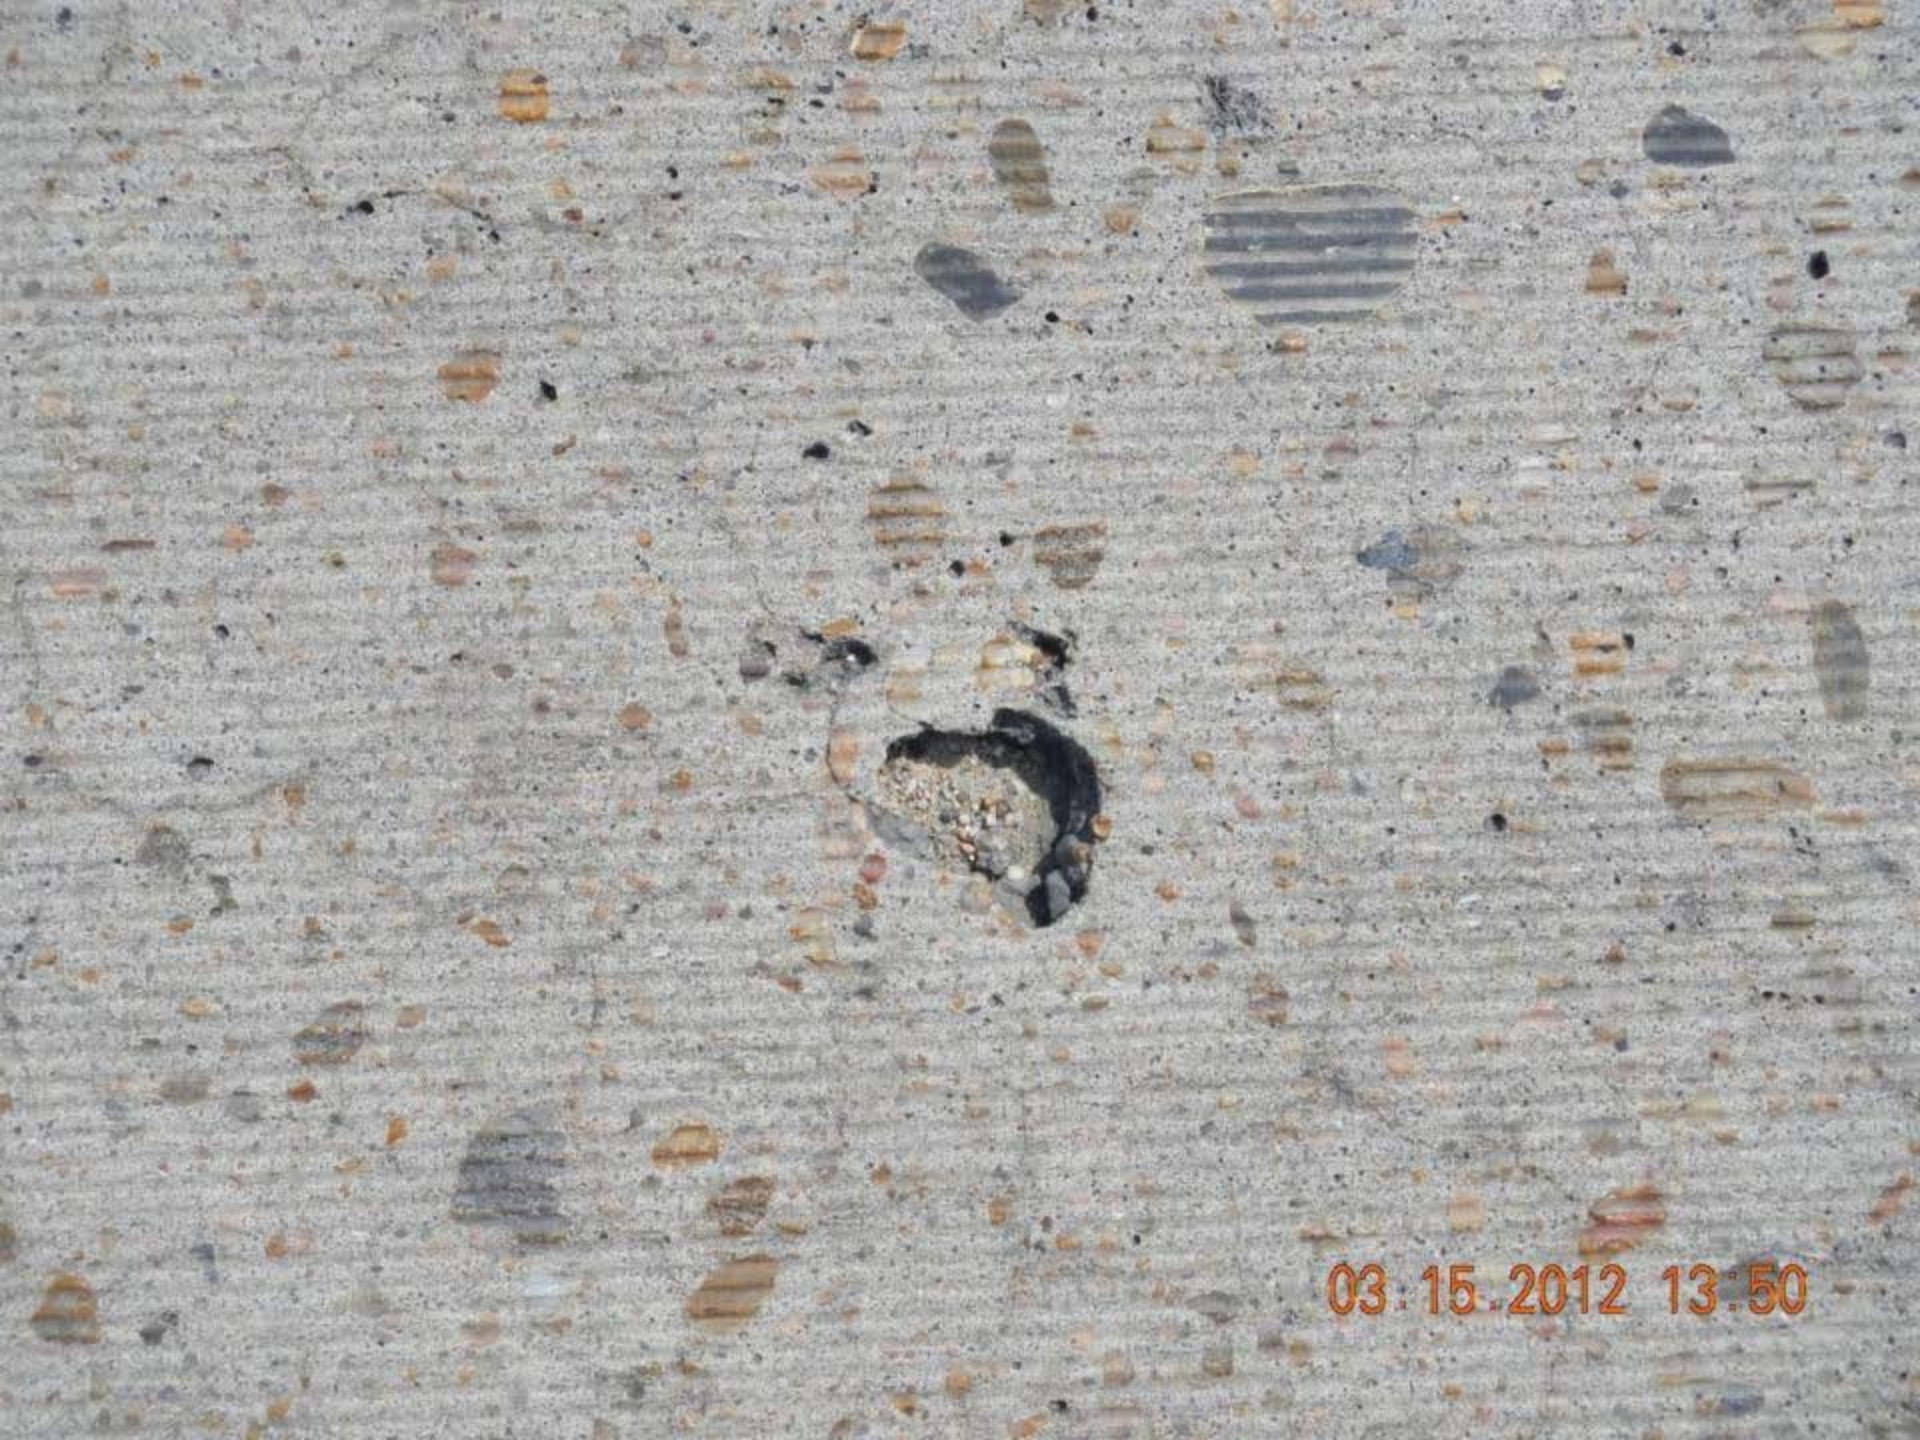
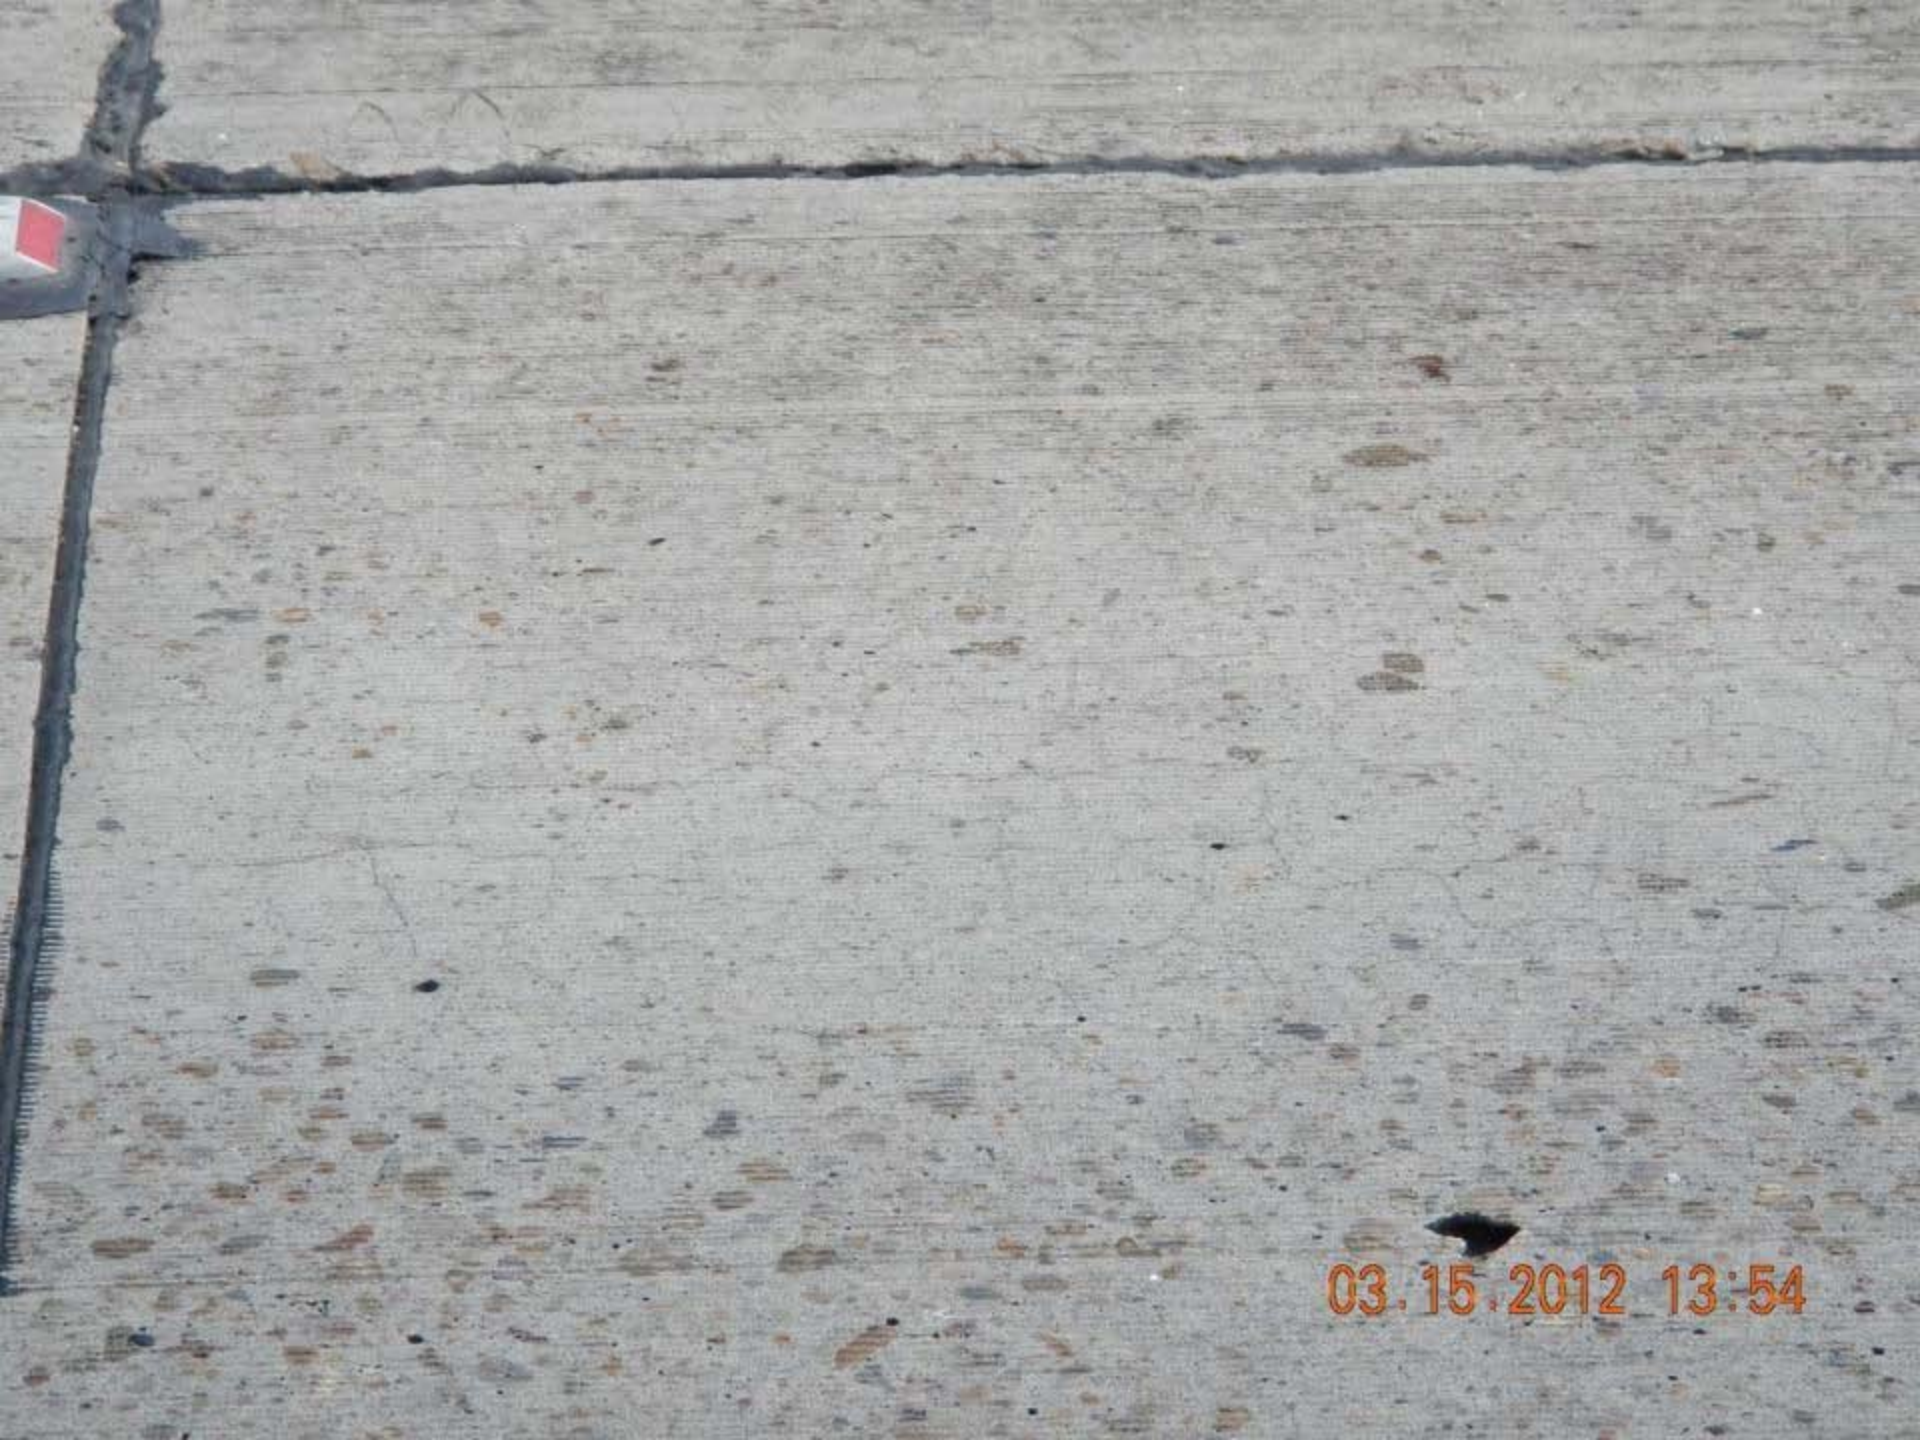
# Small Map Cracking

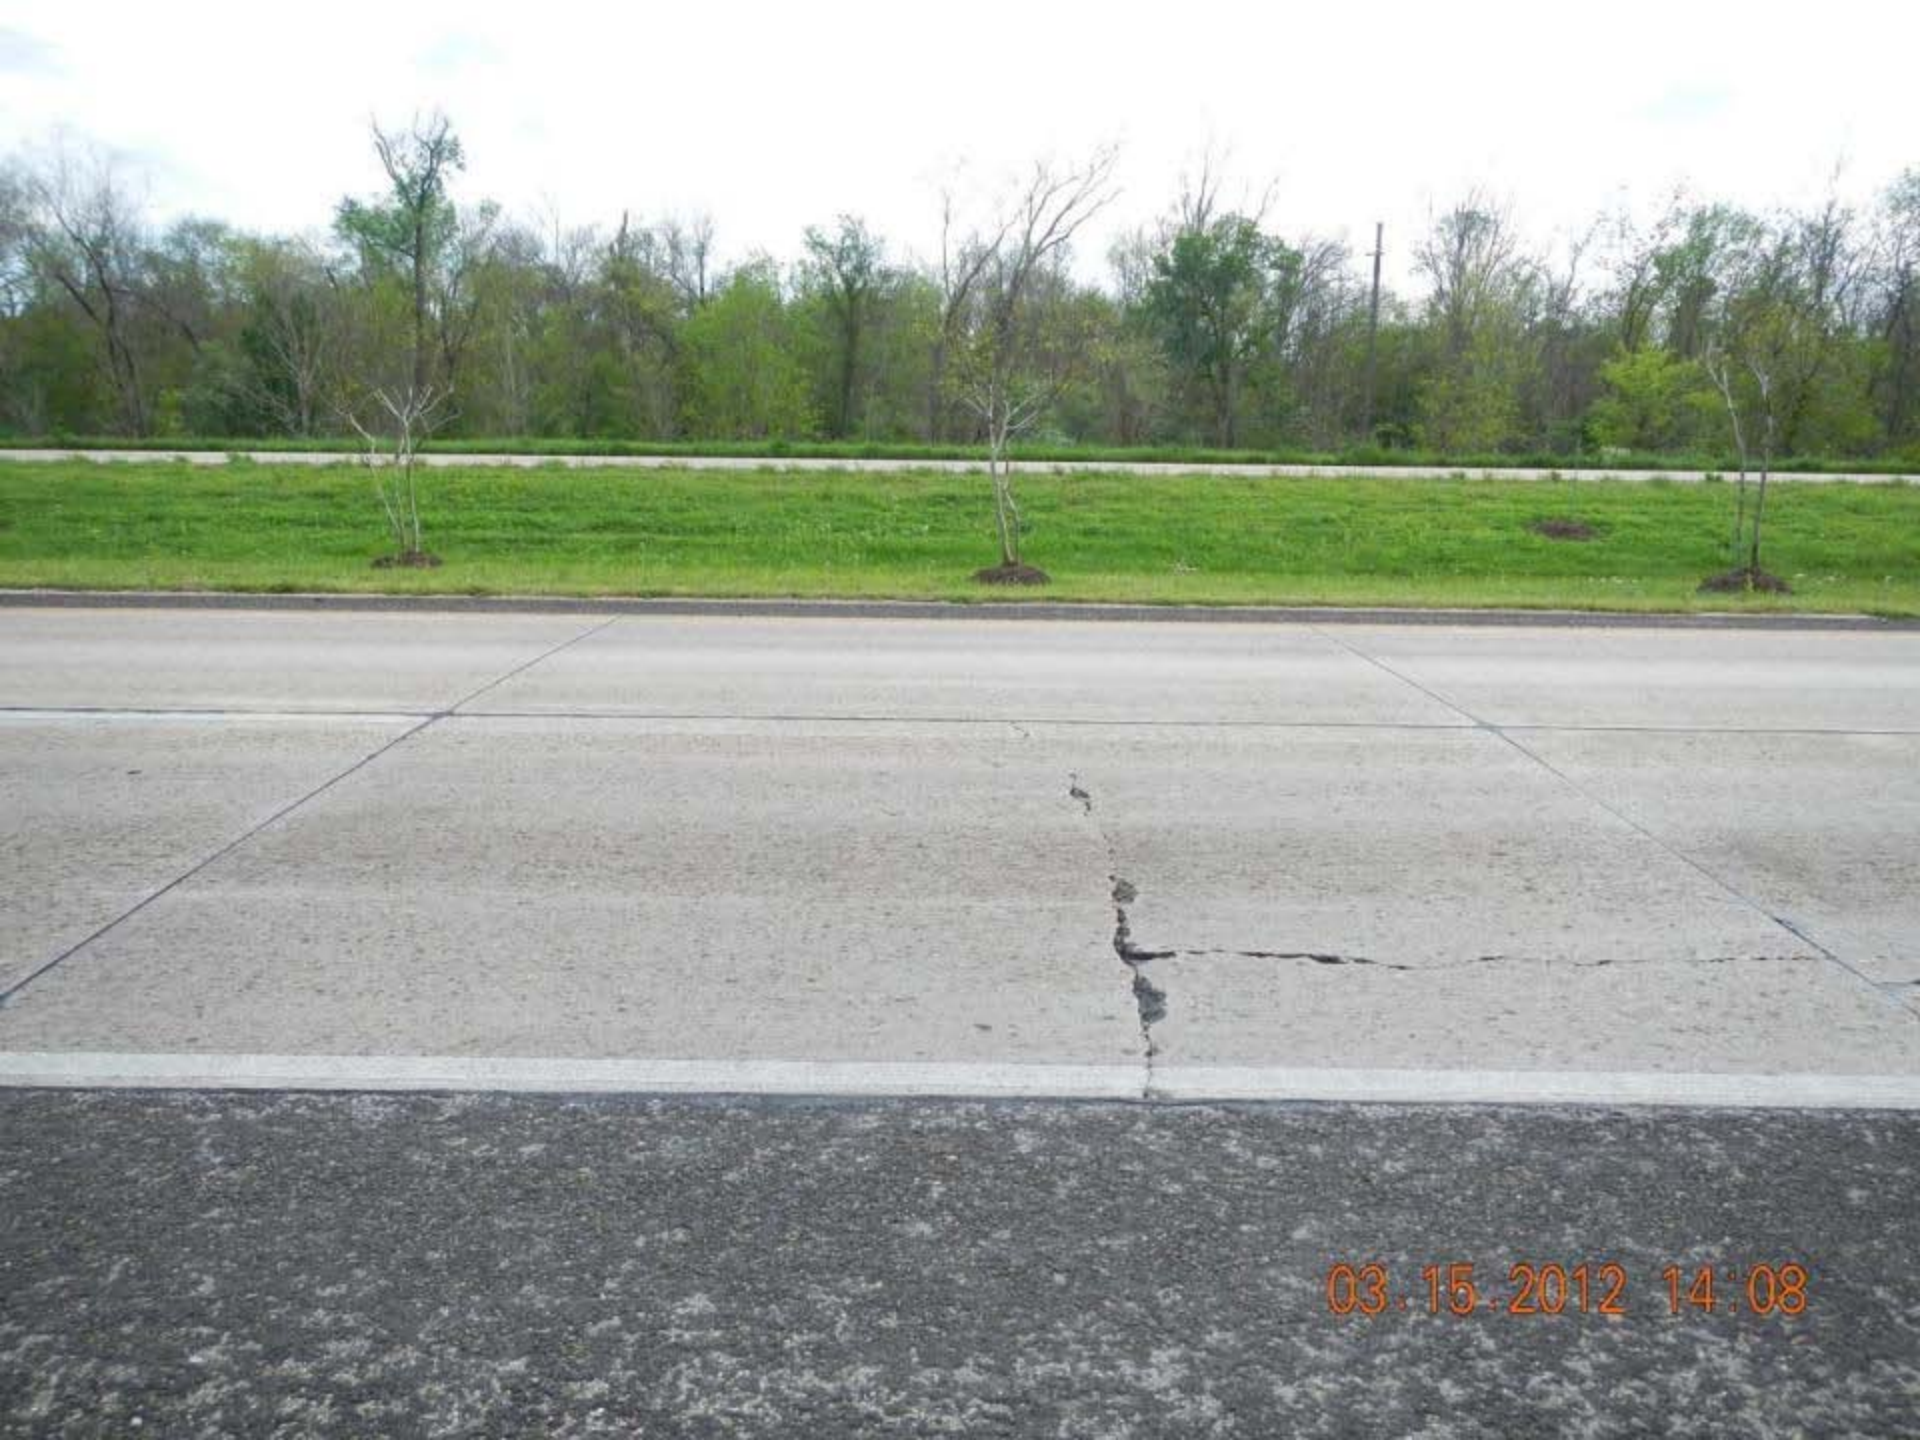
# Transverse Cracking

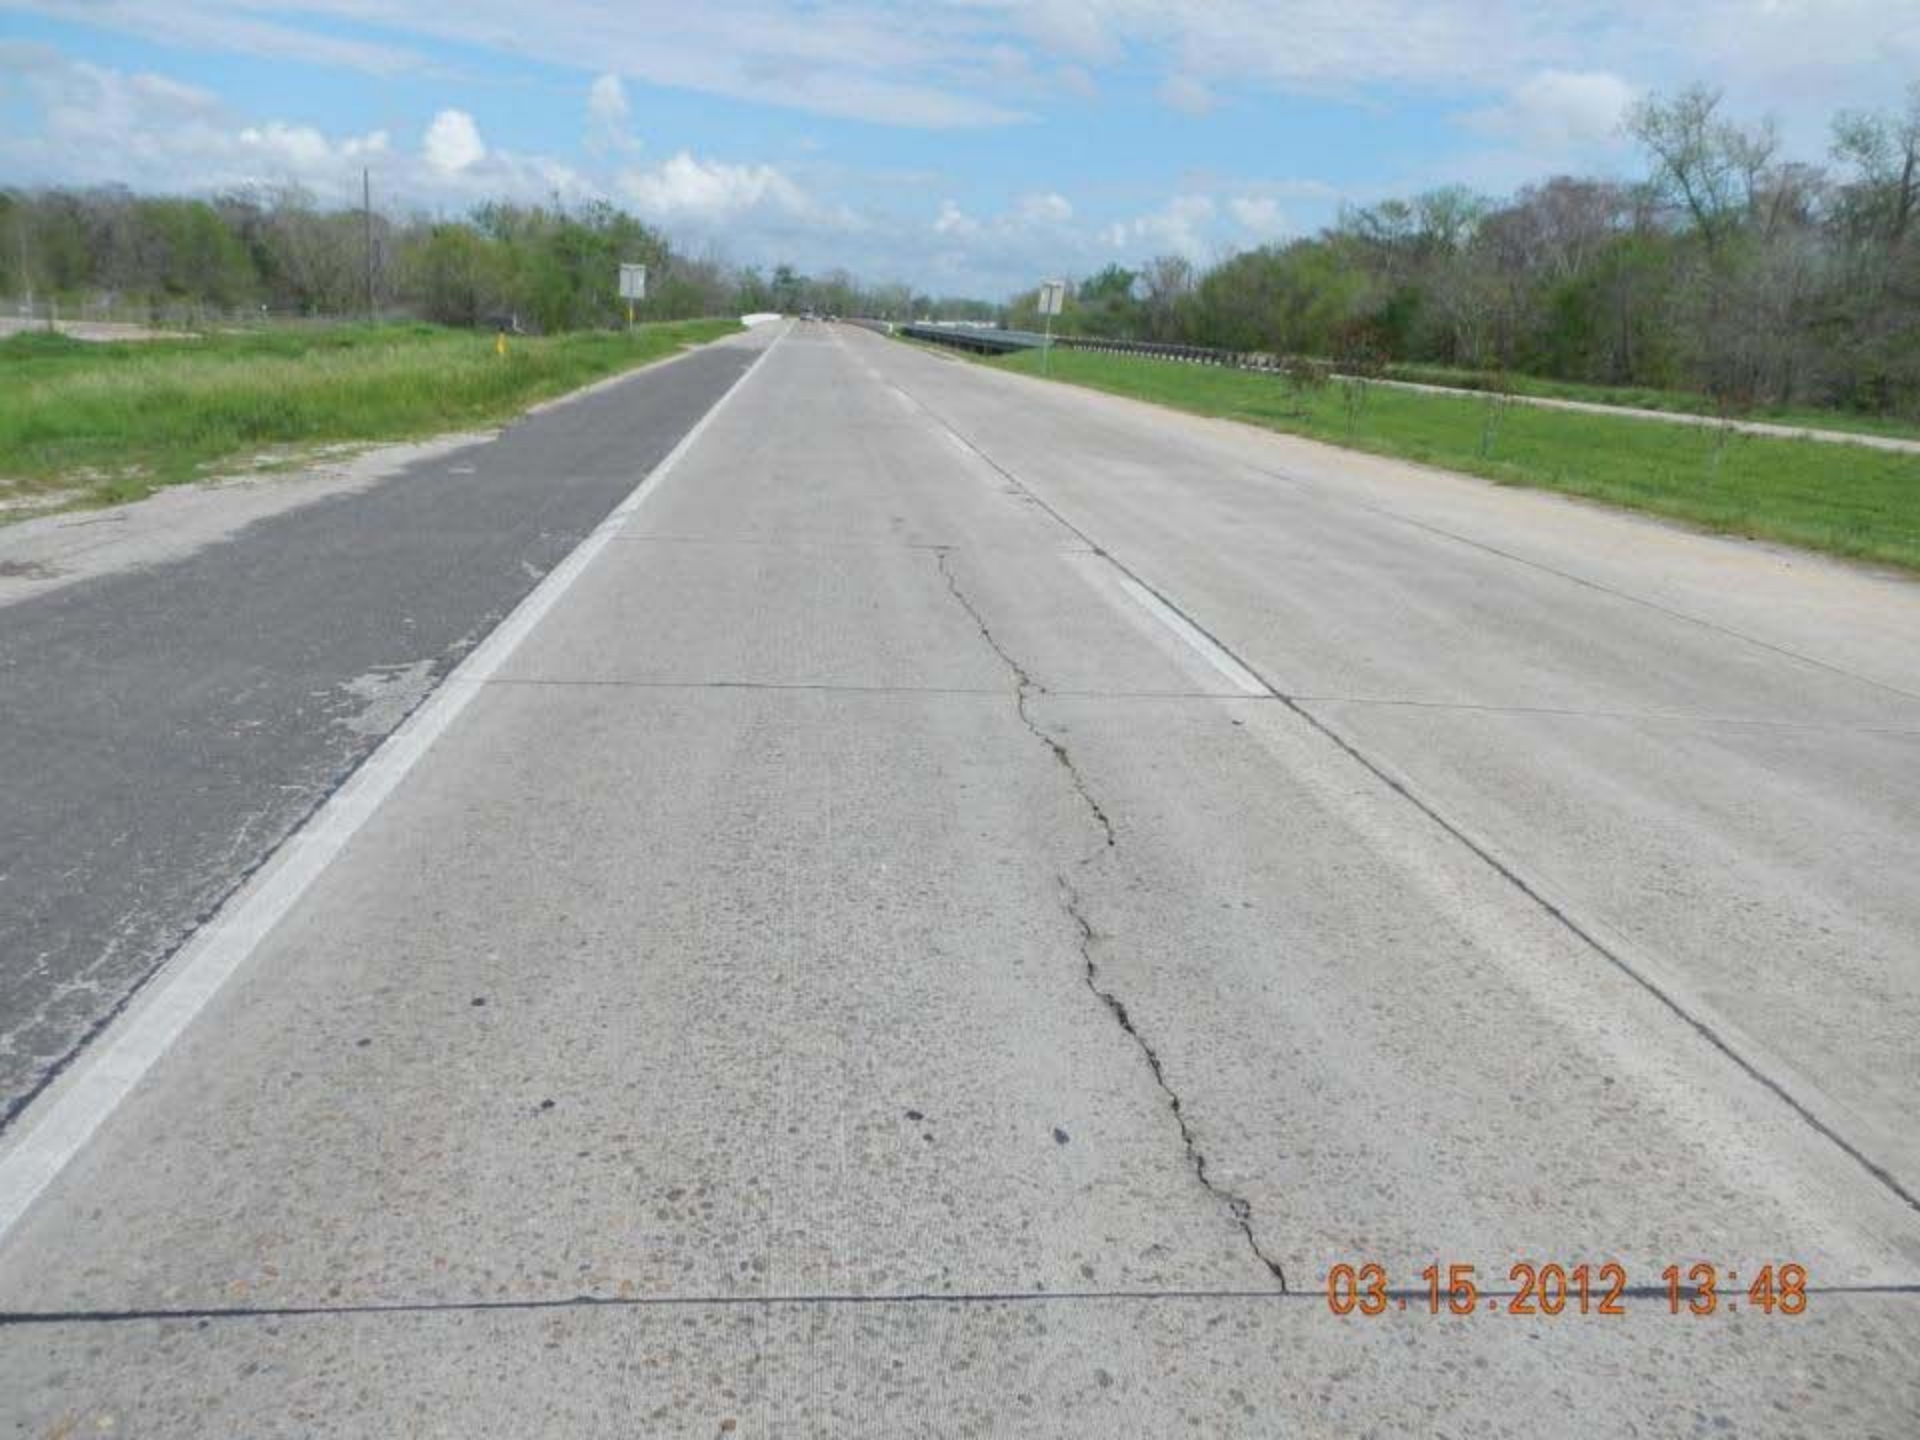
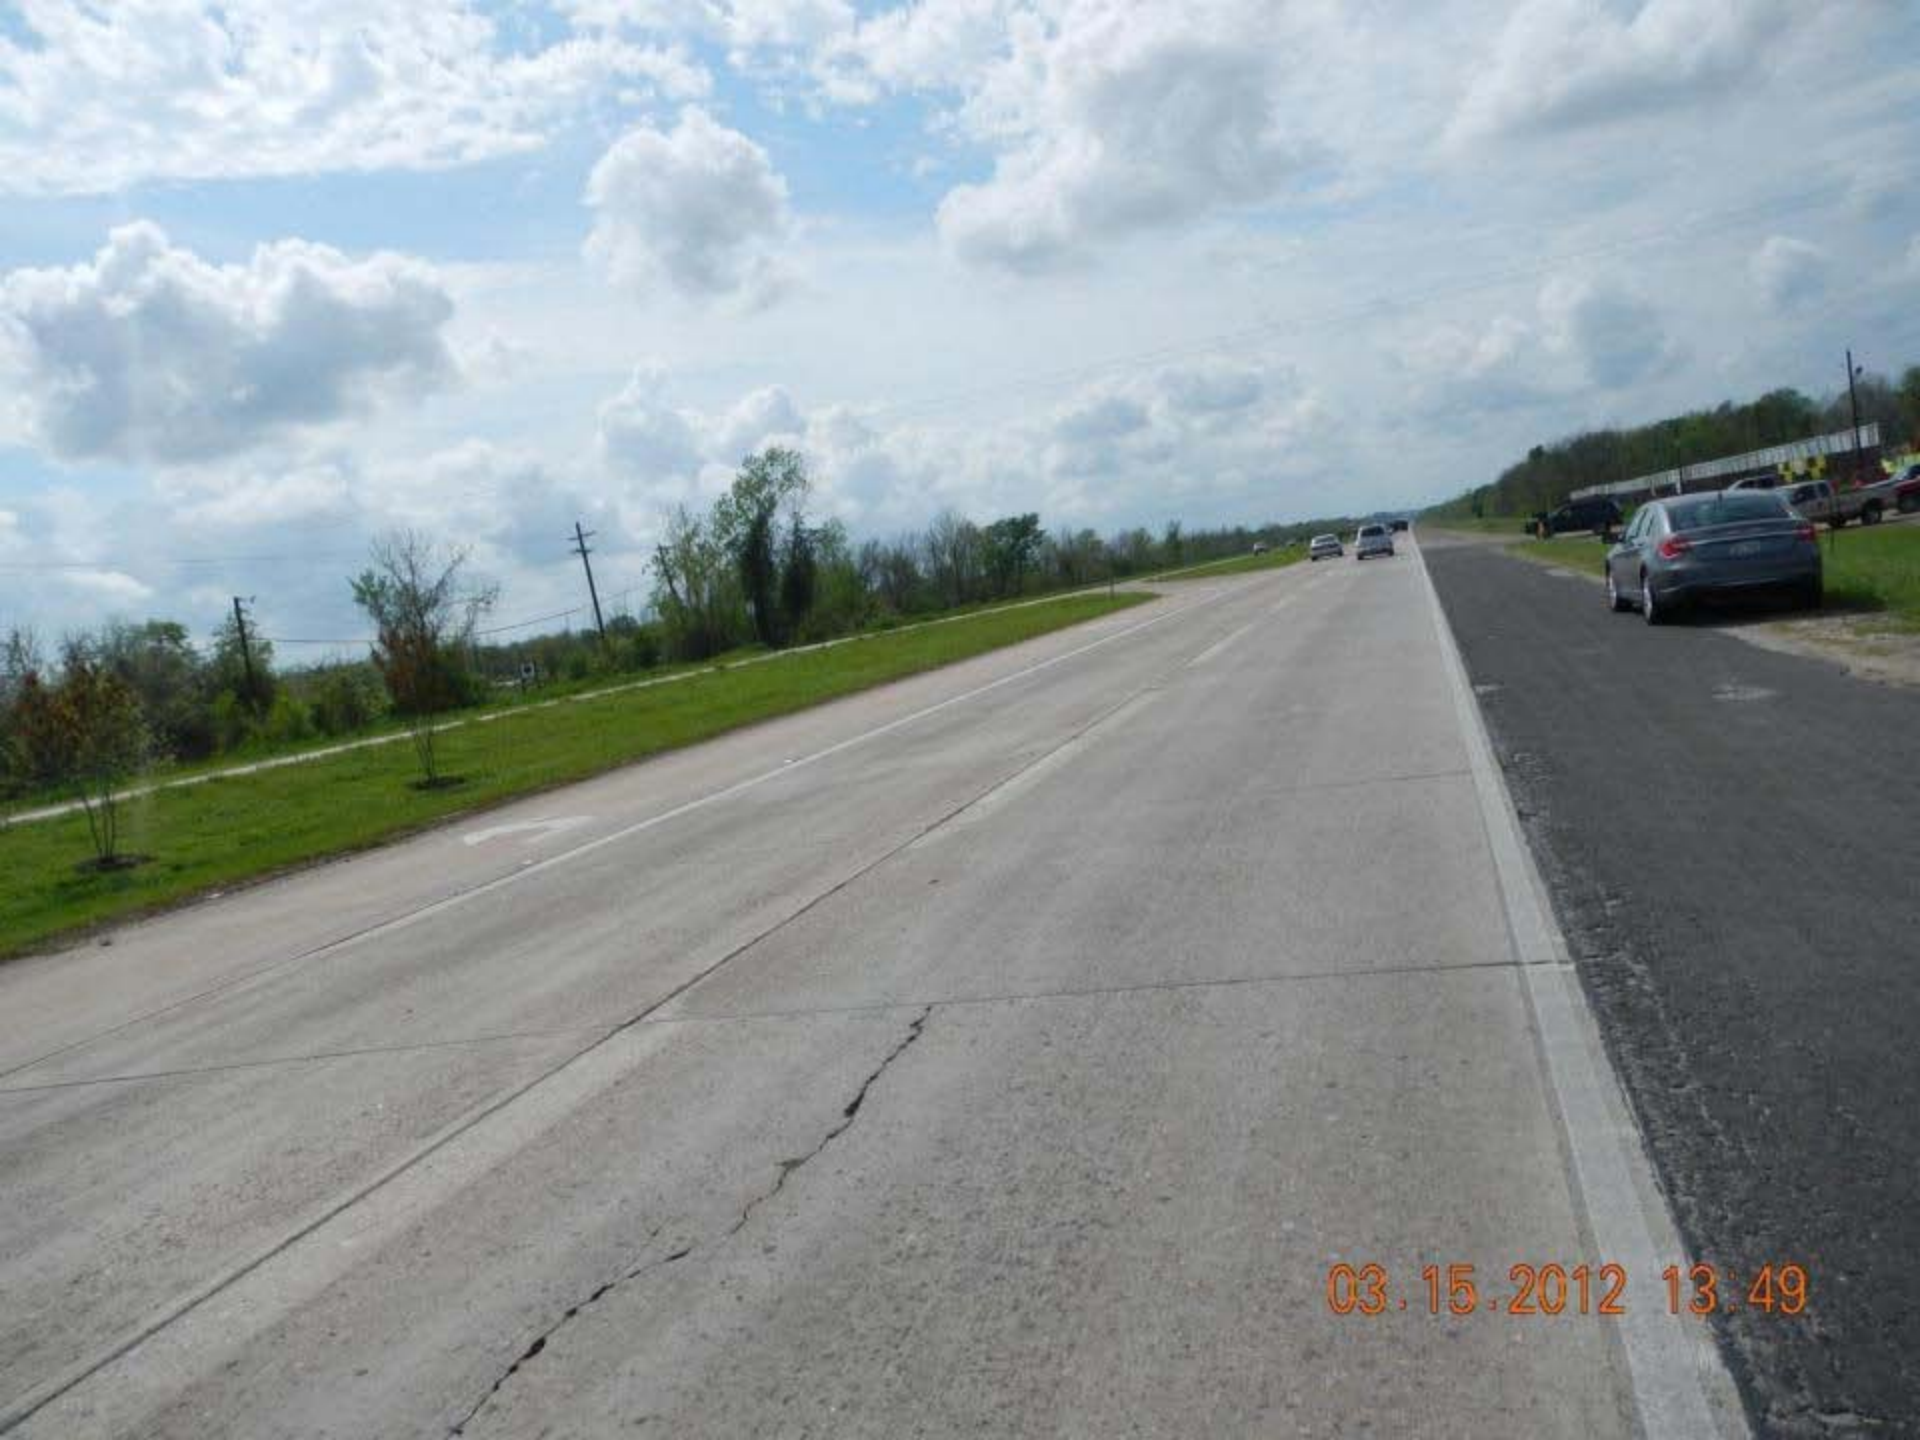
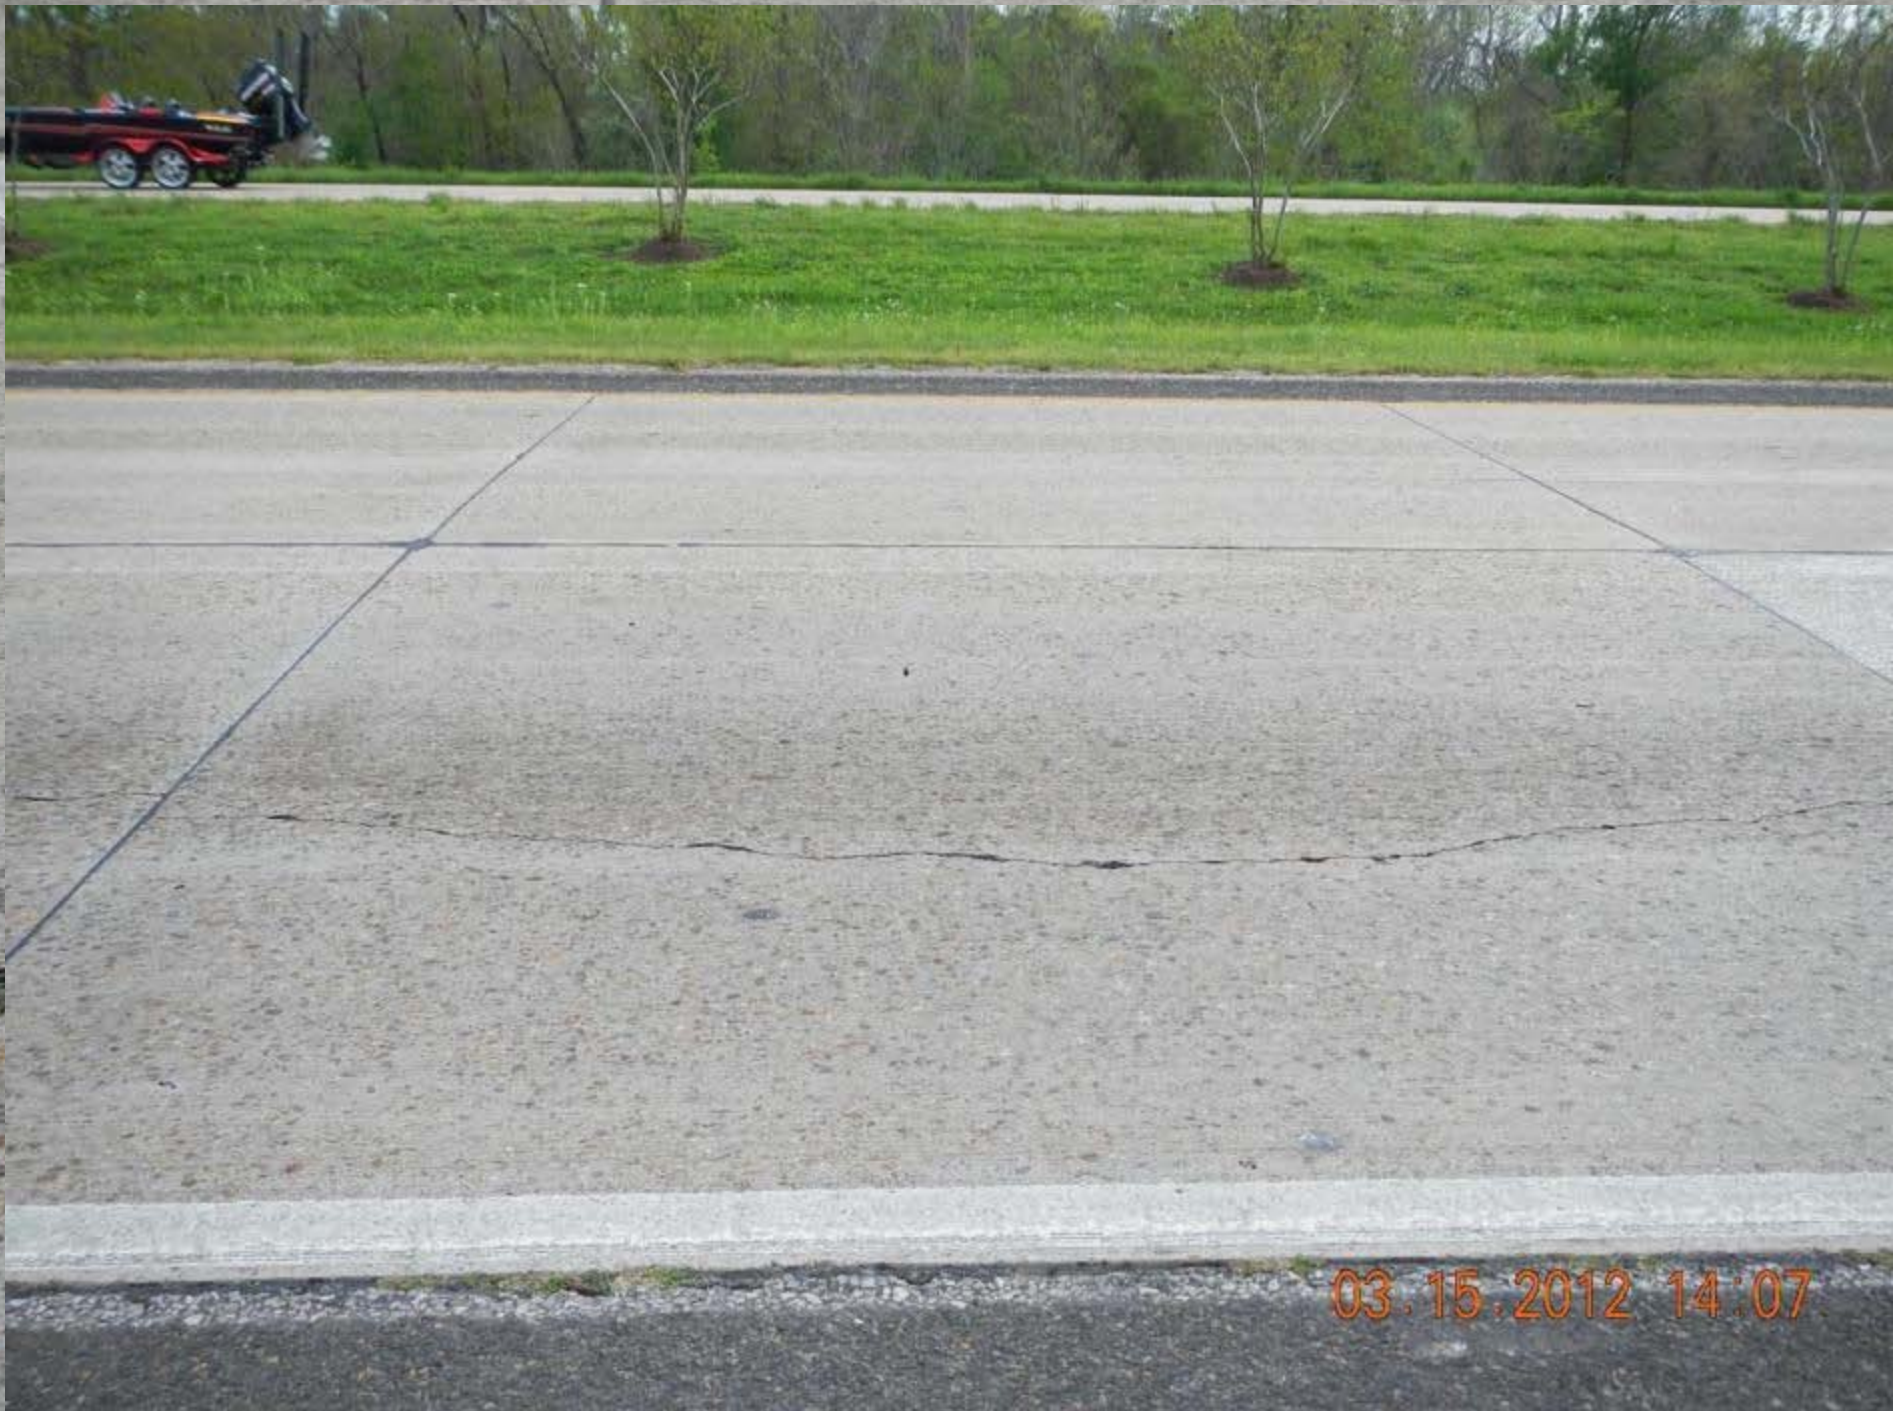
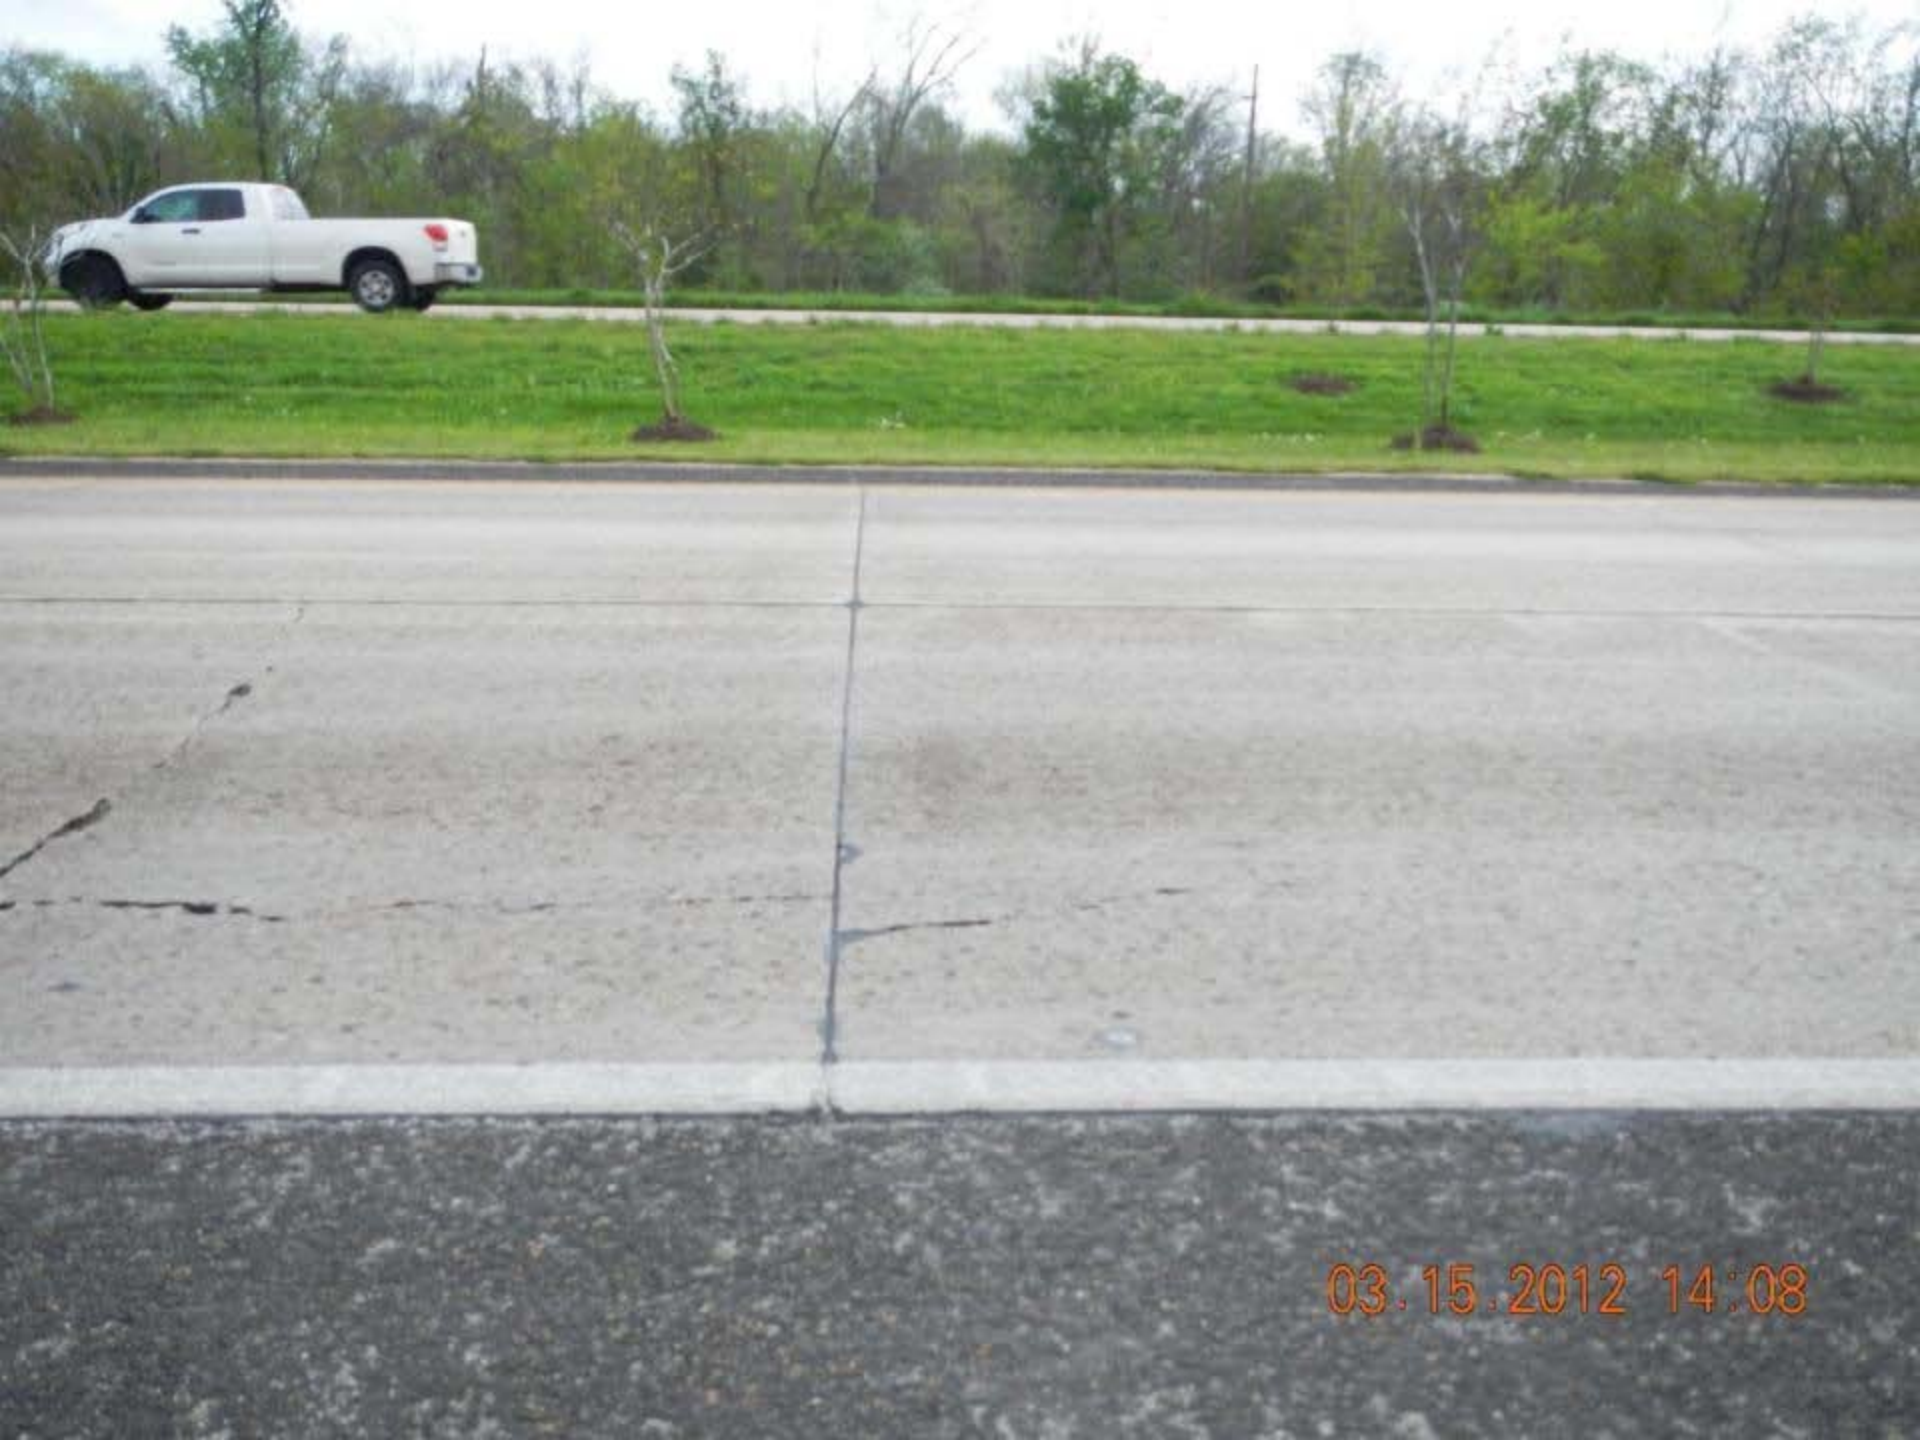
# Longitudinal Cracking
