# US 90 in Beaumont District

- Liberty County, US 90 RM 847
- Project Completed ; 2000
- Thickness ; 10-in
- Base type ; Existing 6" Flexible Base
- Subgrade type ; -
- West (Dayton Direction) ; Gravel
- East (Liberty Direction) ; Limestone(?) or ...
- Survey Date ; 03-15-2012

# Dayton Direction

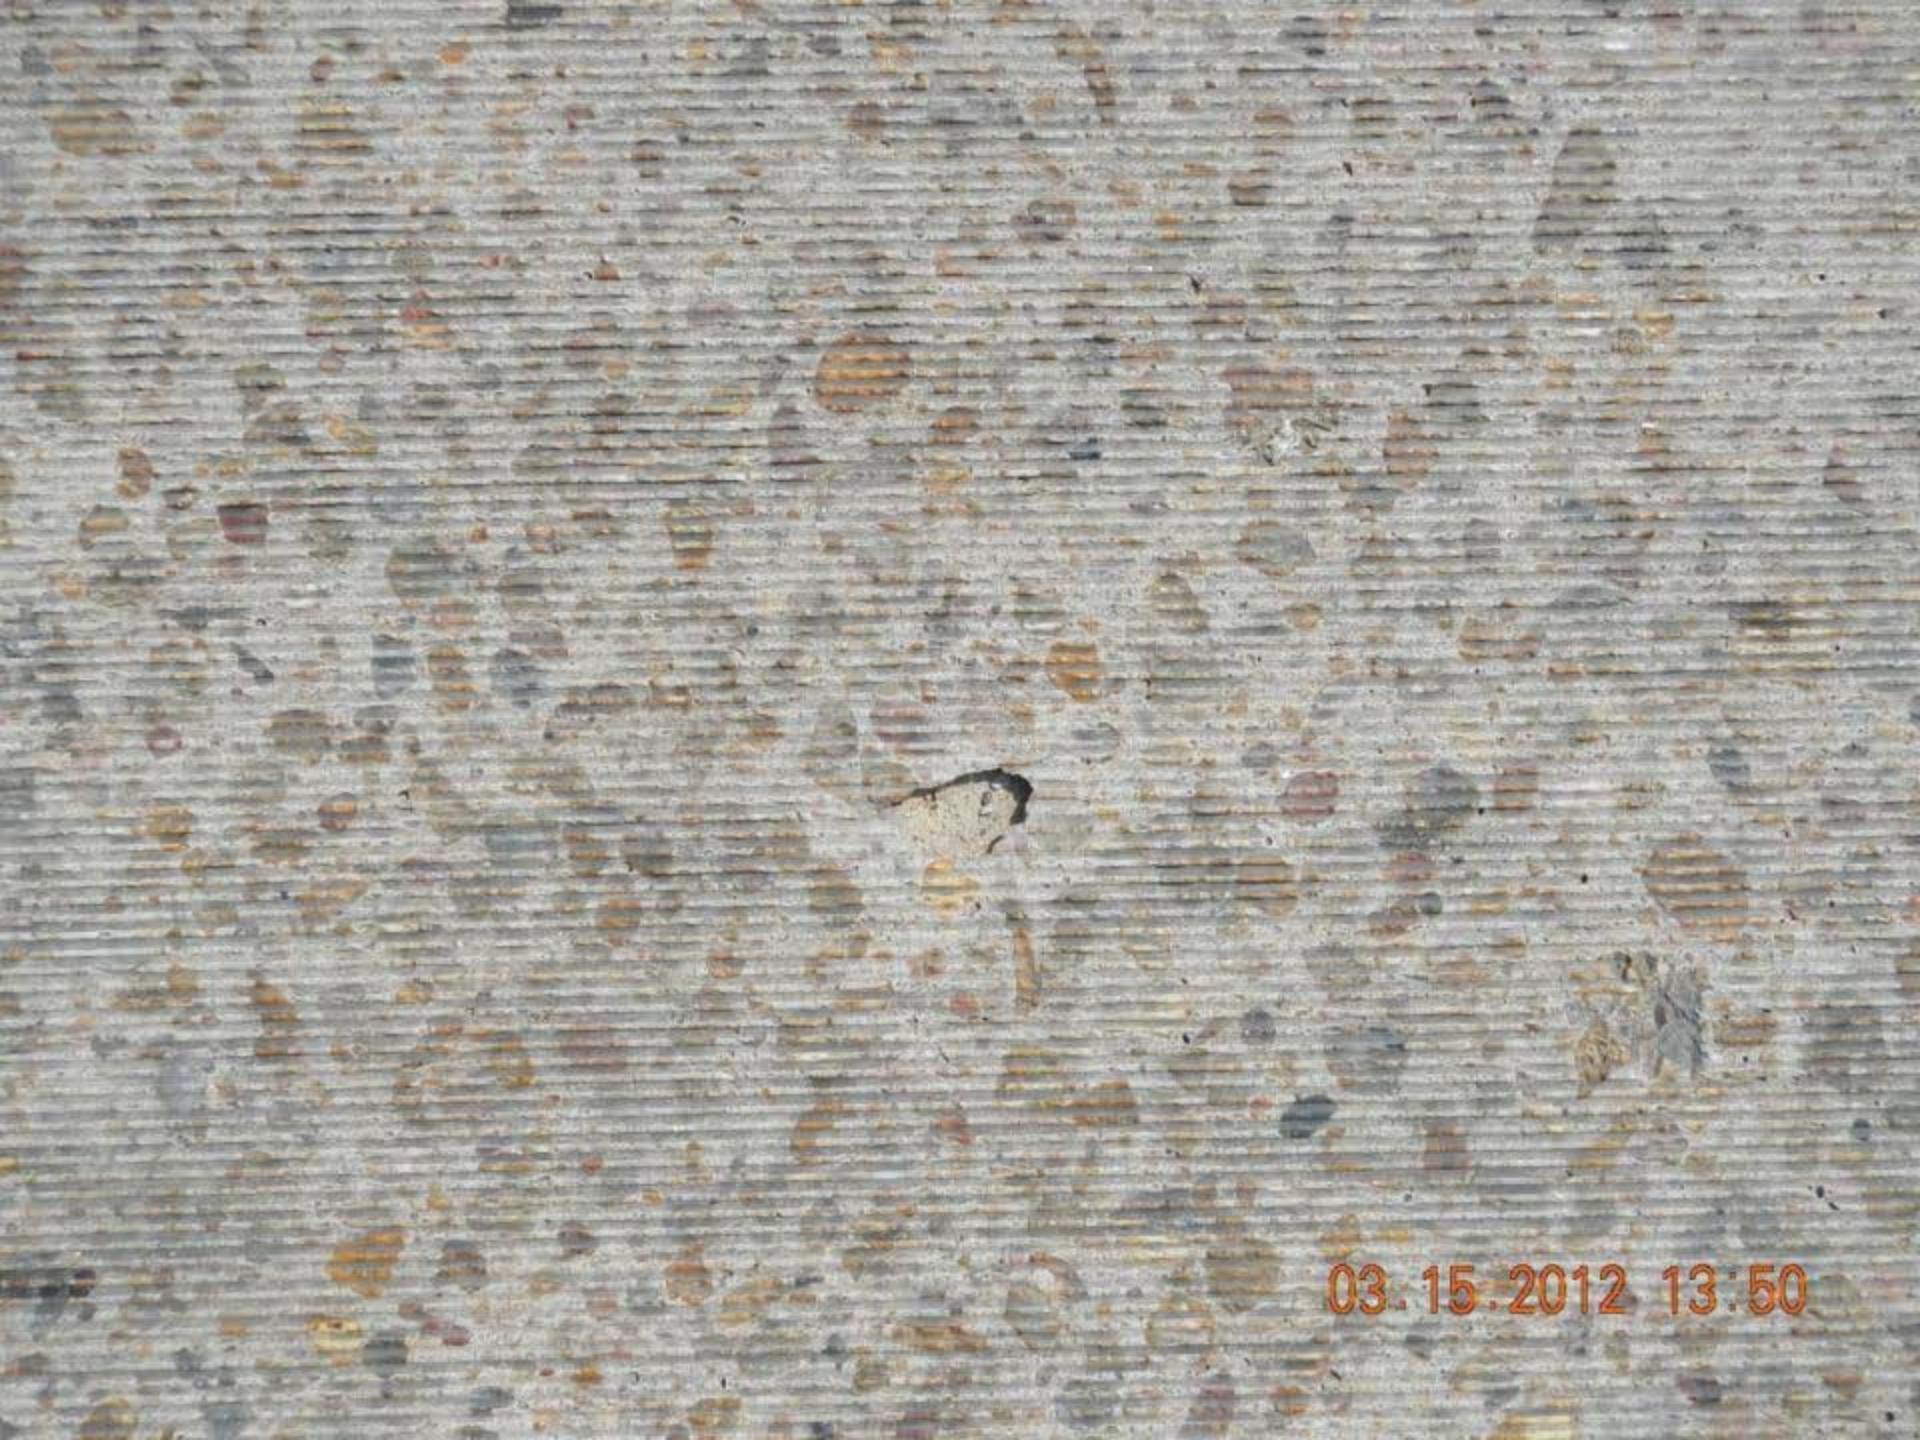
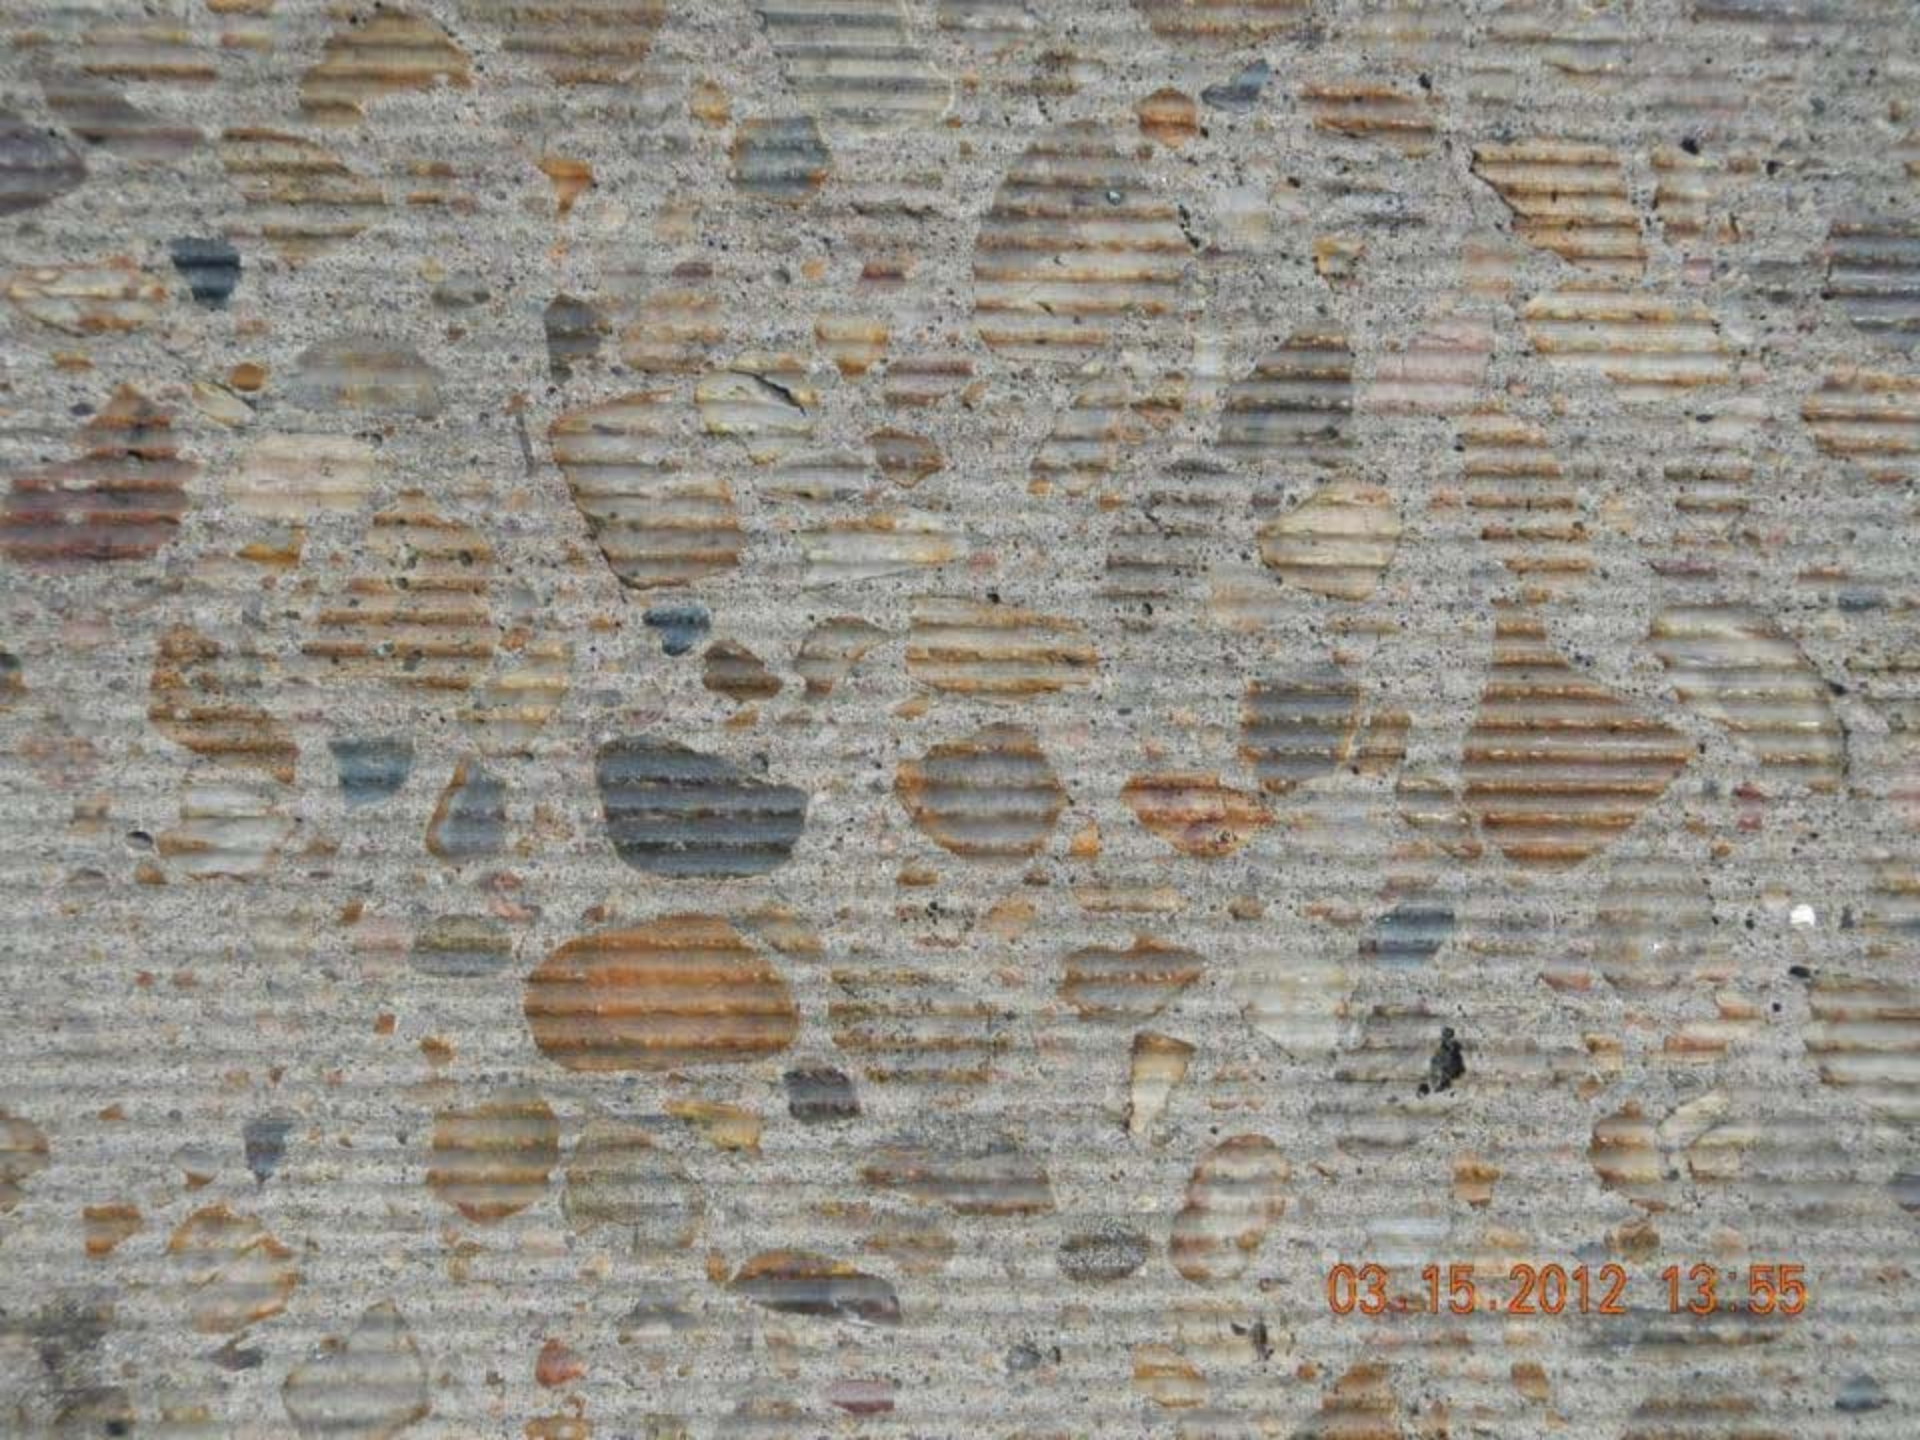
# Diamond Grinding

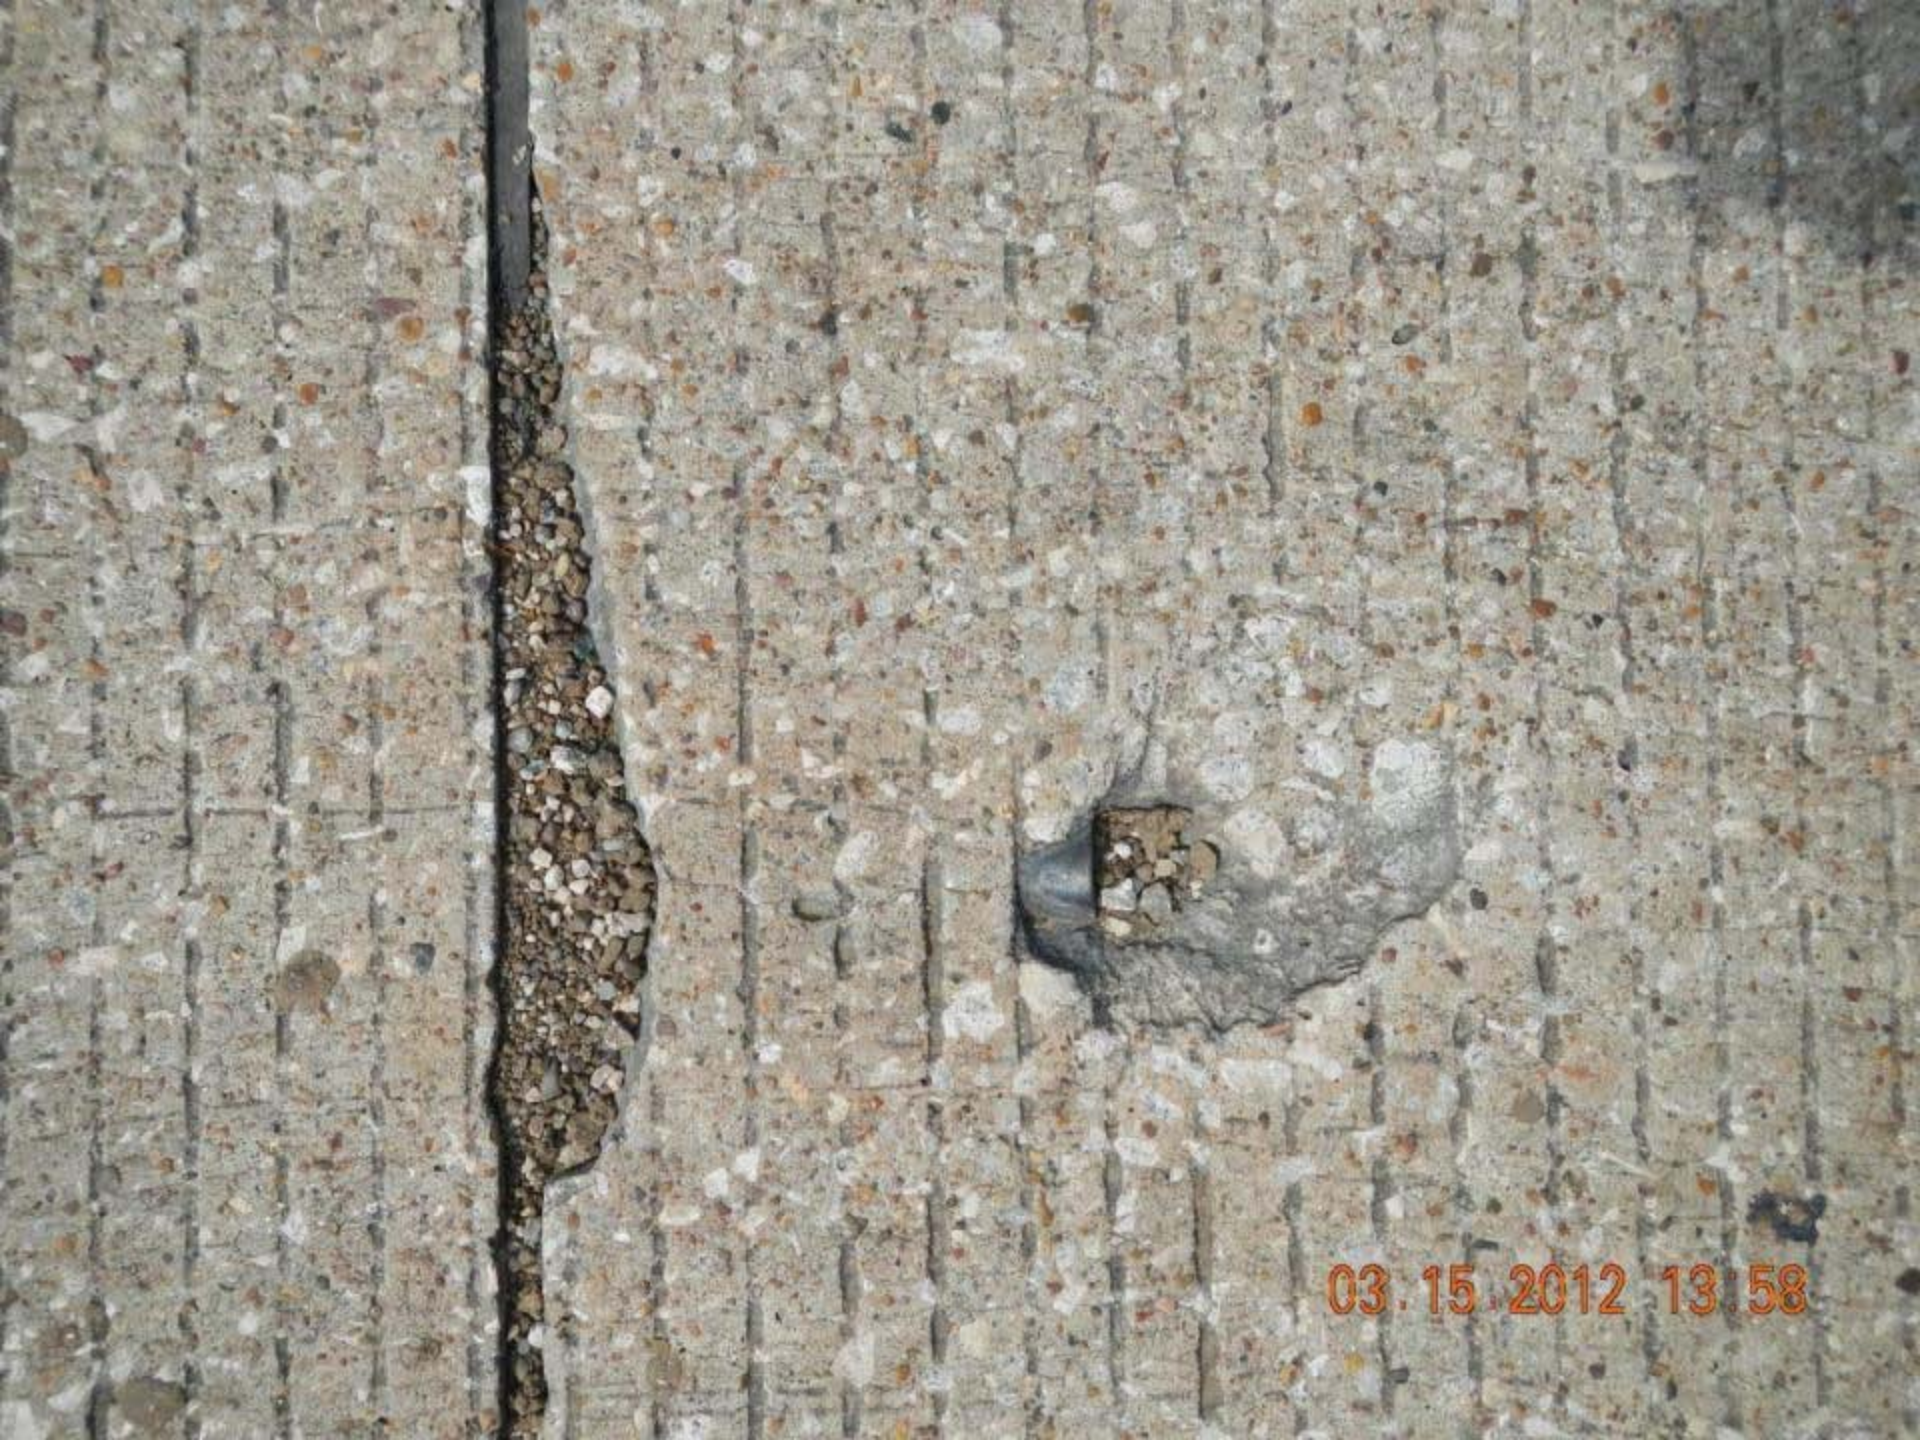
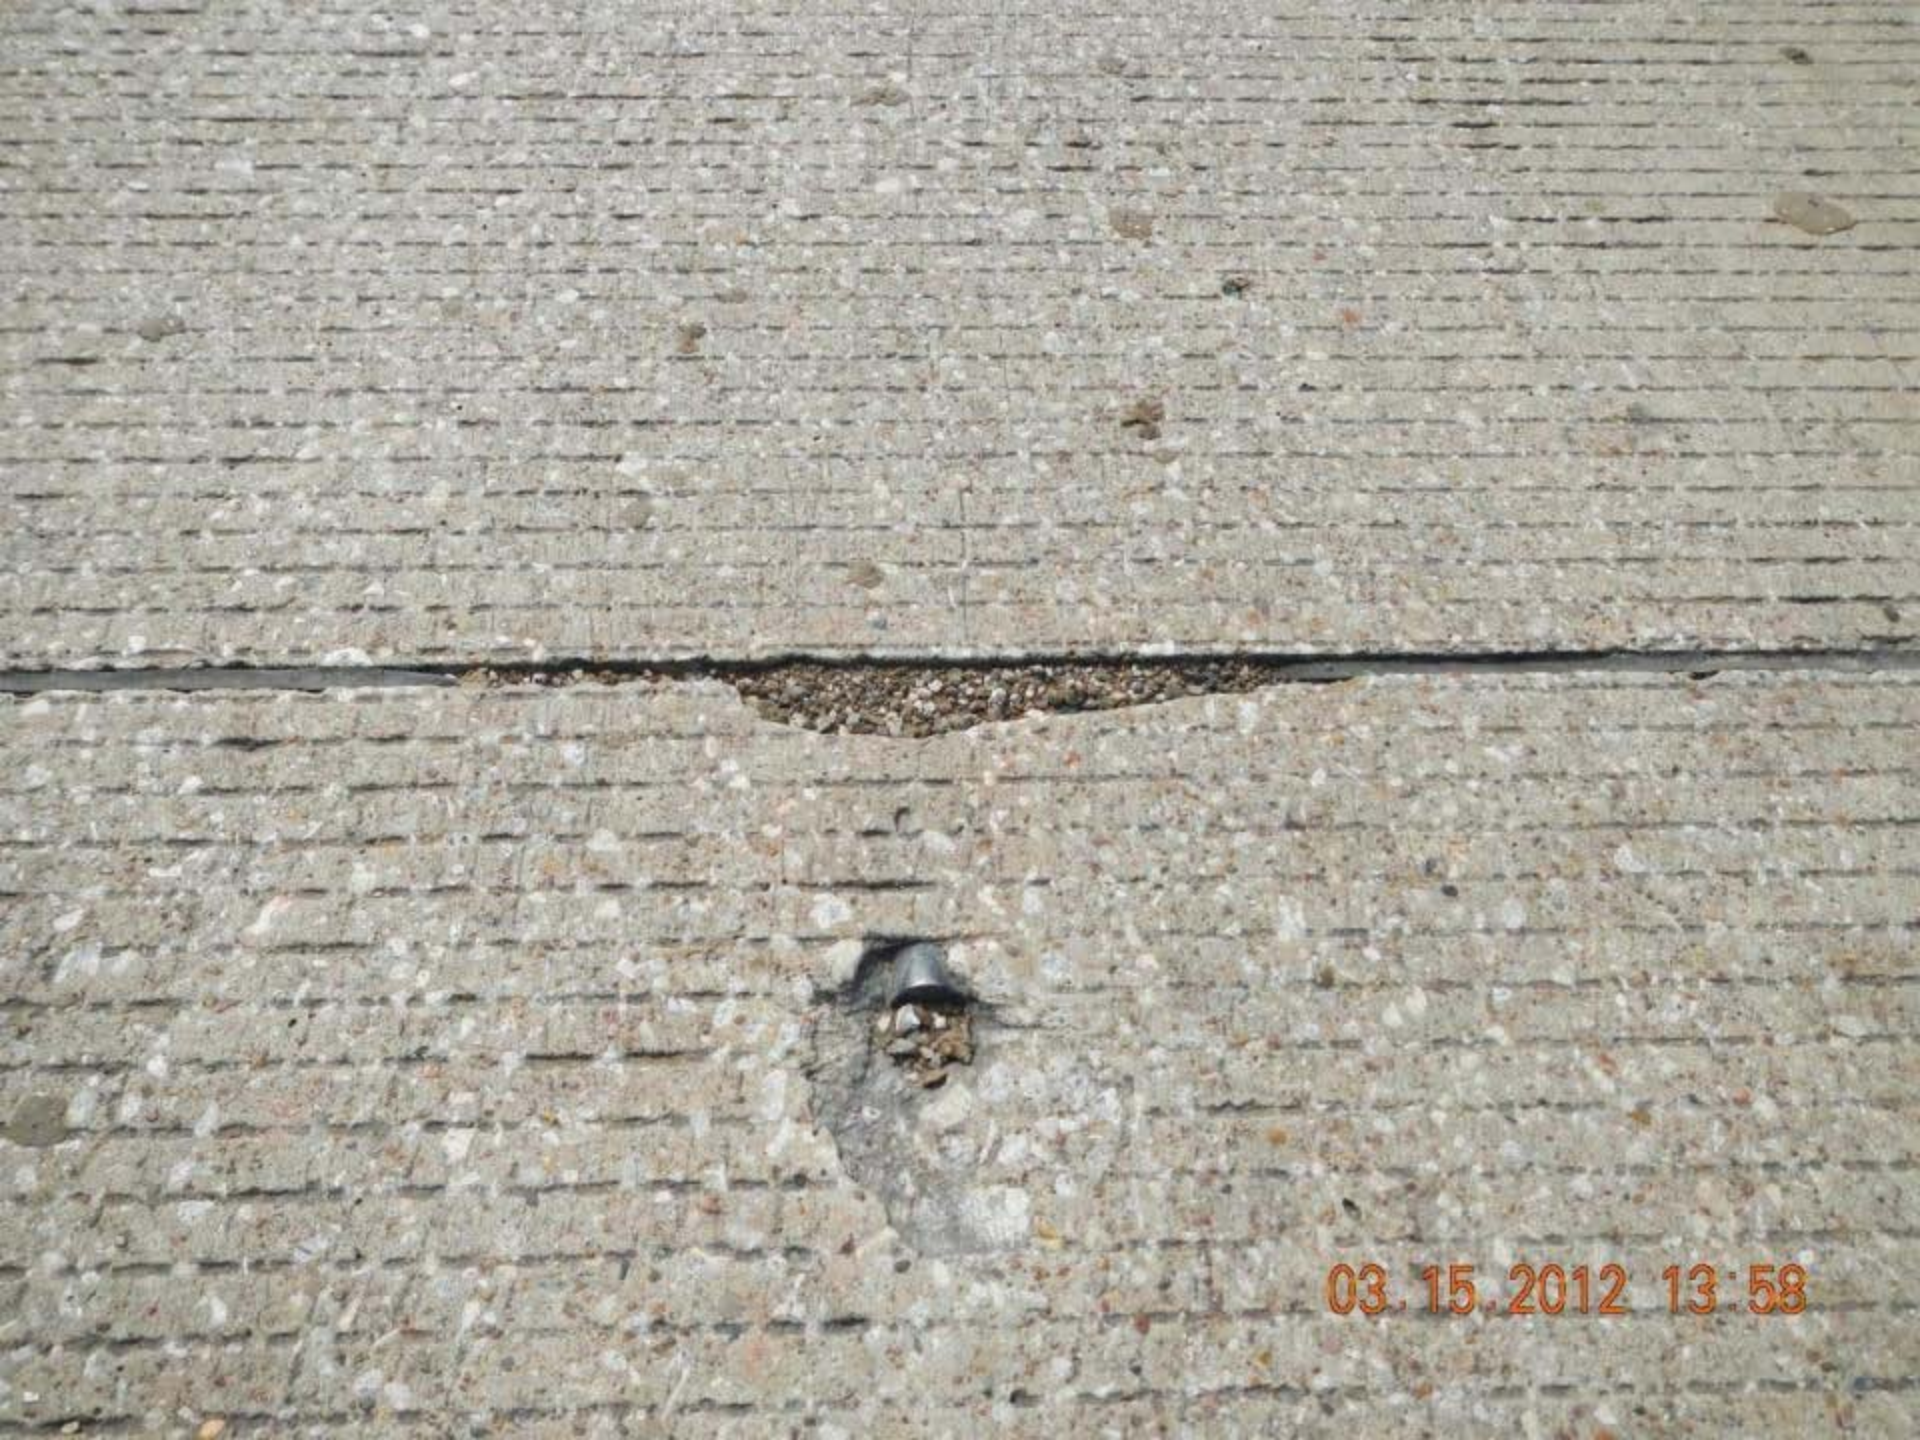
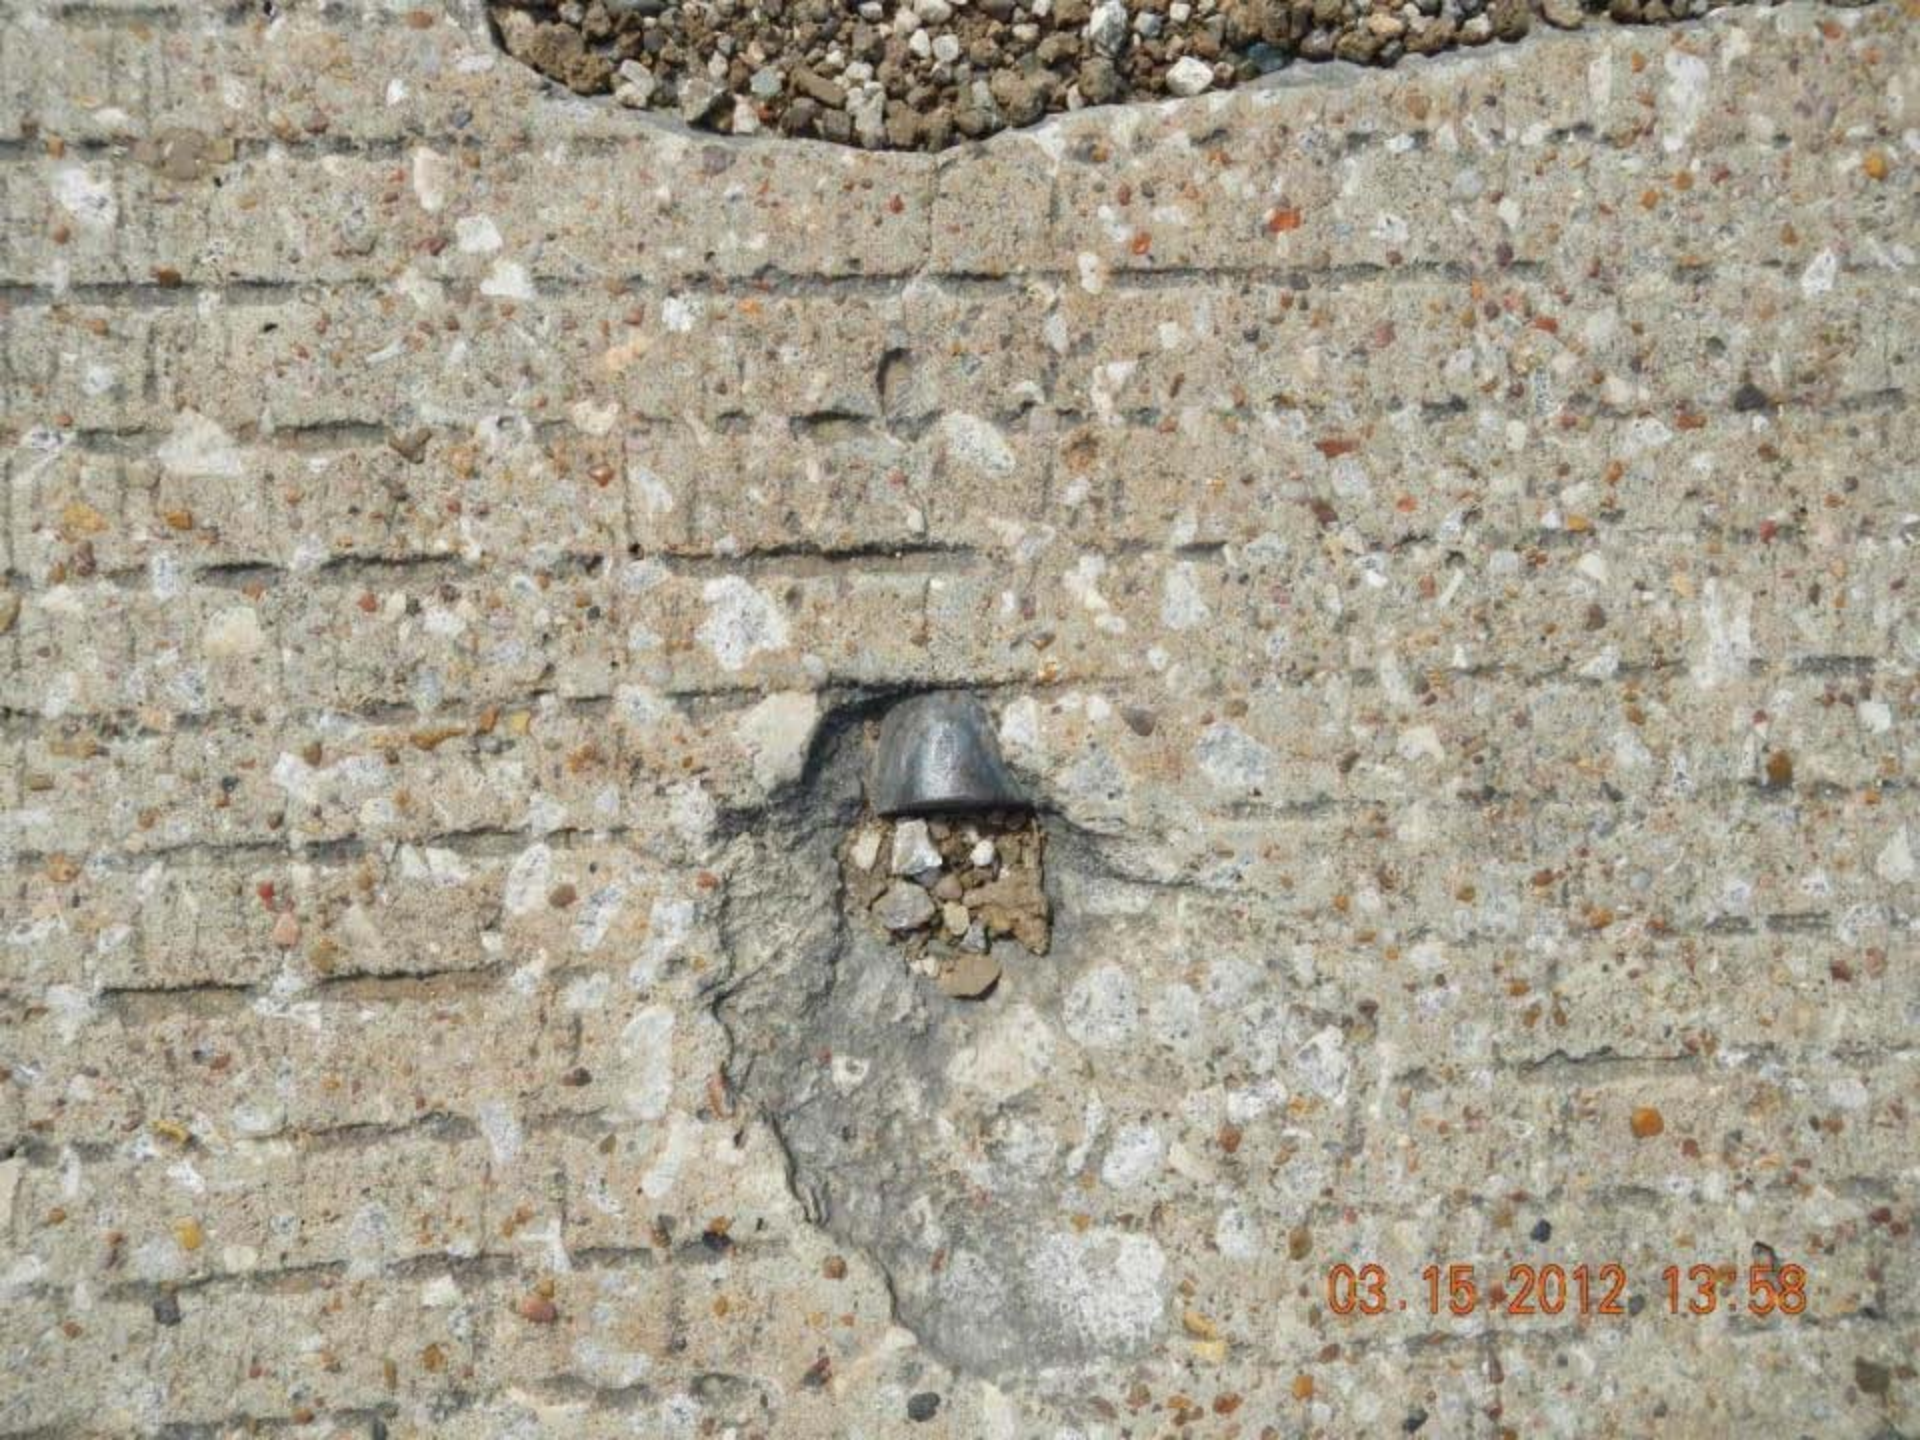
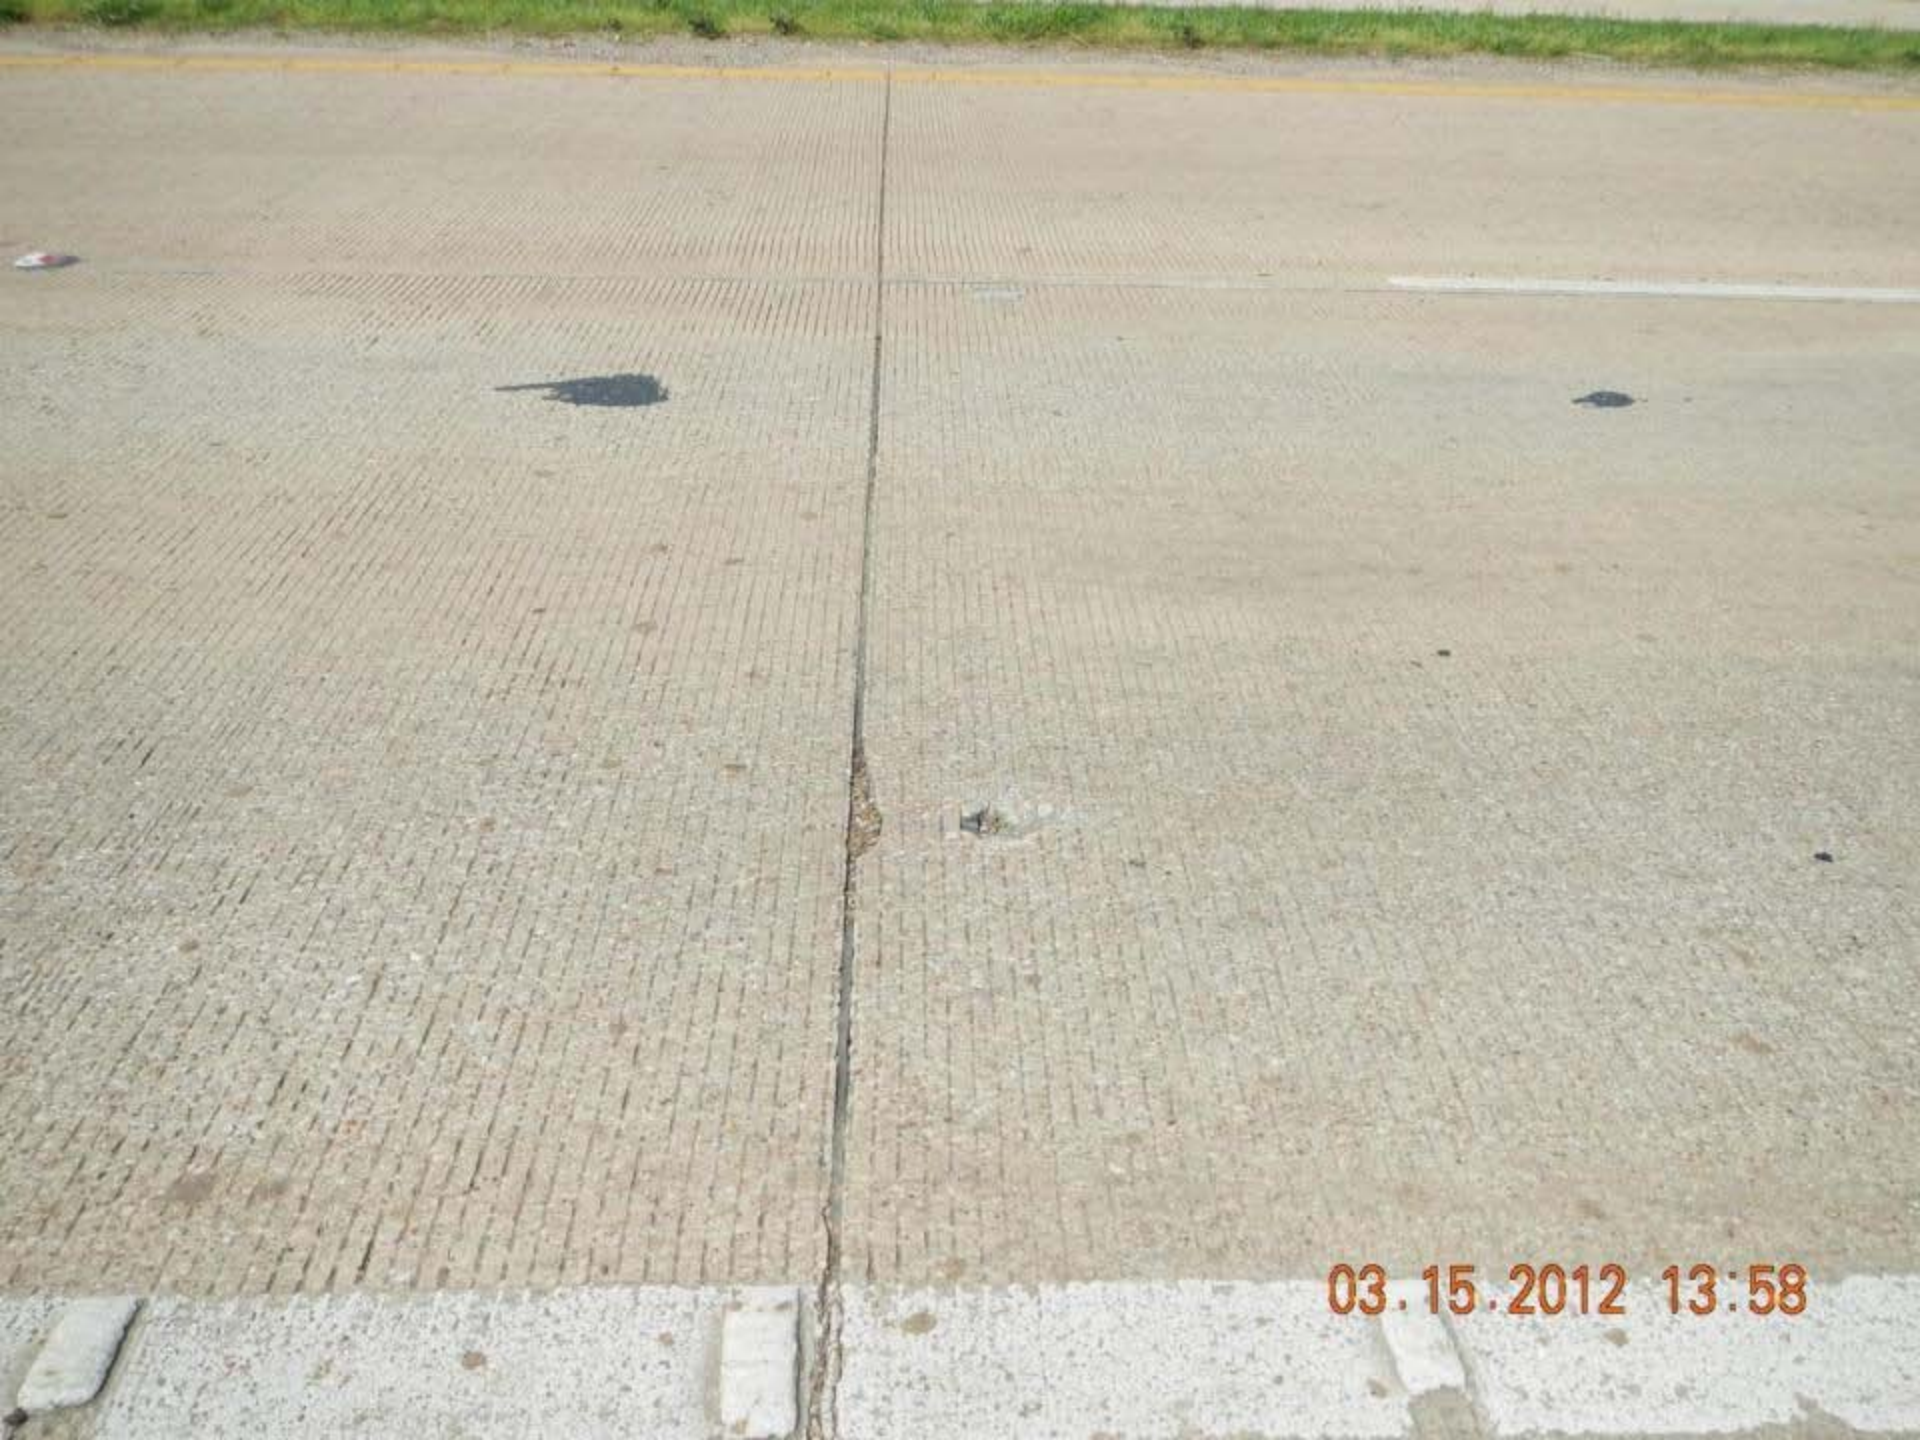
# Exposed Dowel
