TECHNICAL BULLETIN INDEX  
Sorted by Bulletin Number  
04/03/86

BULLETIN NO.: 4P:1

PRODUCT: 26-1080

PURPOSE: Prevention of RAM problems due to glitch in the 240ns delay tap output.

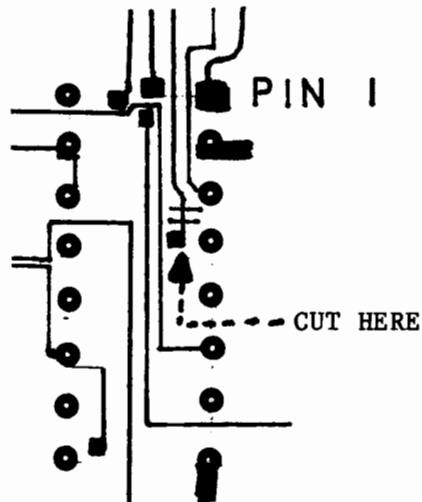
**DISCUSSION:** There is a glitch in the 240ns delay tap of Valor delay devices with a date code of 8351 or less. This glitch causes RAM problems, usually preventing the unit from booting. In the following procedure, "anding" the 150ns, and the 240ns delay tap, stabilizes the 240ns line to properly clock U115.

Below is the PCB art work for U115 as viewed from the solder side of the board. The required trace cut for this modification is as indicated.

- 1.) Cut the run to the solder pad NEXT to U115 pin 4. (see attached art work)
- 2.) Jumper from U129 pin 8, to U115 pin 13.
- 3.) Jumper from U129 pin 9, to U97 pin 10.
- 4.) Jumper from U129 pin 10, to U97 pin 6.

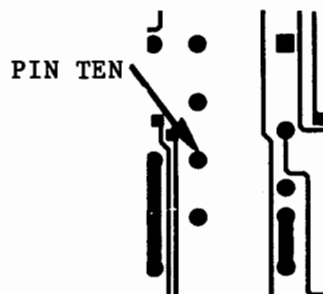
Below is the PCB art work for U97 as viewed from the solder side of the board. U97 pin ten of the delay device as referred to in the above procedure is as indicated below.
