Aviation Investigation Final Report

Location:	Ravendale, California	Accident Number:	WPR22LA090
Date & Time:	January 28, 2022, 14:25 Local	Registration:	N420WT
Aircraft:	Textron Aviation TTX Inc. T240	Aircraft Damage:	Unknown
Defining Event:	Loss of engine power (partial)	Injuries:	1 Minor, 2 None
Flight Conducted Under:	Part 91: General aviation - Instructional

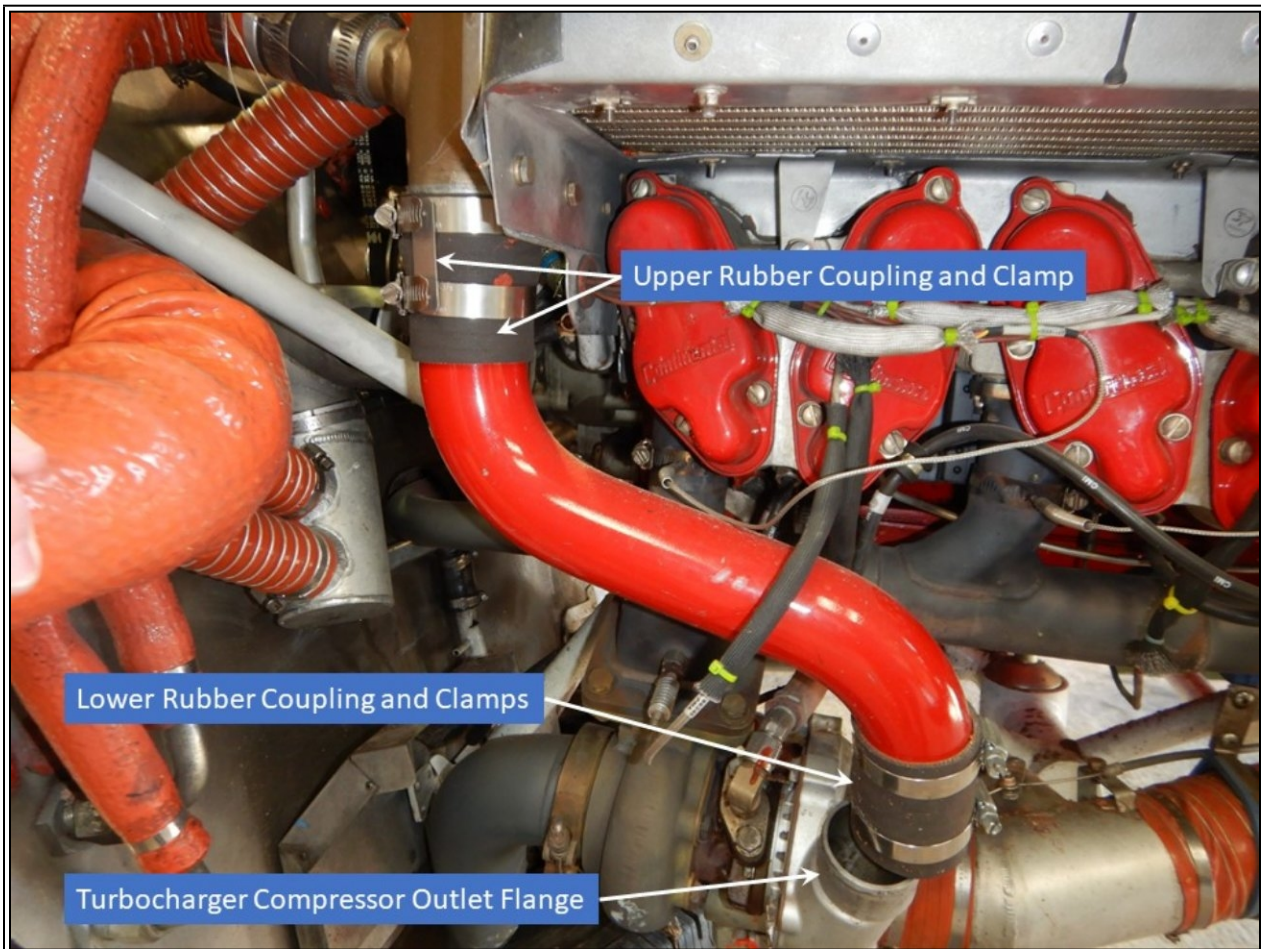
Postaccident examination of the airplane indicated that the right induction tube connecting the turbocharger compressor outlet to the intercooler inlet had separated from the turbocharger compressor outlet flange. Two inches of the induction tube was installed into the 3-inch-long rubber coupling, leaving only 1 inch remaining to be installed on the turbocharger compressor outlet flange. It is likely that when the engine was at high RPM during the takeoff climb, the improperly installed lower rubber coupling separated from the turbocharger compressor outlet flange, resulting in the loss of engine power.

The inadequate maintenance and inspection of the engine induction system, which resulted in the separation of the right induction tube from the turbocharger compressor outlet and the subsequent loss of engine power during departure.

During the postaccident examination of the wreckage, the right induction tube, which connects the turbocharger compressor outlet to the intercooler inlet, was found separated from the turbocharger compressor outlet flange. The examination revealed that two inches of the induction tube was installed into the 3-inch-long rubber coupling, leaving only 1 inch remaining to be installed on the turbocharger compressor outlet flange. The lower rubber coupling, and band clamps remained attached to the induction tube. A required heat shield was not attached to the lower clamps.

Figure 1. Right side induction tube and rubber coupling.
