Aviation Investigation Final Report

Location:	Newport Beach, California	Accident Number:	WPR22FA101
Date & Time:	February 19, 2022, 18:34 Local	Registration:	N521HB
Aircraft:	McDonnell Douglas 500N	Aircraft Damage:	Substantial
Defining Event:	Loss of tail rotor effectiveness	Injuries:	1 Fatal, 1 Minor
Flight Conducted Under:	Public aircraft

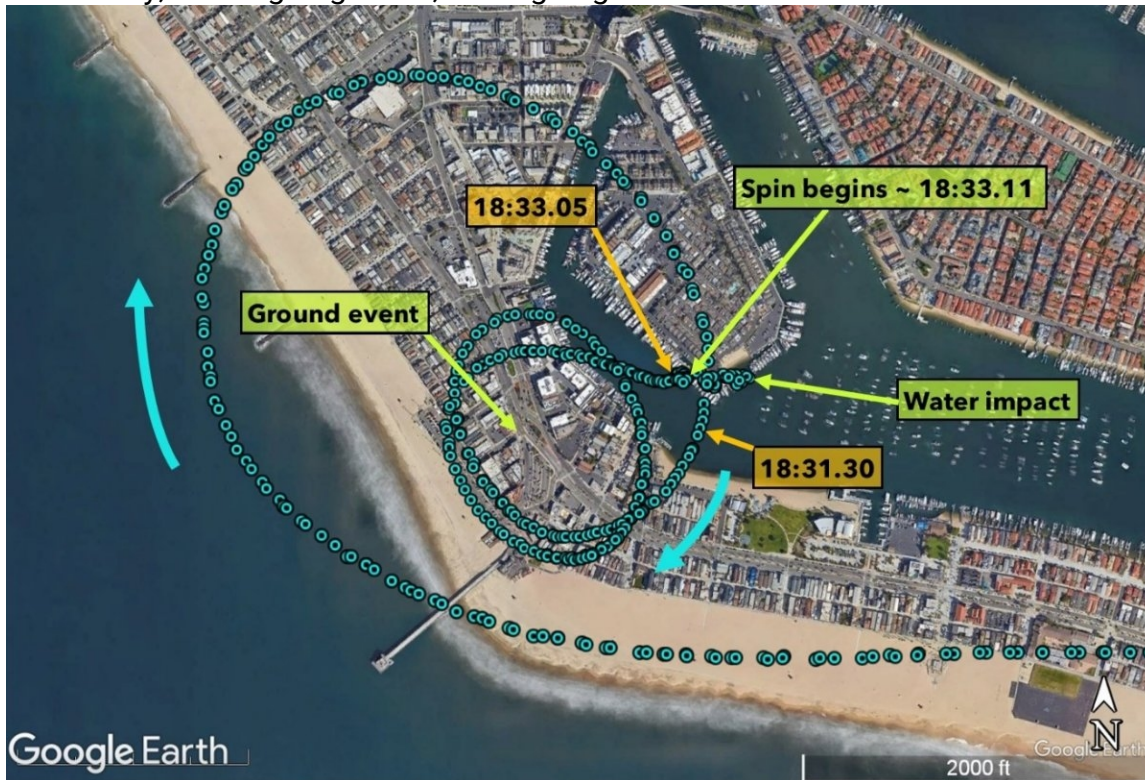
The pilot stated that, suddenly, the helicopter yawed aggressively to the right, and he immediately applied full left foot pedal and forward cyclic to arrest the rotation, but there was no response. He then applied right pedal to see if the pedals had malfunctioned, and observing no change, he reverted to full left pedal. He continued to apply corrective control inputs, but the helicopter did not respond and began to progress into a spinning descent. (see Figure 1.) The

Figure 1 – Final flight path segment
