# Pulse Generator Restoration Notes

January – March 2012, updated August 2012

Delwyn Holroyd

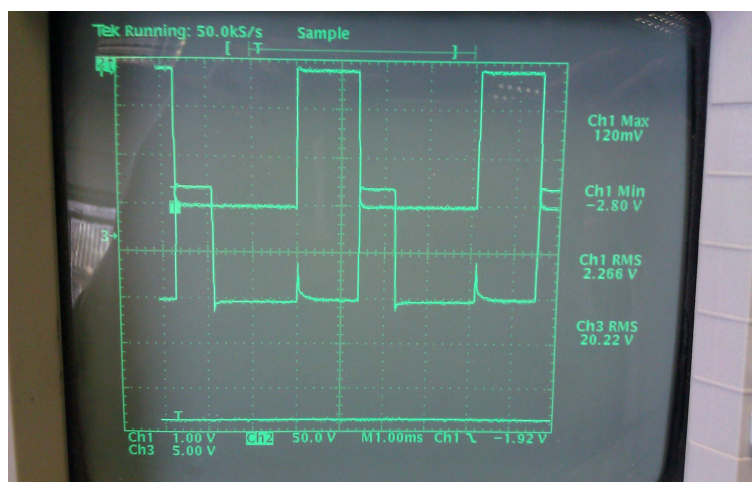
Over the course of the next few weeks as work progressed, B pulse width became highly unstable and narrower. This fault was traced to C19 (two caps – the larger flat mica to blame). These were replaced with new modern 2200 + 150pF caps on 17<sup>th</sup> March.

An unusual feature was observed on the +B outputs from V8 – on the anode positive going and on screen negative going narrow pulses coincident with V9 (+A pulse) rising edge. It is unclear exactly how this arises, but is clearly associated with the current which must flow through C19 into the grid of V8, although there is no evidence of a voltage spike on V8 grid. The -ve pulse on the screen output is effectively removed by the following stage (V13) so has no effect on circuit operation.

The picture above shows +A and +B pulses before C19 replacement.

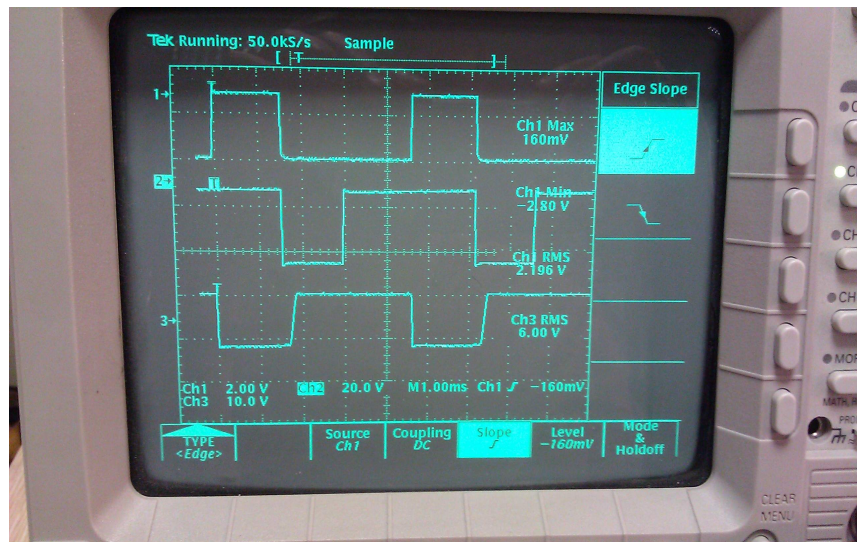
On 17<sup>th</sup> March V10 failed, causing pulse widths and period to contract. The 6AM5 was replaced with an equivalent NOS EL91.

The photo below shows +A, -B, -A pulses after replacement of C19 and V10.

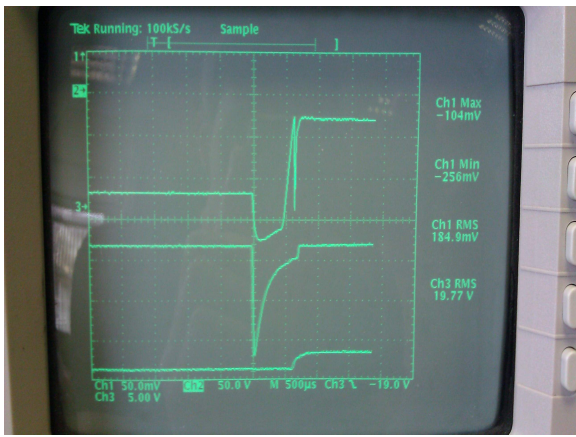
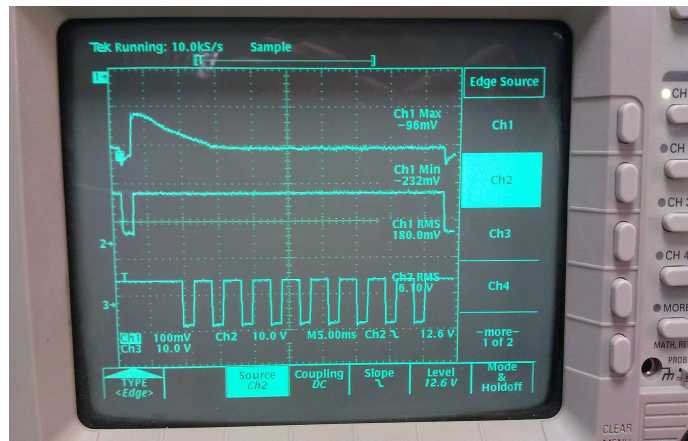
A fault was discovered in this circuit which became more apparent over the period of fault-finding. This was traced to rectifier W2 (actually two germanium in series, probably a Wolverhampton replacement). This was replaced on 17<sup>th</sup> March with a modern 1N4007 silicon diode. This restored the correct timing of the trigger signal to V5 and eliminated spurious narrow pulses from the B pulse switching outputs.

The left picture above shows the V5 trigger, V4 grid and V5 cathode before the repair, the right hand picture shows V5 trigger, RCB and 9B after replacement of W2.

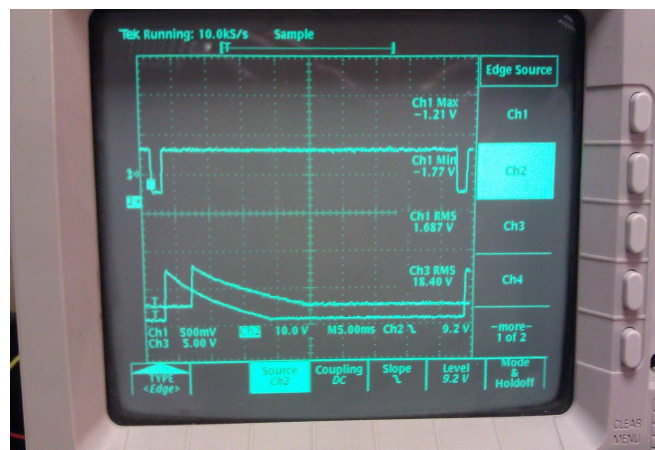
As noted above RV1 must be adjusted correctly to ensure waveform z (from trailing edge of RCB pulses) is not too large relative to waveform y (from trailing edge of first normal B pulse). The picture below shows correct adjustment – RCB, z, y.

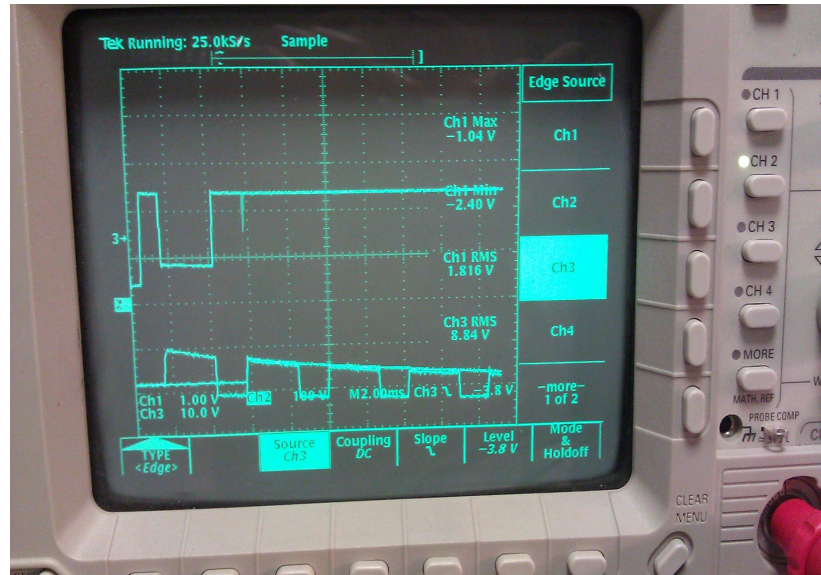
These circuits produced the correct waveforms but with narrow spikes coincident with the rising edge of B pulses. These were traced to V20, the output of which drives SK3 and is mixed into SK2. Initially rectifier W29 was suspected, but temporary substitution with a silicon diode didn't alter the symptom. The picture below shows SK2, and V20 grids.

The problem is hard to see in this picture but there is ringing on the rising edges of the B pulses mixed into waveform z which is compared with waveform y by V20. This problem was solved by adding a 330pF capacitor from the junction of W29/R60 to -180V, to slow down the rising edges. The picture below shows the waveforms on SK3 and V20 grids after the capacitor was added.
