Quality Assurance Division

Model #
Neptune r1.3 (Sept 2024)

No.
002

SUBJECT:

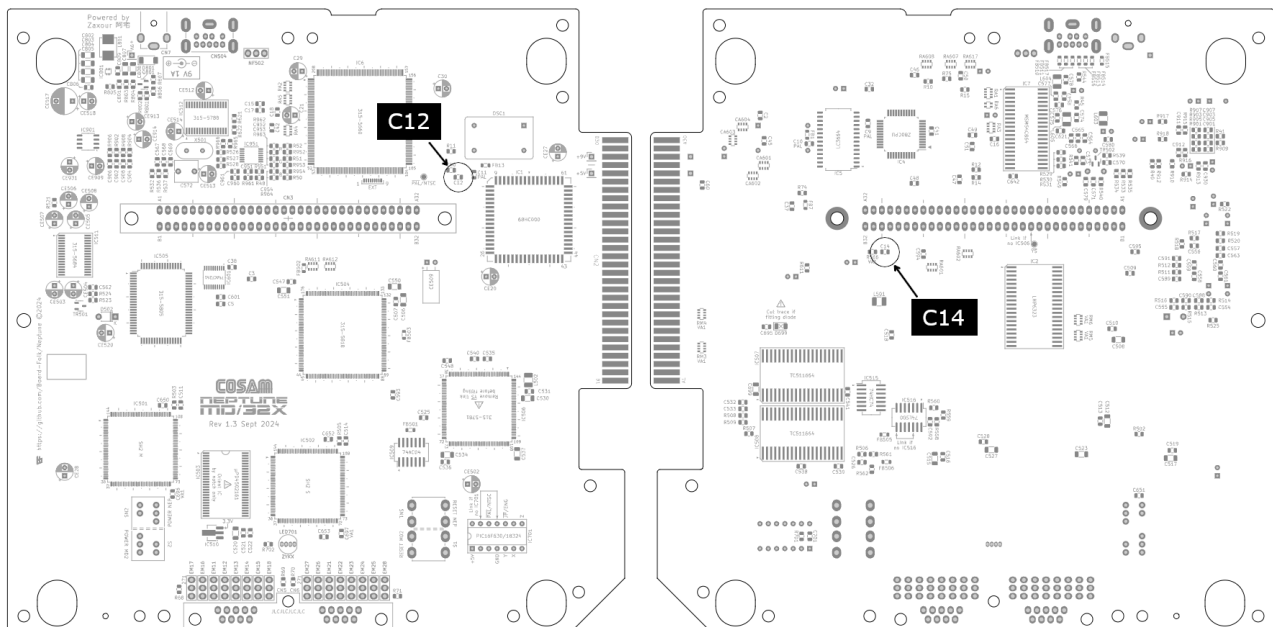
Component Locations

While using the Neptune r1.3 (Sept 2024) and earlier, the console may hang with a black screen after displaying the TMSS message when powered on.

It has been found that the values of capacitors C12 and C14 may be too high to allow a proper power-on reset in some edge case situations.

Capacitors C12 and C14 must be replaced with value 1nF to fix this problem, see COMPONENT LOCATIONS below.

1.	Remove capacitors C12 and C14 (see diagram).
2.	Fit size 0805 capacitors with value 1nF at C12 and C14.
