2009 RESERVE FUND STUDY UPDATE BASED ON A SITE INSPECTION FOR

CCC 750 Merivale Gardens
Glenridge Road, Ridgepark Private,
Garden Glen Private
Ottawa, Ontario

May 27, 2010

Halsall Associates Limited
210 Gladstone Avenue, 4th Floor
Ottawa, ON K2P 0Y6
Contact: Diana Carr, P.Eng

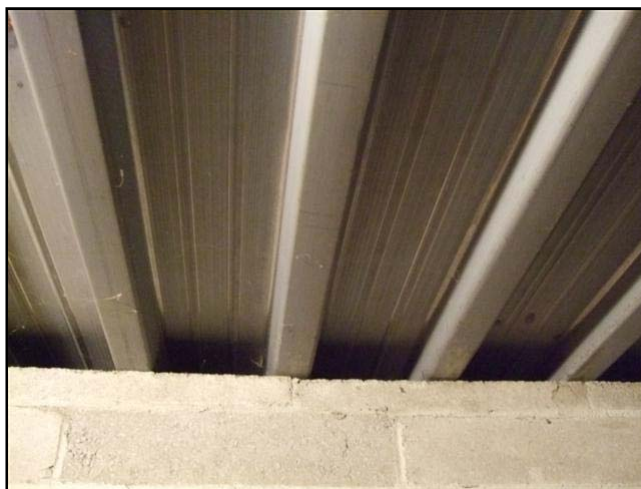
Photo No. 3: Basement ceiling construction

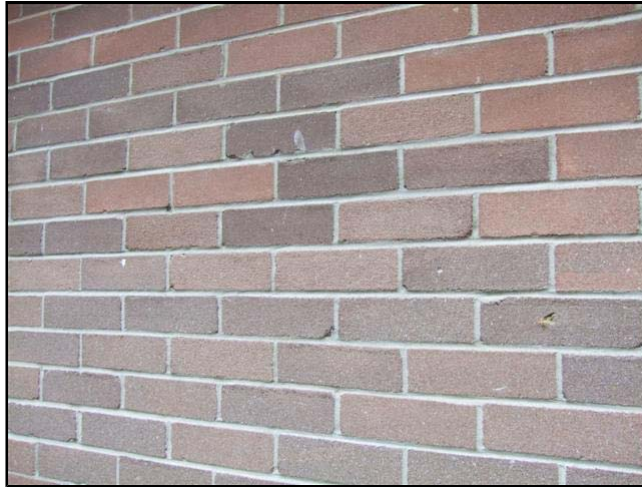
2009 Halsall: Spalled brick and deteriorated mortar was noted particularly at areas with poor water shedding, such as at and below window sills and at chimneys. Most of the chimney caps are deteriorated and require either repair, or replacement.

Photo No. 4: Spalling brick

We recommend completing a wall condition evaluation to refine the repair scope and associated budget. Pending this evaluation, the plan includes an allowance for repointing and local brick repair. In addition, we recommend improving water shedding of the brick sills and chimney caps by installing metal flashings with drip edges. This will help protect the masonry from future damage. local brick repair, installing retrofit connectors, exposing shelf angles for repair to flashings and corrosion protection.

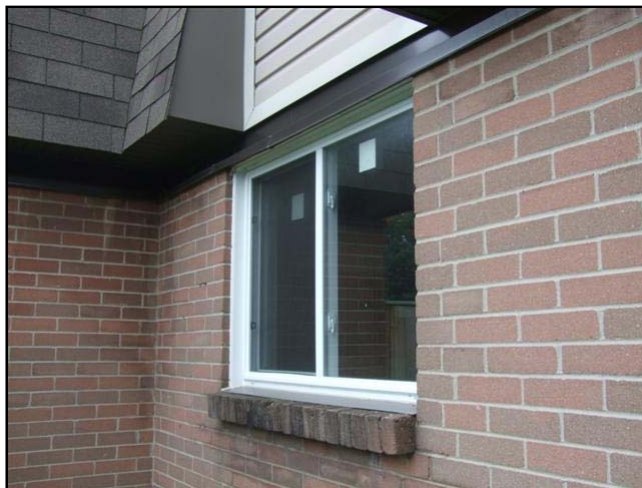
2009 Halsall: Weatherstripping generally appears in good condition. No water or air leakage has been reported to us. Budget for the eventual replacement of the window system. The Plan includes for 95% of the total cost, as the remainder is assumed to be paid from the re-caulking budget.

Photo No. 5: Window (typical)

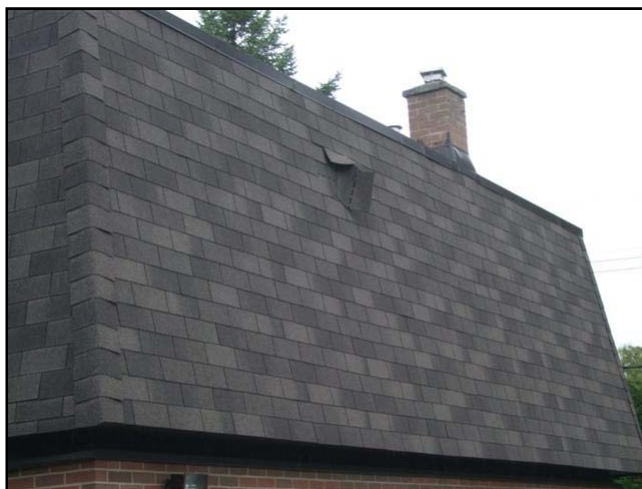
2009 Halsall: There are several dislodged and missing shingles on most of the buildings. This is likely due to the use of improper shingles for this application. Budget for re-shingling.

Photo No. 6: Mansard roof (shingles lifting)

Budget to replace the soffits with every 3rd re-shingling program.

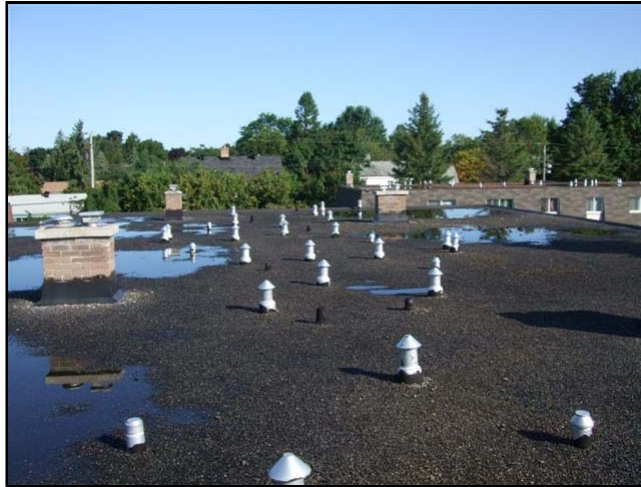
2009 Halsall: The roofs on most of the blocks have been repaired over time. Currently the roof over Unit 350 (forming part of block 344-362) is leaking. There are several reports of leaks as recorded by the Property Manager including at 205, 207, 209, 217 and 247 Ridgeway Pvt., 300 and 350 Garden Glen Pvt., and 39C Glenridge Road. A roof evaluation project is currently being undertaken by Halsall Associates. Pending completion of this evaluation, the Plan budgets for alternating programs of repair and replacement of the roofing membranes, including up to 25% of the sheathing on a phased basis. We have assumed that the modified bitumen roofs are less than 5 years old, based on their condition.

Photo No. 7: Roof of TH Block 344-362 (water ponding)
(water ponding)

2.4.2 Re-roof Built-up Roofing Block 344-362	\$88,560	\$90,331	2011	25 yrs	recurring	1	Forecasted
2.4.3 Repair Roofing Allowance	\$14,586	\$17,780	2020	7 yrs	recurring	3	Forecasted

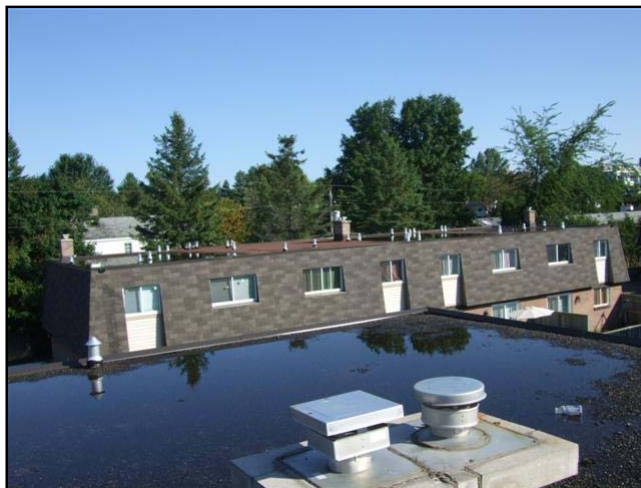
Photo No. 8: Adjacent roof layout (water ponding)

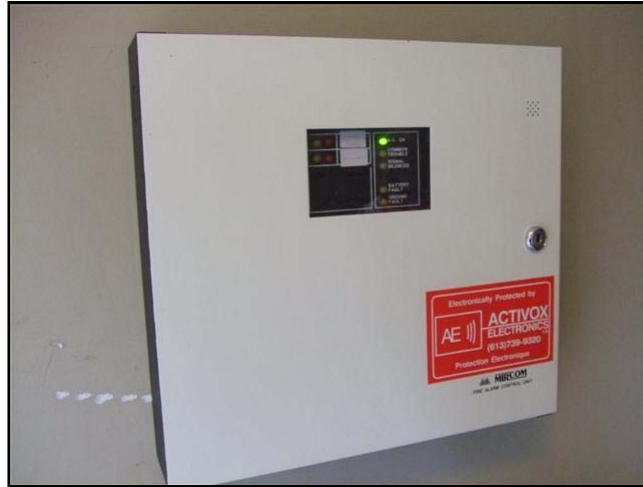
2009 Halsall: Vipond is in the process of installing a fire alarm system in each of the remaining 3 townhouse blocks. The systems are new/currently being installed. Budget for their eventual replacements. The Plan allows to replace all of the wiring and devices with every 3rd panel replacement, in order to maintain compatibility with changing technology.

Photo No. 10: Fire alarm panel

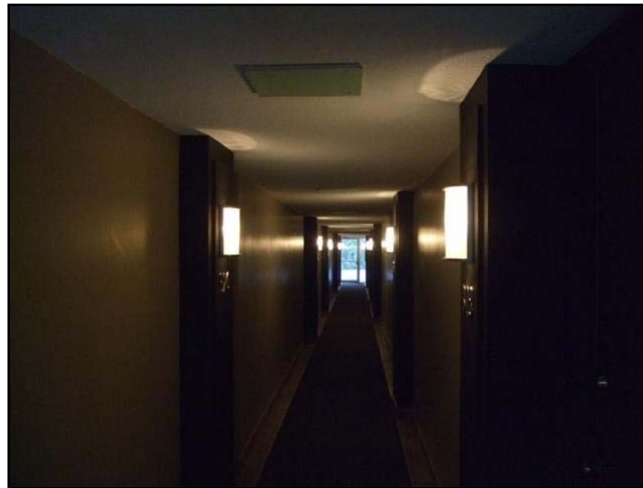
Photo No. 11: TH corridor (typical)

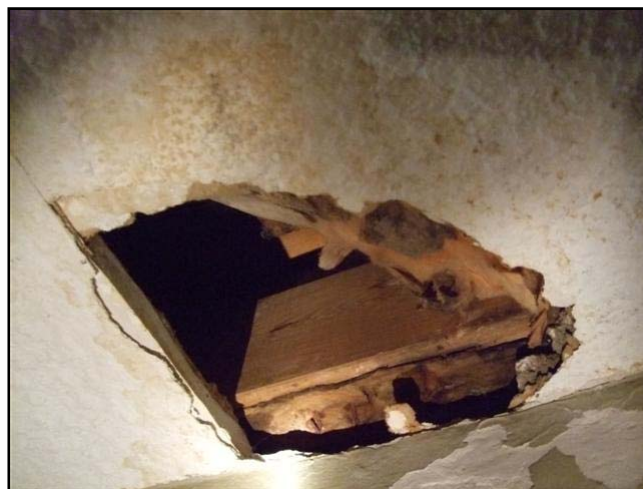
2009 Halsall: The corridor finishes are generally in good condition. However, throughout each corridor, some of the drywall ceilings have been damaged by water leaks stemming from 2nd floor bathrooms. The leaks should be promptly repaired, including the ceilings. as part of normal maintenance.

Photo No. 12: Damaged corridor ceiling (water leak from upstairs bathroom)

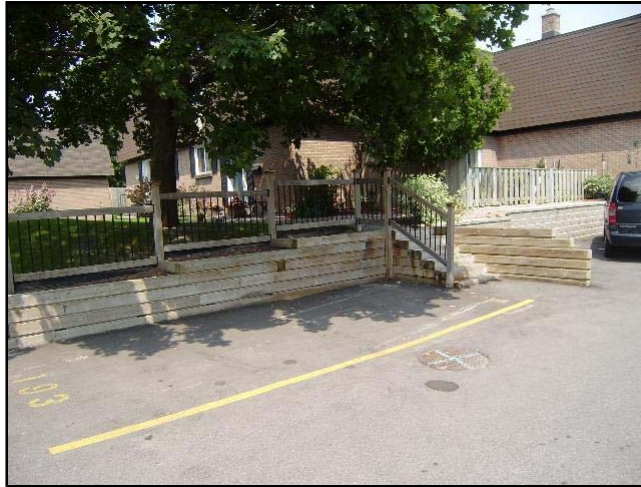
Photo No. 13: Retaining wall

Budget for repairs to the wood and precast retaining wall within the term of this report and for its eventual replacement.

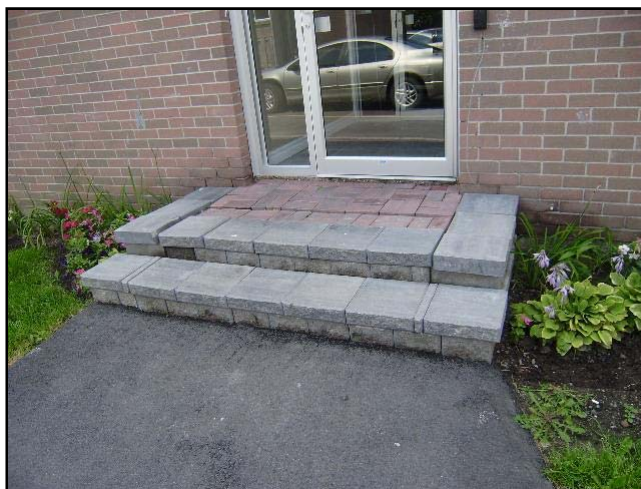
At some of the entrances, the brick unit pavers have settled and need to be reset as part of normal maintenance. General replacement of the unit pavers is not anticipated, provided periodic repairs and re-setting are carried out as maintenance.

Photo No. 15: Unit pavers at front entrance to TH blocks

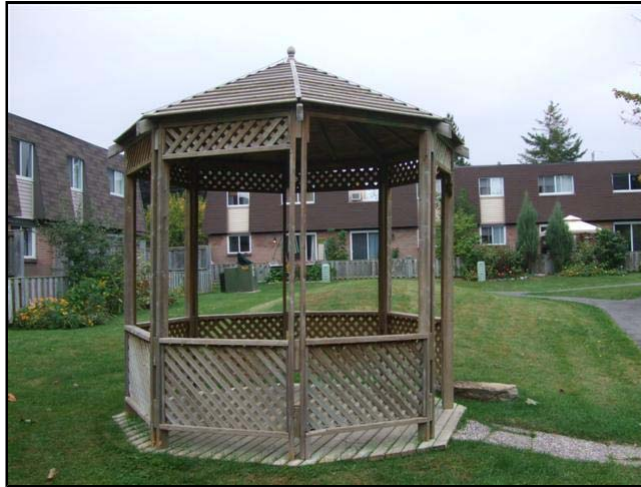
Photo No. 16: Gazebo

Replace the fencing and gazebo at the end of their service life.

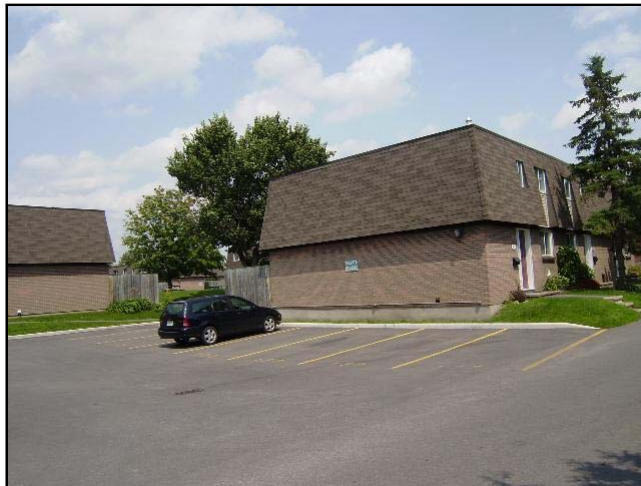
2009 Halsall: The asphalt-paved parking areas and walkways showed no major deterioration. Budget for alternating programs of repairs and replacement.

Photo No. 17: Parking area (typical)

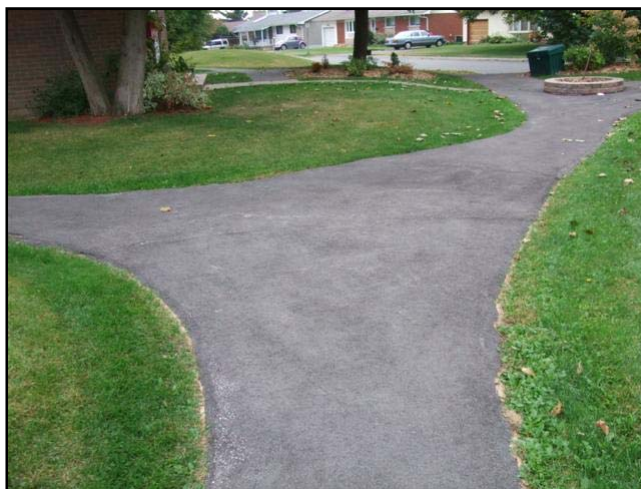
Photo No. 18: Asphalt walkway (typical)

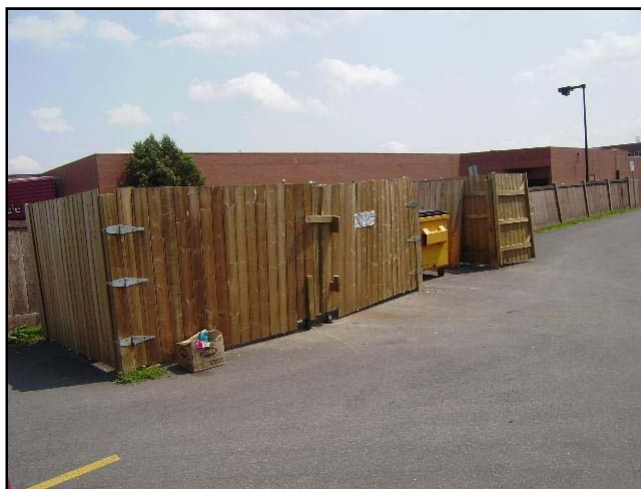
2009 Halsall: Garbage bins are provided throughout the site. The fence enclosures at some locations is falling down. The maintenance and replacement of the bins and enclosures is typically managed from the operating budget.

Photo No. 21: Garbage enclosure

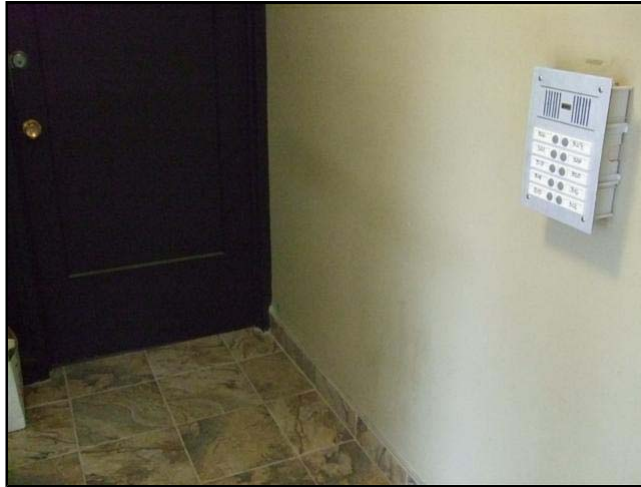
2009 Halsall: No concerns were noted and reported to us. budget for the eventual replacement of the intercom systems.

Photo No. 22: Intercom in TH lobby
