## Volume 6 Paper H012

### In advanced Creep Failure of H.P. Modified Reformer Tubes in an Ammonia Plant

#### Abstract

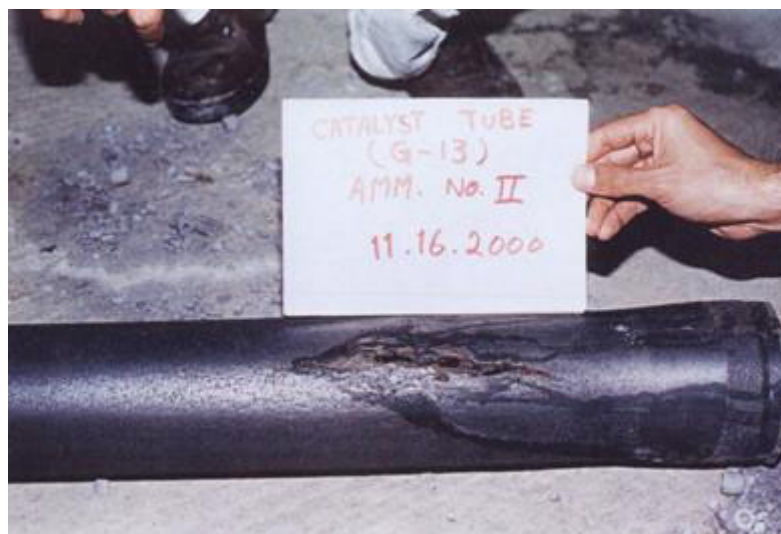
The split are of the tube showed a large local bulging. A rough measure of tube circumference in the bulged area showed a 350 mm value compared to 337 mm in adjacent visually non damaged area. Nominal tube OD is 104.8 (+0.2) mm which gives a nominal circumference of 329 to 335 mm. Visually the failure has a typical creep aspect with numerous longitudinally oriented cracks. Obviously it is not a brittle failure (*Figures 4,5*).

Figure 4. Local Bulging at the Split Area of the Tube

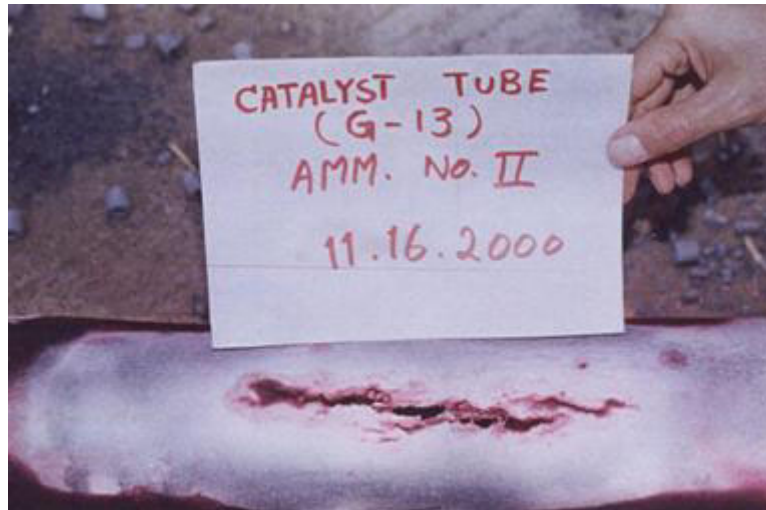
Figure 5. Longitudinal Cracks at the Bulged Area of the Tube

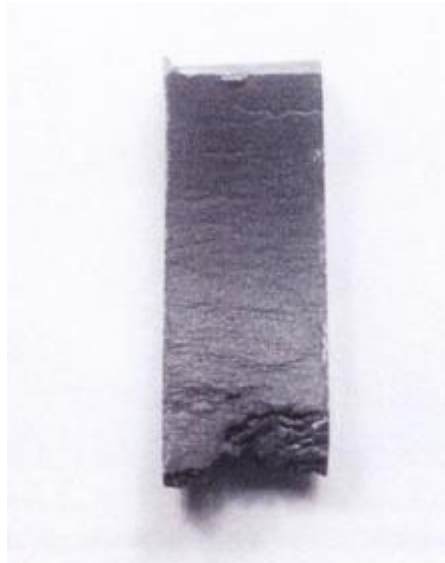
Five samples labeled A, B, C, D1 and D2 (*Figure 6*) were collected for evaluation. The locations from which the samples were taken are shown in *Figure 7*. Visual examination of samples A and B did not reveal anything untoward. Examination of samples C and D2 revealed a smooth inner surface to the tube typical of a machined finish. Sample D1 showed undulations oriented in the axial direction typical of macrostrain accumulation (*Figure 8*). The outer surfaces of samples D1 and D2 appeared unusually smooth for centricast tubes; however, discussions with manufacturer revealed that the failure occurred within the area machined as part of the manufacturing process for this section of tube.

Figure 8. Inner surface of sample D1 with strain lines apparent

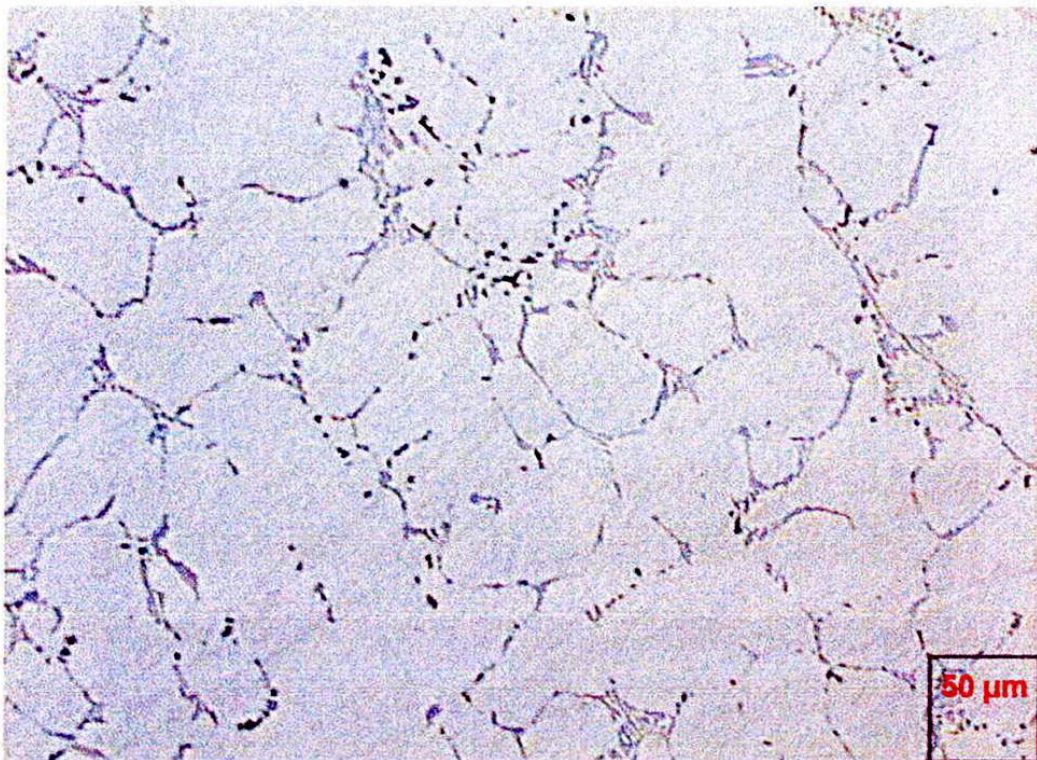
Sample A – A network of primary carbides was apparent on the grain boundaries, consistent in appearance with an HP Modified furnace tube on entering service (*Figure 9*).

*Figure 9. Sample A with primary carbides clearly visible*

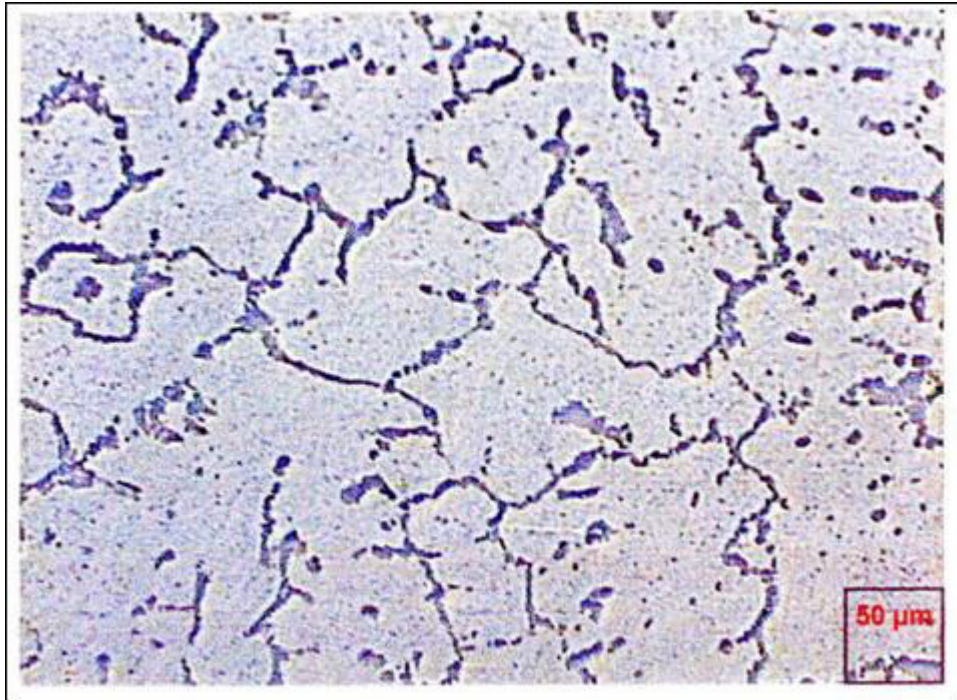
Sample B – The network of primary carbides was still clearly apparent. A fine dispersion of secondary carbides has precipitated within the grains (*Figure 10*).

*Figure 10. Sample B with Primary and Secondary Carbides*

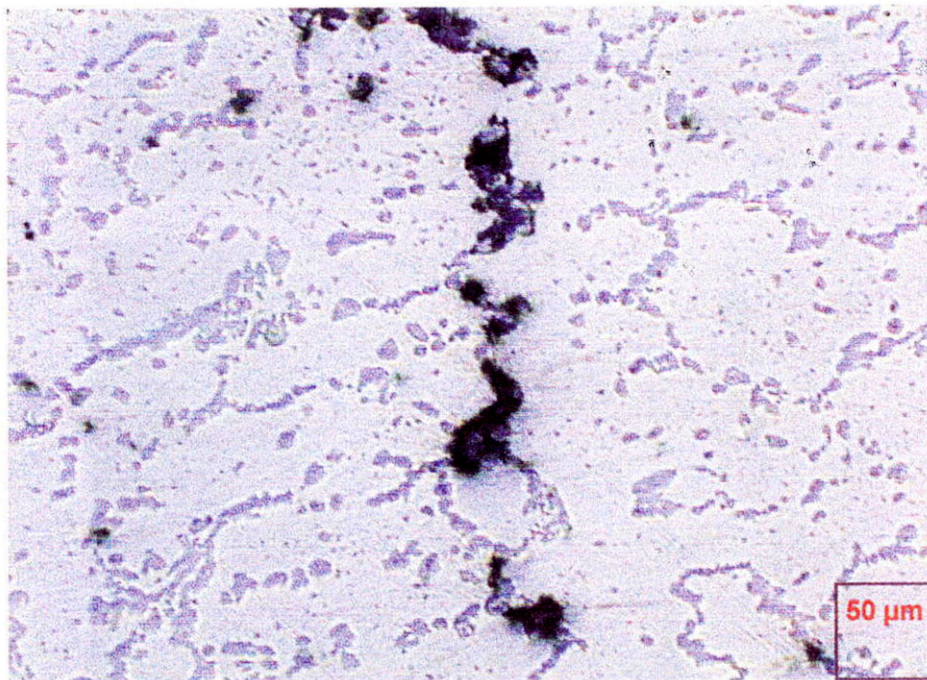
Sample C – Examination of this sample revealed large primary carbides on the grain boundaries and large secondary carbides within the grains. Creep cavities were also apparent on the grain boundaries on this sample (*Figure 11*).

Figure 11. Primary and Secondary Carbides and oriented cavities in Sample C

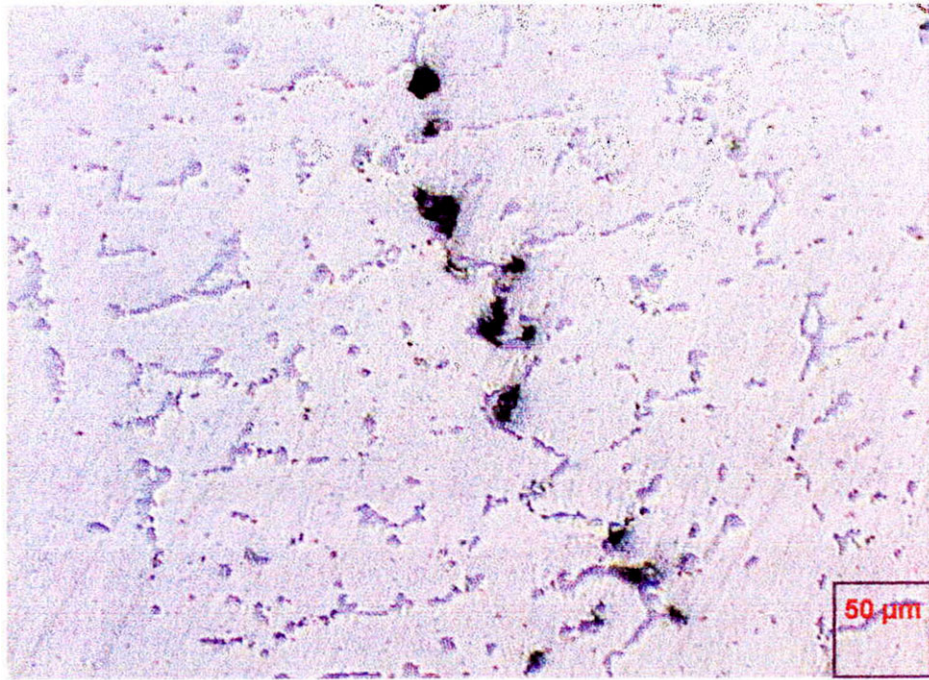
Sample D2 – Examination of this sample revealed large primary carbides on the grain boundaries and large secondary carbides within the grains. Microcracking was apparent in the outer third of the tube wall oriented in the through wall direction; oriented cavitation was apparent through the sample (*Figure 12*).

Figure 12. Microcracking and oriented cavitation in Sample D2

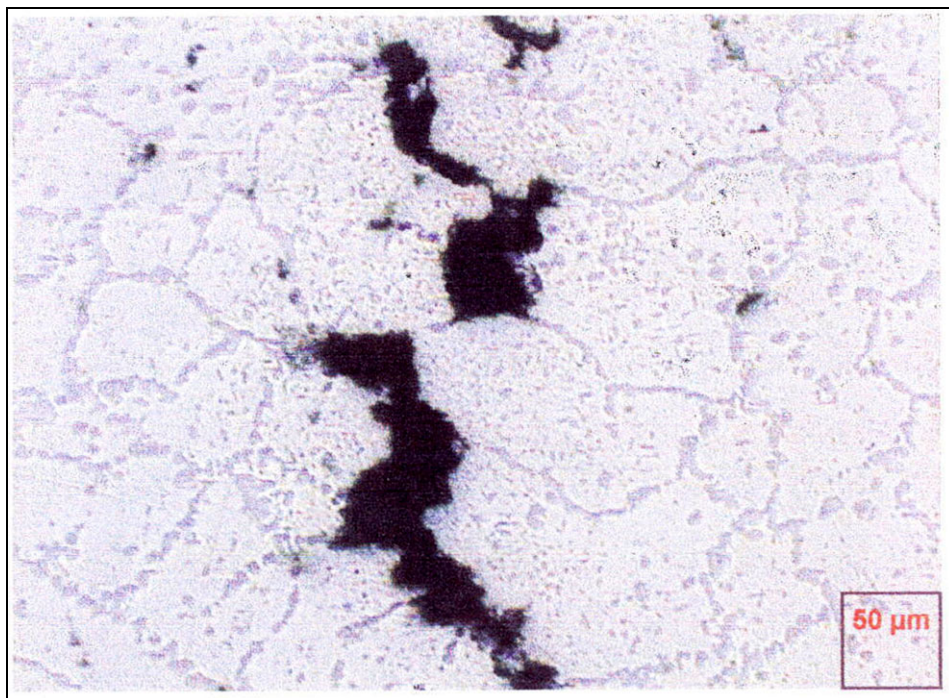
Sample D1 – Examination of this sample revealed large primary carbides on the grain boundaries and large secondary carbides within the grains. Macrocracking, microcracking and cavitation were apparent through the tube wall oriented in the through wall direction. There was heavy precipitation of secondary carbides associated with some of the larger cracks. Again the highest concentration of cracking was seen in the outer third of the tube wall (*Figure 13*).

Both the location of the damage in the tube wall and its appearance are typical of creep damage resulting from high temperature operation under an internal pressure stress. The lower levels of microstructural degradation in samples A and B, when compared with samples C, D1 and D2, indicate that damage is unlikely to occur at these locations in the short term.

Figure 13. Sample D1 showing Macrocracks
