## Summary of Findings on Failed Gas Valves

This note summarises our findings on the failure of gas valves associated with hydrogen embrittlement of bolts used in the assembly of the valve.

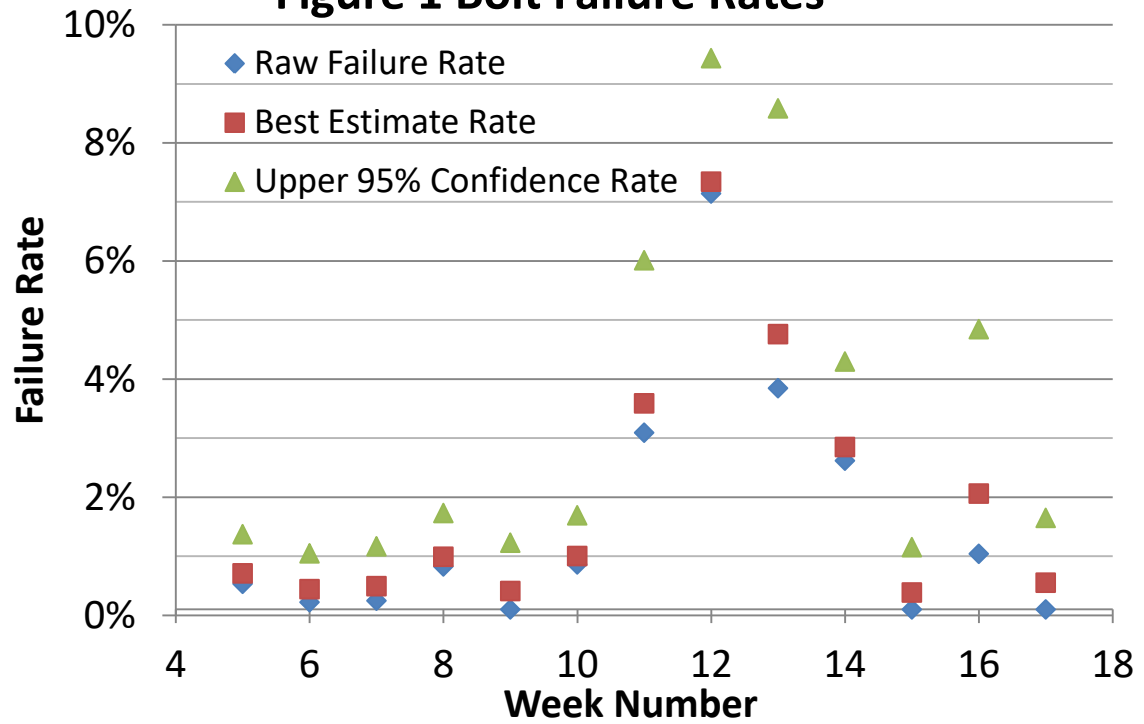
**Figure 1 Bolt Failure Rates**

In summary, the statistical analysis, last updated in March 2014, suggests that there were one or more 'bad' batches of bolts, supplied by one manufacturer (TVS) that had a higher than normal susceptibility to IHE, and gave rise to a cluster of failures in weeks 11 to 14 in 2010. This is shown in Figure 1, which plots the estimated probability of bolt failure as a function of the date of valve production. Three estimates of bolt failure probability are shown:

- Raw failure rate - this is simply the number of failed bolts divided by the number of bolts examined. Owing to the small number of bolts from some periods (especially outside the known 'at risk' period), this may under-estimate the true failure probability.
- Best estimate failure rate - this assumes that the next bolt to be examined will have failed. This will typically over-estimate the failure rate, especially when no failures are observed.
- 95% confidence estimate - this provides a very conservative estimate of the possible failure rate.

Based on Figure 1, assuming that at least three bolts must fail for a valve to fail, and ignoring deviations from homogeneity and independence, a bolt failure probability of 1 % leads, as explained above, to a valve failure probability of 1 in 1 million, which can reasonably be considered as acceptable. From the data of Figure 1 it can be seen that there is a significantly enhanced probability of valve failure in weeks 11 to 14, as is found for actual valve failures. Week 16 also has an apparently high failure probability, but this is based on very limited data, with only one failed bolt in a sample of 96. This highlights the difficulty of obtaining adequate data for reliable statistical analysis when the probabilities of failure are low.
