Volume 6 Paper H069

An Investigation on the Corrosion Behavior of Transfer lining Exchanger (TLE) in Olefin Plant of Arak Petrochemical Complex

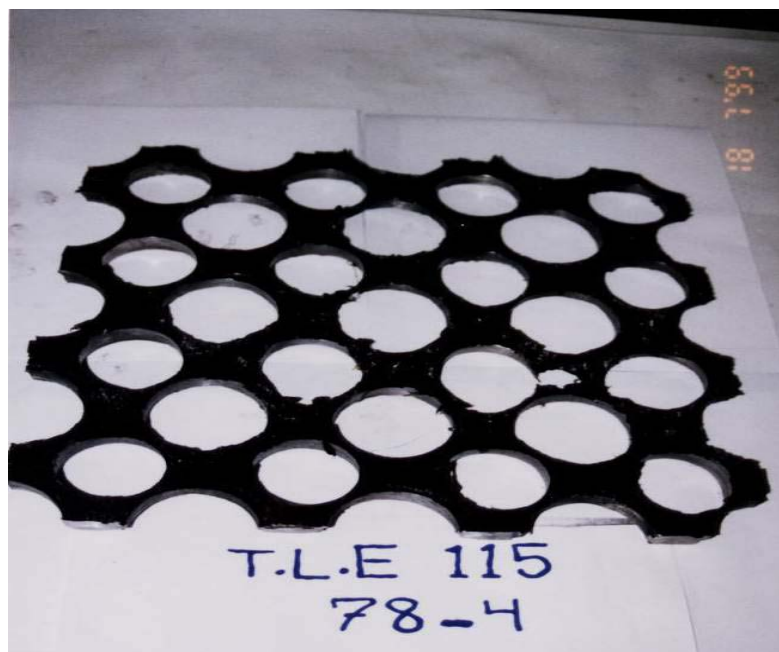
1. There is a considerable reduction in thickness observed in the gas side of the tube sheet. In some places thickness is reduced to around 5 mm. This could be due to impact of high velocity vapor bubbles.
2. In the welded joint between the tube and tube sheet a high degree of erosion due to gases are observed which makes the tubes loose in their place.
3. In the water side of the tube sheet, large pits with dimensions in the range 15 to 20 mm and depth of 1 to 15 mm are observed. (Fig. 3). These have all led to the perforation of the part.
