## Volume 4 Preprint 5

### AC Induced Corrosion - Summary of AC Corrosion Cases

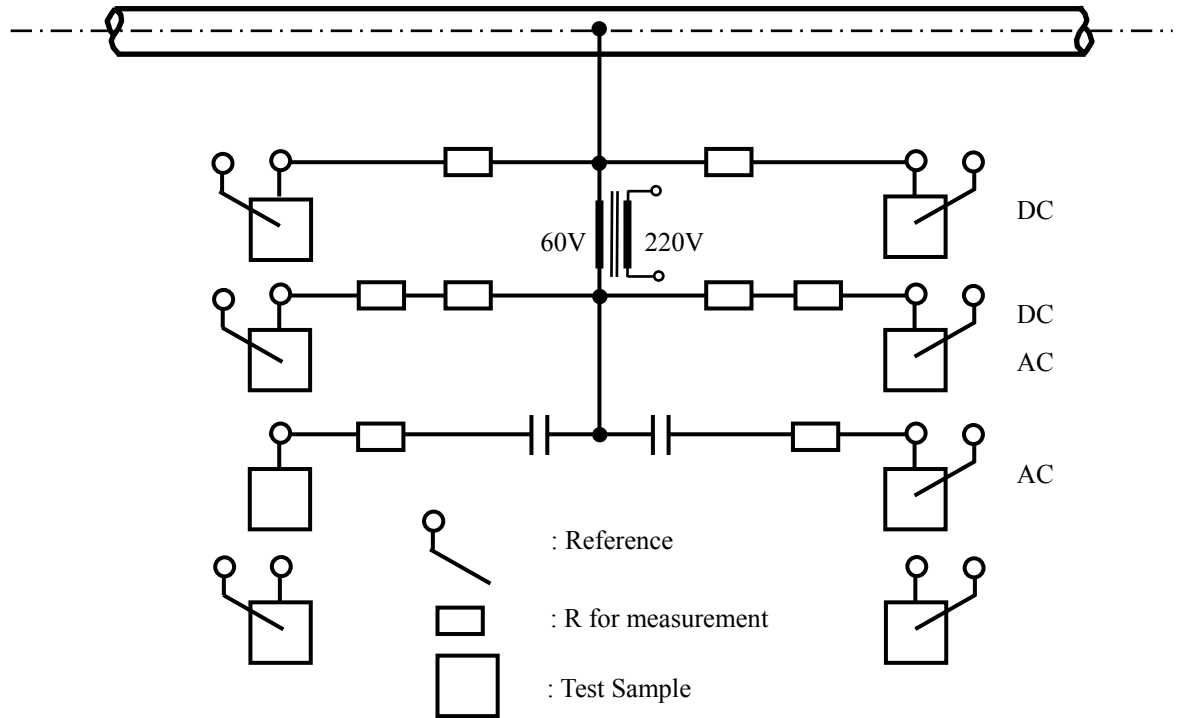
Figure 2.1 The Field Test Layout (in the clay and the sand environment)

- Fig 2.1 shows the layout of the field test (in the clay and the sand environment).

- Two cases, clay and sand environment, were simulated.
- Applied alternating currents in the sand environment were 10 to 30[A/m<sup>2</sup>]
- Applied alternating currents in the clay environment were 300 to 1,000[A/m<sup>2</sup>]

- Both of the tests showed that the corrosion was more severe when the alternating current was applied
- There were some corrosive attack when the alternating current was applied even with the cathodic protection.
- No corrosive attack was observed when the condition was without the effects of the alternating current and with the cathodic protection.

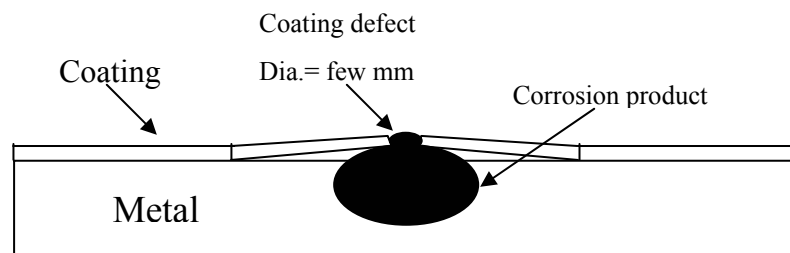
Figure 2.2. The Characteristics of AC corrosion

- The corrosion surface had a hard layer of the oxide
- The corrosion products shaped the form of a bubble under the coating defect as shown in Figure 2.2.
