Corrosion Studies on Silver coated Second Surface Mirror Reflectors for Parabolic Trough collectors

Y. Raja Sekhar, S. Angel Jeba, J. Premjit Daniel

Abstract

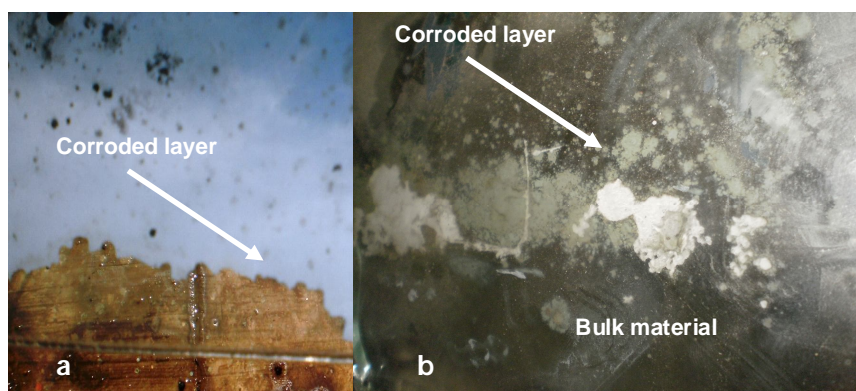
Fig. 1 a) Edge corrosion on the mirrors kept indoor b) Pitting corrosion on the mirrors kept indoor

2 inch were cut from three different types of mirrors and named them type 1, 2 and 3 respectively. Edge and pitting corrosion were also observed on the spare mirrors as shown in Fig.1b even though they had been kept indoors for future use. The type 2 and type 3 mirror samples were tested under accelerated environmental conditions. Stereo micrograph images were taken at the corroded regions of all the samples. The type 2 mirror samples exhibited pitting corrosion after subjecting them continuously to 100% RH and salt fog during humidity and salt spray test for 150 hours and 168 hours respectively. It was observed from SEM and XRF analysis of type 1 sample that the thin silver coating on the glass substrate had uneven coating thickness varying roughly from $0.6675\ \mu\text{m}$ to $0.7949\ \mu\text{m}$ as shown in Fig 2. The reason for uneven thickness of the coating must be due to erosion of the thin silver layer along with other coating layers supporting the reflective layer. Also, visual inspection of the mirror showed decrease in reflectance due to erosion of the silver layer. EDX analysis performed on type 1 and accelerated corrosion tested type 2 sample, resulted in presence of Magnesium (Mg) element. The weight percentage of Magnesium present in the sample subjected to corrosion test was observed to be more. The EDX analysis of type 1 and 2 samples had also shown much reduction in weight percentage of silver and complete loss of copper. The elemental analysis results of these samples supported the argument as shown in Table 4 and 5 respectively.

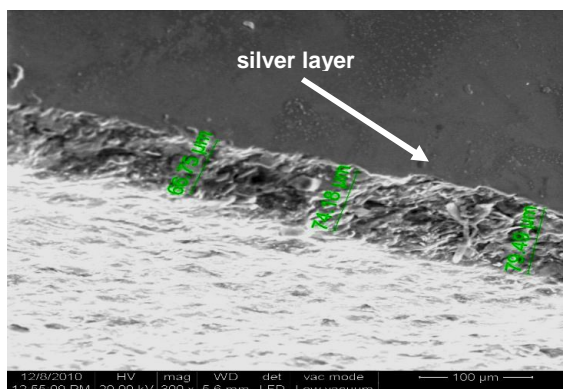
Fig 2. Cross-sectional view of type 1 mirror sample coating

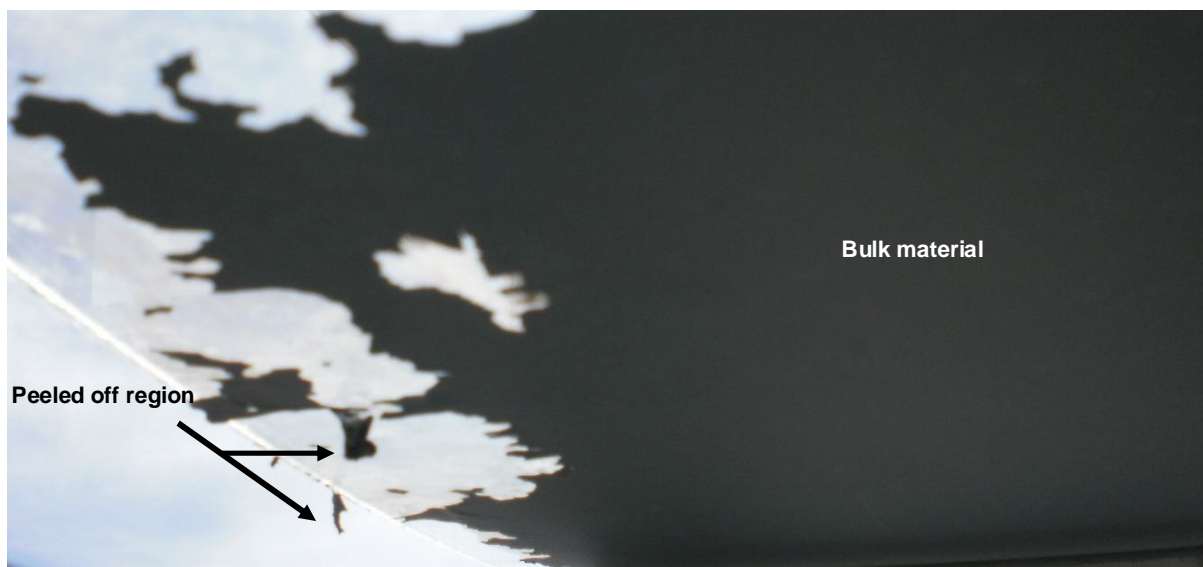
during the day. When the ultra-violet radiation ($295 < \lambda < 400$ nm) in sunlight is absorbed by paint, it starts to cleave weak chemical bonds, leading to photo-oxidation (bleaching, fading, discoloration, chalking, brittleness and cracking) as shown in Fig 4. The bond cleavages resulting from UV absorption cause the formation of radicals. Each free radical will trigger a chain of reactions (in the presence of air), leading to more bond cleavages and destruction explained by the following reactions [19].

Fig. 4. Photograph showing peeled off regions of the mirror sample due to corrosion

Once the cracking of paint begins, the Mg content present in paint and the $MgCl_2$ aerosol in air penetrate through the pores of the paint layer and come in contact with the copper layer underneath. Galvanic corrosion takes place at the Mg-Cu interface, where Mg act as anode because of its high electro-negativity in the electromotive force (EMF) series, further deteriorating the paint layer. The mechanism of the galvanic corrosion is expected and given by the following equations:

The liberated hydrogen collects as bubbles underneath the paint layer causing it to swell slightly finally leading to blistering and peeling of the paint. The failure of the paint layer results in the exposure of Cu to the ambient atmosphere. In the initial stage, magnesium dissolves and Mg^{2+} (aq) cations are produced, possibly through intermediate steps involving

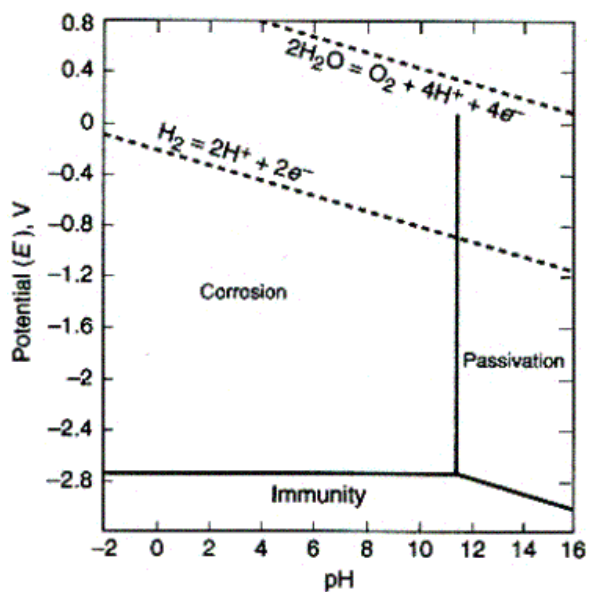
Fig. 5. Magnesium in water Pourbaix diagram at 25 °C

monovalent magnesium ion. In the second reaction, magnesium dissolution is accompanied by hydrogen evolution, since magnesium in neutral and low pH aqueous solutions is well below the region of water stability. Finally, $\text{Mg(OH)}_2(\text{s})$ is formed as pH rises due to release of OH^- ions in the cathodic reaction, as shown in Pourbaix diagram Fig. 5 [20,21].

The whole domain of stability of magnesium is well below that of water. Magnesium therefore dissolves as Mg^+ and Mg^{2+} with accompanying hydrogen evolution. The quasi-passive hydroxide film formed on magnesium is less stable than the passive films which form on metals such as Aluminium and stainless steels. This quasi-passivity provides poor resistance to pitting for magnesium. The films that form on magnesium are slightly soluble in water and do not provide protection over long periods. They also break down in the presence of certain ions like chloride, bromide, sulfate and chlorate, or in water exposed to acid gases such as CO_2 . Since, the standard reduction potential of Mg is -2.4V , magnesium corrodes rapidly at higher potentials. A stable layer of Mg(OH)_2 will form only at pH values higher than 11 which provide protection against further corrosion as shown in Fig.5. This protection is highly dependent on the prevailing environmental conditions.

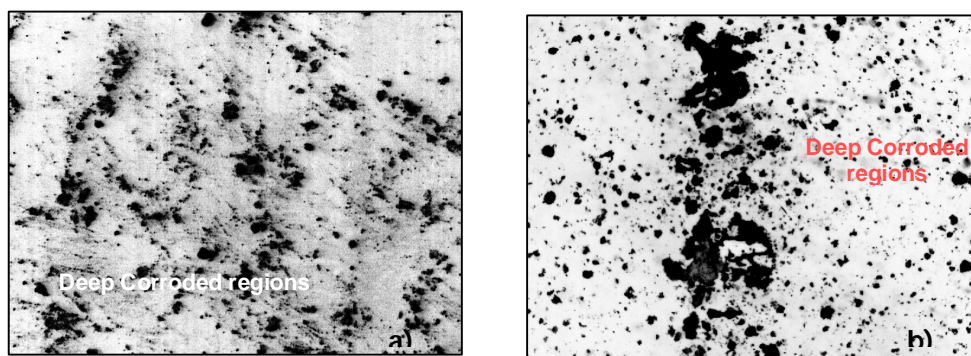
Fig. 6: Stereo micrograph of the corrosion damage to 6 mm thick mirror type 1 sample HT 1
a) After subjecting it to humidity test (100% RH) for 150 h. (X 63)
b) After subjecting it to salt spray test for 168 h. (X 63)

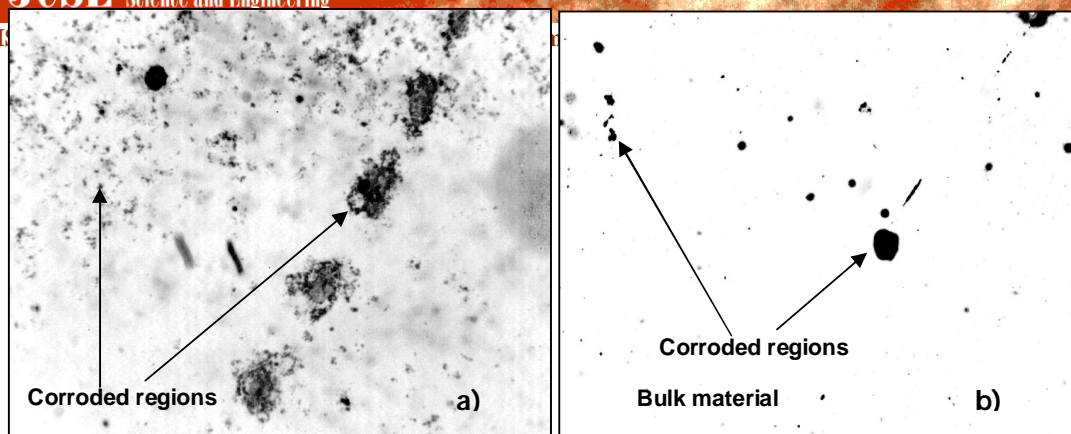
Fig. 7 Stereo micrograph of the corrosion damage to 6 mm thick solar reflector mirror type 3 sample HT 3 coated with white polyurethane a) After subjecting it to humidity test (100% RH) for 150 h. (X 63) b) After subjecting it to salt spray test for 168 h. (X 63)

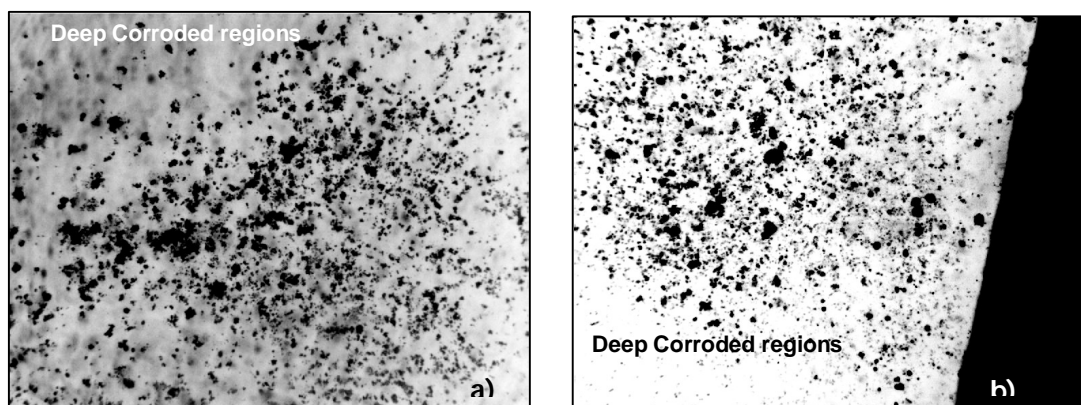
Fig. 8 Stereo micrograph images of corrosion damage observed on the 6 mm thick type 3 mirror sample HT 2 coated with transparent polyurethane coating after subjecting it to humidity test (100% RH) for 150 h. (X 63)

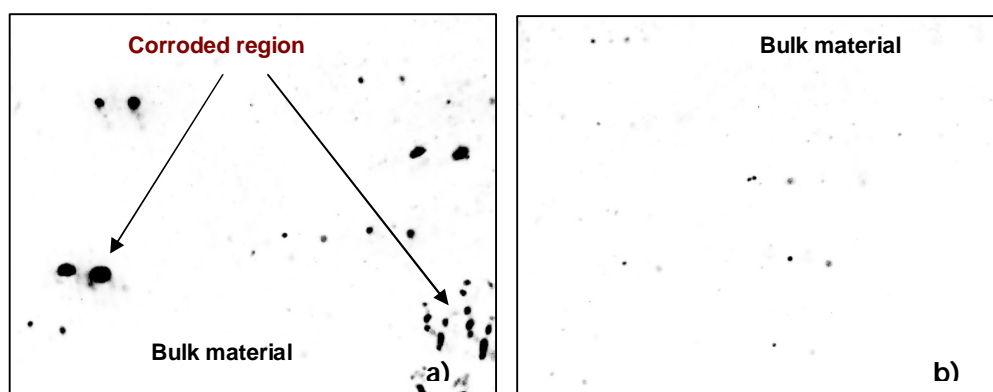
Fig. 9 Stereo micrograph of the corrosion damage to 4 mm thick type 2 commercial mirror sample SS 5 after subjecting it to salt spray test for 168 h. (X 63)

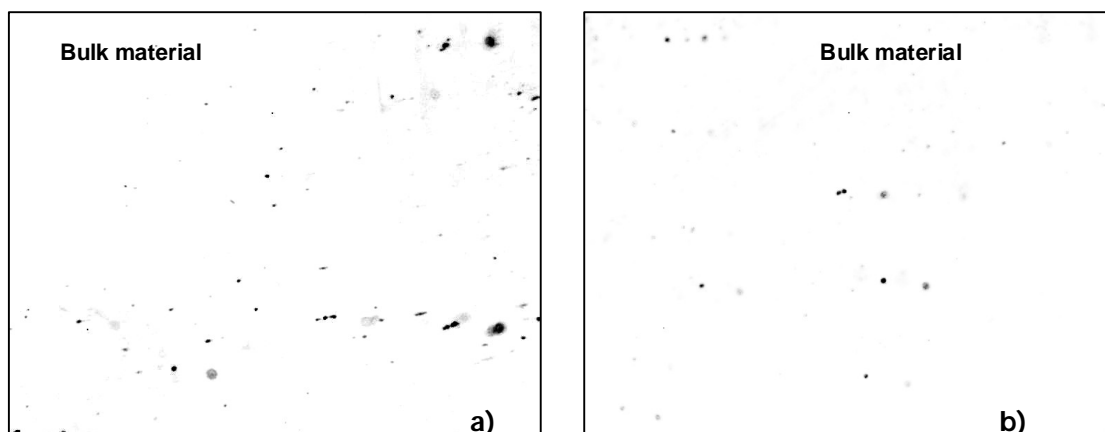
FIGURE 10: Stereo micrograph of the corrosion damage observed at the central region of 4 mm thick commercial type 3 mirror sample SS 6 coated with white polyurethane coating
a) After subjecting it to humidity test (100% RH) for 150 h. (X 63) b) After subjecting it to salt spray test for 168 h. (X 63)
